# RAPID ASSESSMENT OF ZALUN BANK EROSION (DRAFT)

field inspection, diagnosis and first recommendations

RVO in collaboration with DWIR

8 FEBRUARY 2020

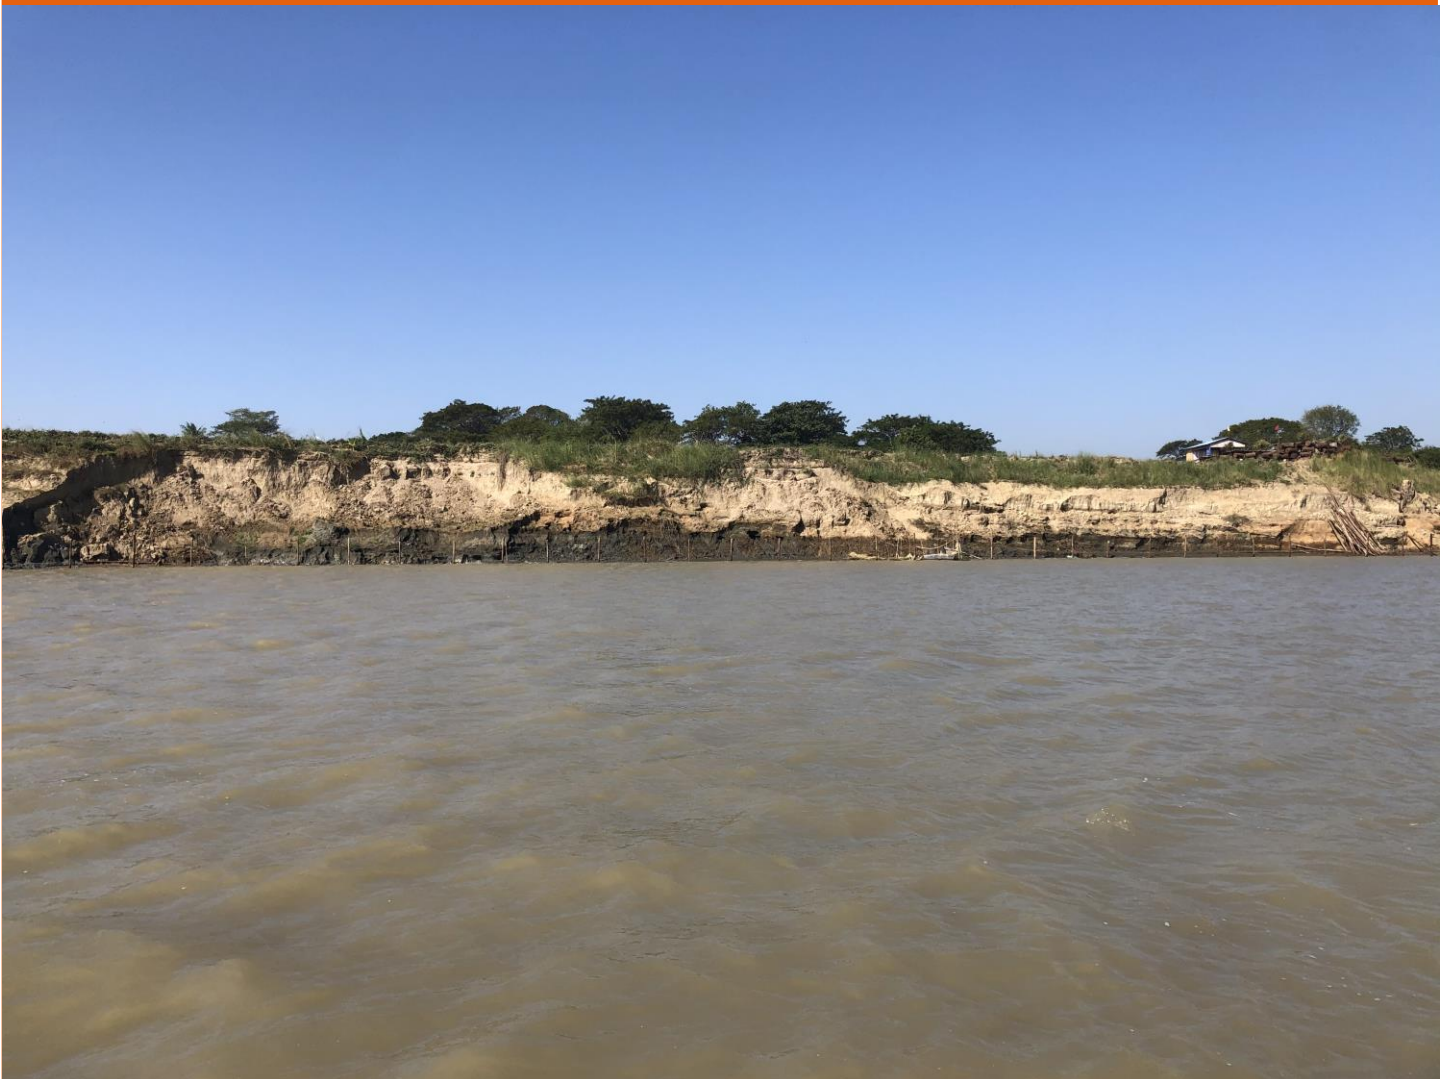
*Photo on front page: river bank erosion 8 km north of Zalun (photo taken from boat on 27 January 2020)*

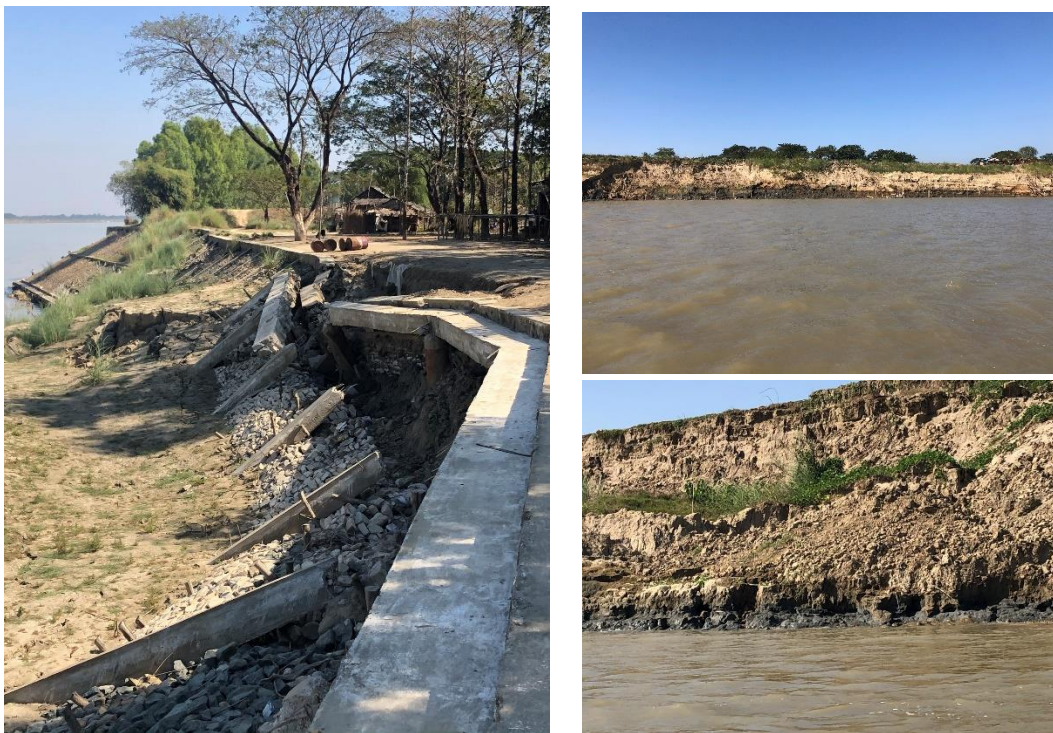
The morphological response of the river to these interventions was intense: the new cut-off channel quickly deepened and widened, started to meander itself and extended southwards, resulting in significant erosion of the floodplain downstream. Intense erosion was also observed along the primary west embankment, around mileage 22.0 (some 8 km north of Zalun) – see right two photos taken from the boat during the field inspection on 27 January 2020. Today, the erosion has reached the city of Zalun, where the existing revetment is already undermined and damaged (left photo below in Figure 3).

*Figure 3 photos taken during field trip on 27 January showing serious erosion on west bank*

On an even smaller scale, and on very short notice (i.e. coming wet season), the revetment at Zalun is under serious threat. The left photo in Figure 3 clearly shows the current structural damage. When the water level rises again from May onwards, the river flow will most likely further damage the structure.

The first, and foremost most important measure that should be taken is the rehabilitation of the failed revetment near Zalun so that the coming 2020 flood season does not deteriorate the current situation. Best option to do this is by covering the failed revetment works with sand-filled geobags. This is a cost-effective solution given the required urgency. In the long run a strong revetment at Zalun, built both above and under water with a sufficiently long falling apron, is the only way to stop the local bank erosion. However, it is hardly possible to build (17 m deep and 8 m high with already very steep slopes 1:2) and it will be very expensive (estimated at least 6000-10000 USD/m). In case the latter would be preferred in the long run, it is uncertain whether such a project has a feasible cost-recovery which implies that the avoidance of (monetary) damage to be larger than the costs for preventing this damage. We are not convinced this to be the case at Zalun.

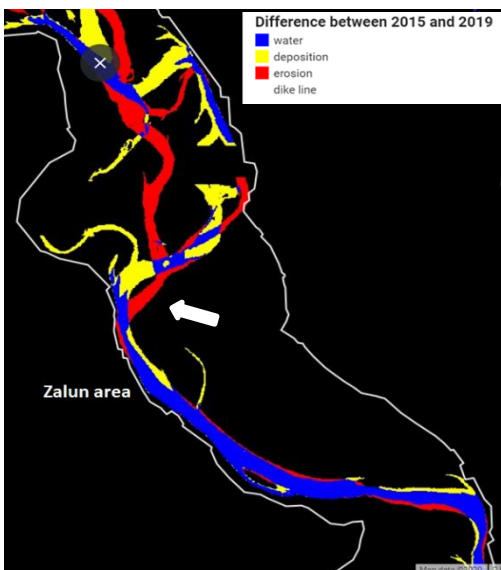
Figure 5 Satellite difference map 2015-2019 showing areas of erosion and deposition

The new channel that was dredged in 2016/2017 can be clearly recognized, but also its southward extension into the flood plain (indicated with the white arrow). What also can be seen is the abandonment of the old river meander that in 2015 still caused the erosion problems near Du Ya (see yellow colored remnants of the old meander). The meander cut-off was clearly very effective in stopping the erosion at Du Ya.

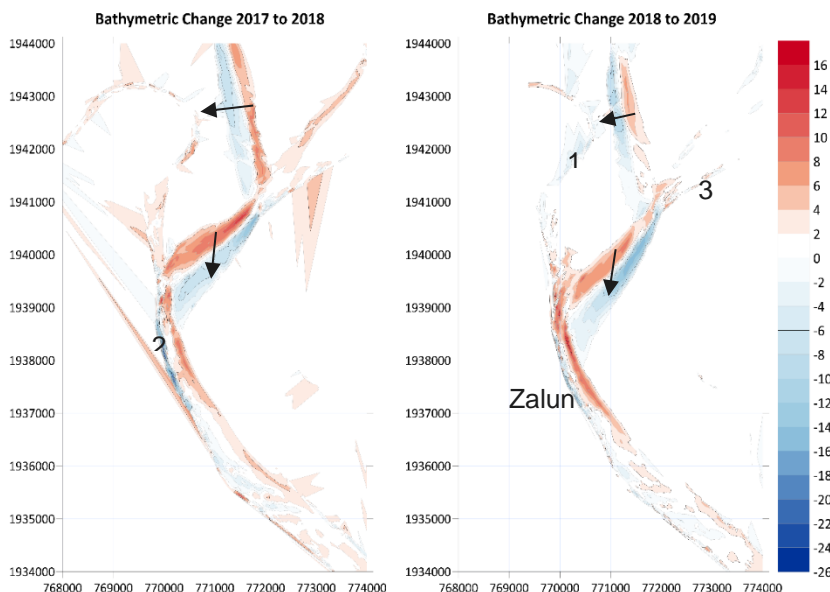
Figure 7 Patterns of erosion and accretion 2017-2018 (left) and 2018-2019 (right)

The arrows in Figure 7 show the westward migration of the cut-off channel over a distance of hundreds of m over the period 2017 – 2019. What can also be observed is that the cut-off channel is no longer straight but curved, with a tendency to develop a new meander to the left, i.e. to the west. The location indicated with nr “1” in the Figure suggests that erosion is taking place in an older river channel that may further develop into a new channel after some time.

The lowest two arrows in the Figure show how the cut-off channel has eroded the sand bank on the east side of the river. The northern bank has already moved southwards over a distance of more than 1 km in just two years’ time. This is not a surprise because the flow from the cut-off channel approaches this bank almost “perpendicular” (in reality flow curves bend) leading to high erosive forces. The new cut-off channel outflow consequently moved southward and re-orientated in counterclockwise direction. This is not positive for the stability of the riverbank at Zalun, because it will become more attacked by river flow if this continues.

Another possible “sign of change” can be the observed erosion near location “1” in Figure 7. It is possible that here a new side-branch of the cut-off channel develops, which may divert part of the river discharge away from the cut-off channel. This would then result in further shallowing (and narrowing) of the cut-off

To “help nature a bit”, we recommend to investigate the impact of excavating a connection channel between the “old” cut-off channel and a possible new side branch (“1” in Figure 7). This would lead water more parallel into the river and therefore decrease the flow attack on the westbank near Zalun currently induced by dominant flows coming from the eastern two current dominant channels.

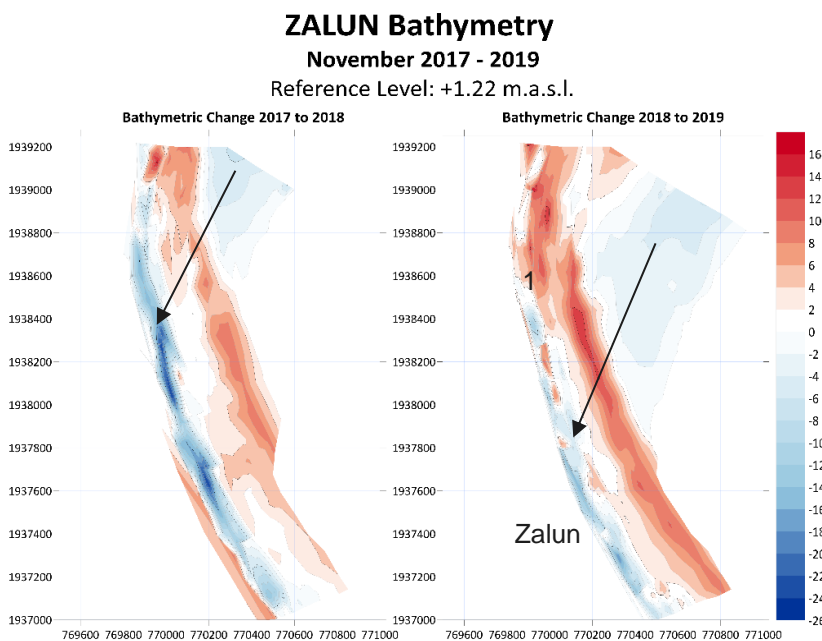
Figure 8 Patterns of erosion and sedimentation 2017-2018 and 2018-2019 – detail

Figure 8 shows a detail of the calculated sedimentation / erosion patterns. It shows the strong scouring along the riverbank north of Zalun in the period 2017-2018 with erosion rates of locally 10 -15 m. The erosion zone shifts gradually southwards (downstream) in the next year and starts to reach Zalun. The area that eroded most severely in 2017-2018 now seems to start accreting again (indicated with “1” in Figure 8). Both observations are the consequence of the southward movement and re-orientation of the outflowing discharge from the cut-off channel (illustrated with the two arrows below).

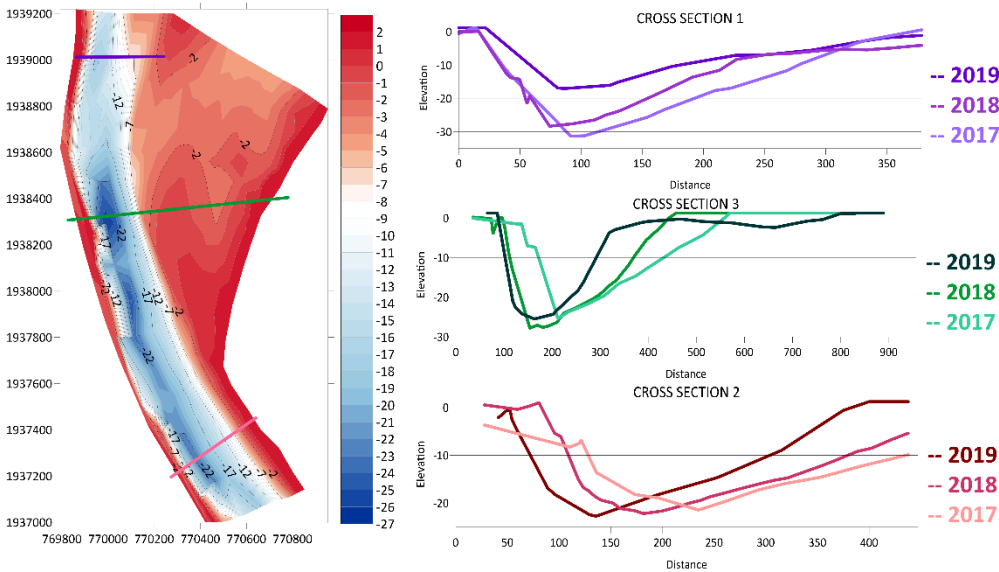
Figure 9 Cross sections 2017, 2018 and 2019

The middle cross-section (“3”) shows how the channel moves westwards. The channel slope on the west side is approximately 1:1,5 (vertical : horizontal). Such steepness can only occur when the bed material consists of clay, which is much less erodible than sand. To check the riverbed composition, a bed sample was taken by using a Van Veen grab. The sample confirmed that the composition of the riverbed is clay. Observations from the landside also confirmed the presence of clay layers around the water line (see photo in Figure 3 and further details of collected sediment samples in Appendix B). If no such clay layers would have been present, then it is likely that the erosion would have been many hundreds of meters having destroyed all local primary and perhaps even secondary embankments.

The lowest cross-sections (“2”) in Figure 9 show how the river has moved towards the west bank. This cross-section is near Zalun, and shows how the depth in front of the city’s waterfront increased with locally more than 10 m (!). Clearly this is a serious threat for the local embankments and revetments. It also increases the probability of a landslide given the likelihood of clay layers in the underground (similar as what happened in January 2020 at the city of Nyaungdon at the Pan Hlaing River bifurcation).

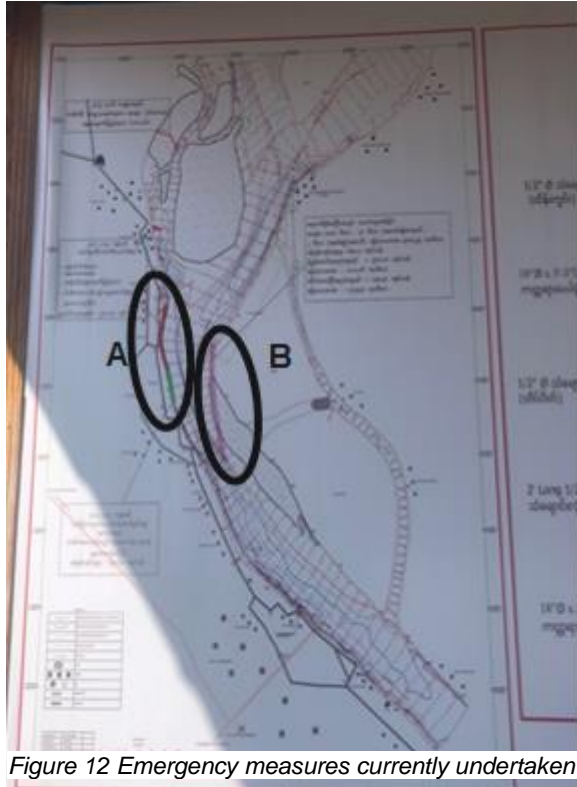
Figure 12 Emergency measures currently undertaken

Figure 12 shows the planned activities at two key locations (indicated with A and B), i.e.:

- the construction of provisional slope protection using sand-filled barrels near mileages 22 to 24 as an outer-bend erosion prevention measure (A); and
- the excavation of a new 70m long and 5 m deep channel through the sand bank on the east river bank (B).

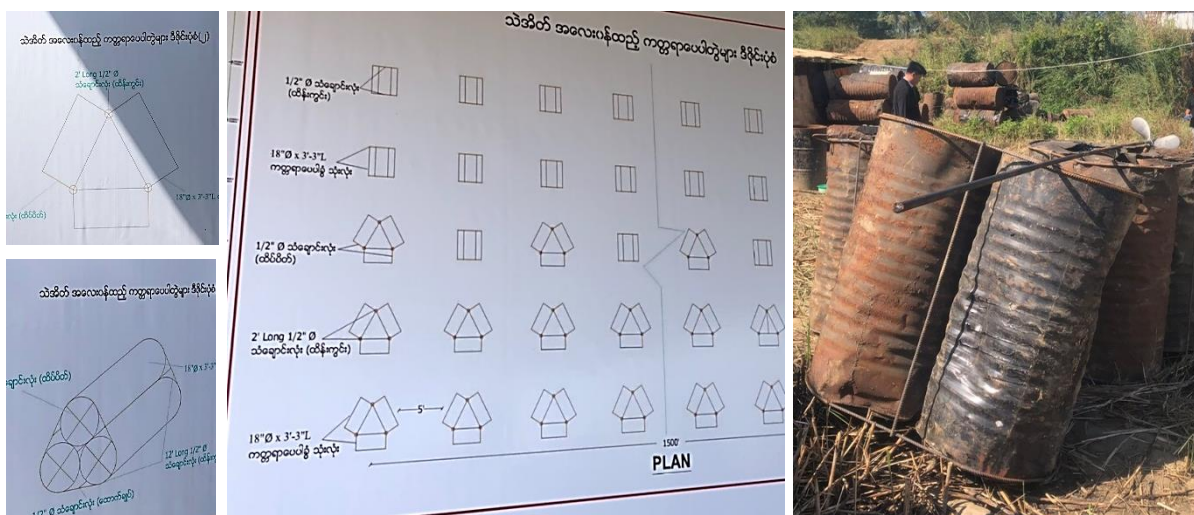
Whereas the applied barrel measure is possibly the only possible measure given the limited budget (said to be 30.000 USD), the local DWIR staff indicated that some barrels were found at the toe of the slope, hence the protection measure might not last throughout the full wet season.

Figure 13: Barrels in triangular formation (top left); Stacked Barrels (bottom left; right); Overview of the barrel measure (middle).

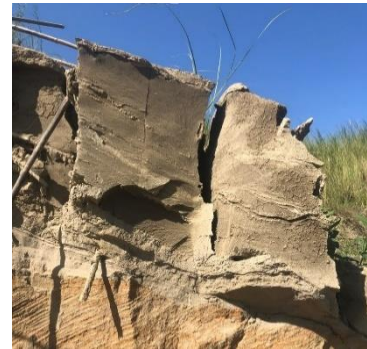
Additionally, considering the use of sparsely distributed protection elements (the barrels), rather than full slope covering protection works (such as revetments), one could argue that the subsequent flow turbulence around the barrels could worsen the slope stability. However, following soil sampling of the river bed and bank during the field inspection (Figure 14 and Appendix B), various silt/clay layers were found indicating that the impact of turbulence might be limited as compared to dominant sand-bed river systems.

Figure 14: Clear Clay formation found along the riverbank

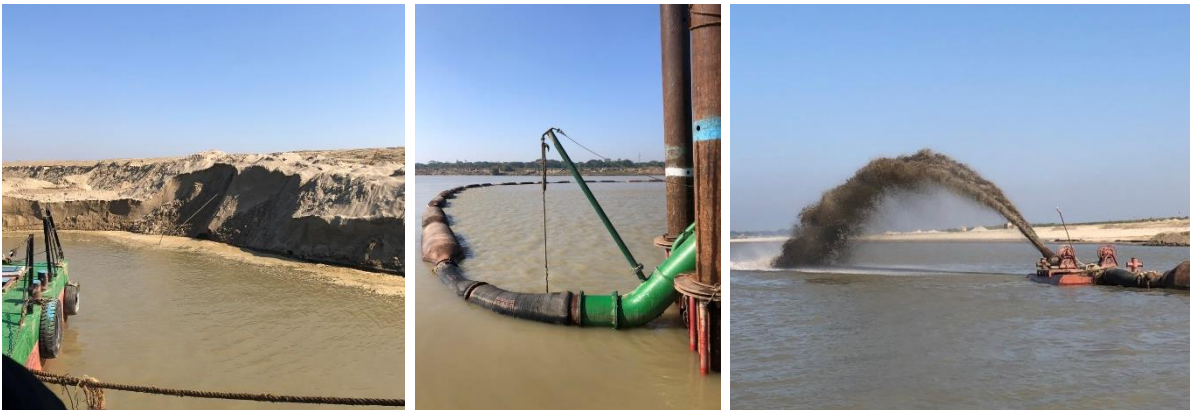
Figure 17 (left to right); formed sand point-bar across mileages 22 to 24; dredger pipeline; dredged sand/water being released back into the Ayeyarwady River.

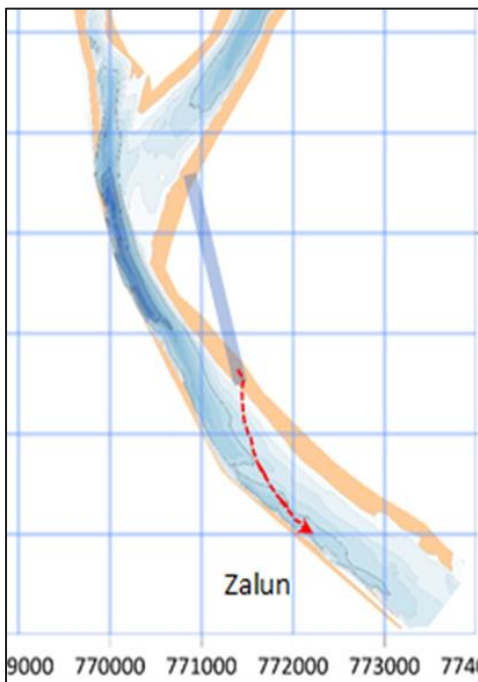
If, on the other hand, the new channel would indeed attract flow and play a role in the river run-off, then the new channel may also develop into a larger river channel. And if that happens, then a portion of the river discharge will be directed towards the westbank at Zalun, in theory worsening the local safety situation (Figure 15 – left, and Figure 16).

Figure 16 The possible erosive attach on the Zalun west bank following the new excavated canal

We consider the current dredging of the channel through the east sand bank not desirable because (i) we expect the channel to silt up soon after its construction in the first months of the wet season, or in contrast (ii) the event that the channel does become a significant flow channel, this channel may further aggravate the erosion at the Zalun bank as more river discharge will approach its west bank more directly. As an alternative option, it may be considered to remove the current vegetation on the flood plain/sand bank on the east and to lower it with say 2 m. This gives another 2000 m<sup>2</sup> cross-sectional flow area which is significant compared to the cross-sectional flow areas presented in Table 1 (between 5000 and 6000 m<sup>2</sup>). Note that the flow resistance will be higher due to shallower depths, but nevertheless it can be expected that it has a noticeable impact on the flow distribution on the short term. If the quality of the sand is good enough, this sand can also be removed from the river system and sold to compensate for the costs via a Public Private Partnership (PPP). The advantage of such eastern bank modification is that water from the upper cut-off channel can flow over it more easily (decreased flow resistance) and enter the main channel more gradually thereby decreasing the impact of erosive attack on the west bank near Zalun as it may lower the flow velocities directed under an angle towards the west bank.

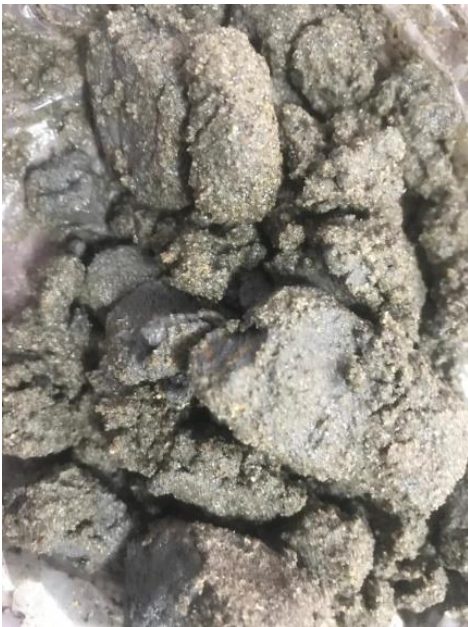
From the river bank at eroded section (near mileage 22.0):

Dark Grey Silt with Sand

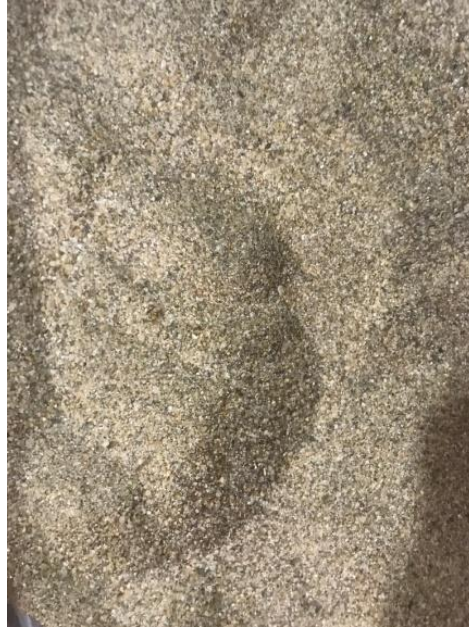
Brown Yellow Fine Sand

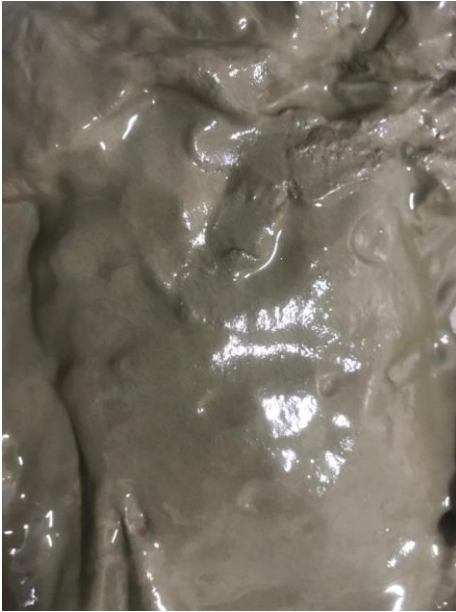
River bed in front of eroding section: Soft Clay

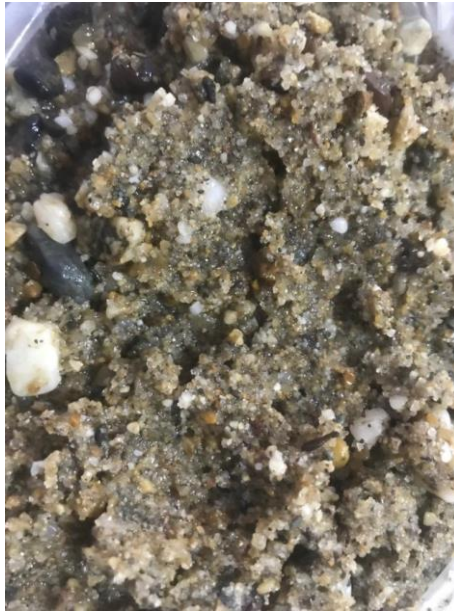
near the south end of the cut-off channel:

Coarse Sand (>0,500 mm) with Gravel

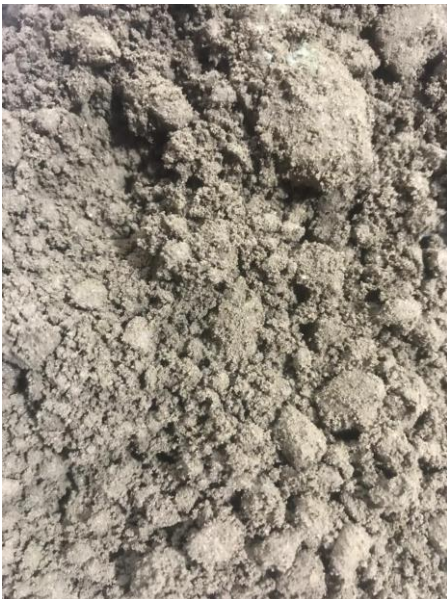
Near Zalun revetment

Brown Grey Silt
