| General info | | | |
|---|---|---|---|
| Subject: | Boroscoop inspection Gasturbine 3 (GT3) | Inspection Date: | 30-06-2020 |
| Manufacturec: | General Electric | Inspection done by: | R. van Dongen |
| Type: | Frame 9E (MS9001E) | Report by: | J. Sassenburg |
| KKS: | EFR31-MB | Report no: | 21-1332 |

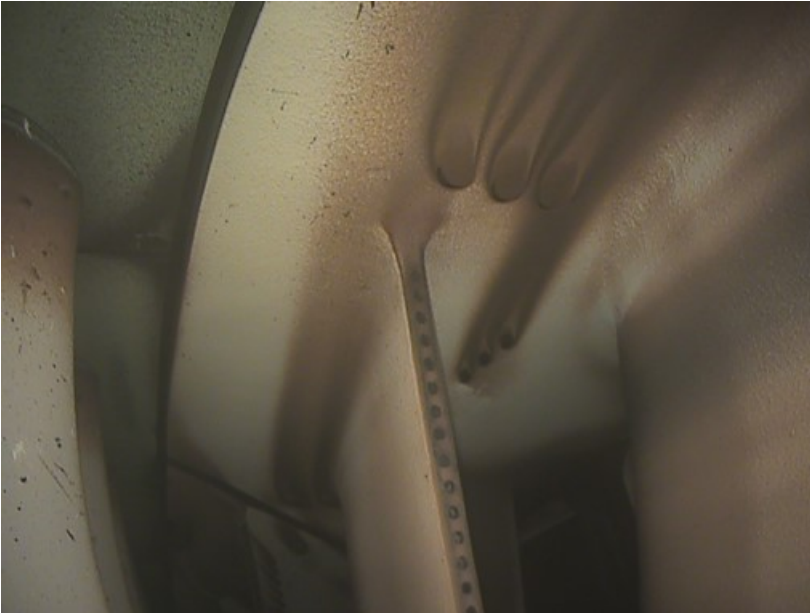
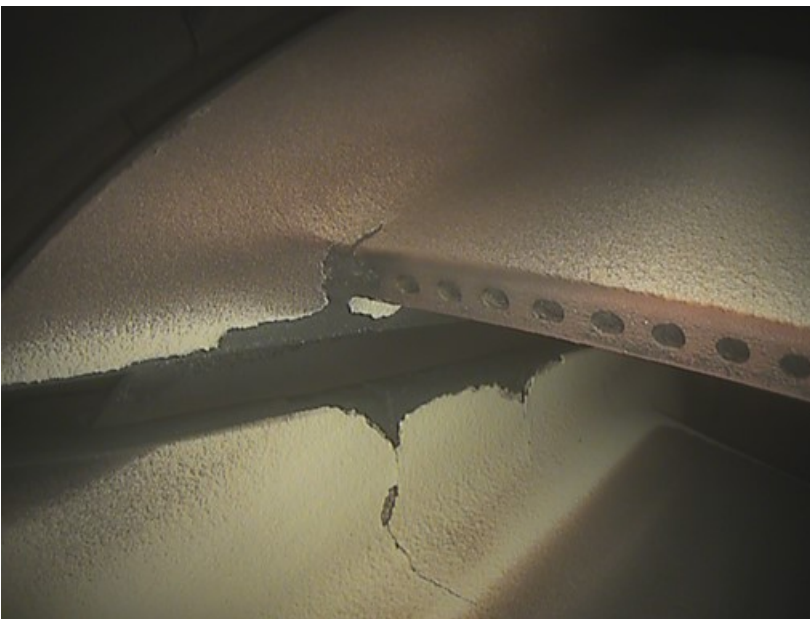
## First Stage Nozzle (Set 3)

- There was 1 small crack in the inner wall (see picture) same as 2019
- No closed cooling holes detected
- TBC Coating applied in 2015 some places coating cracked or moved
- Furthermore nothing special.

Image of the cooling holes on the TE of the inner and outer walls. The TBC coating applied in 2015 is cracked at some segments. Crack found in T/E outer wall.

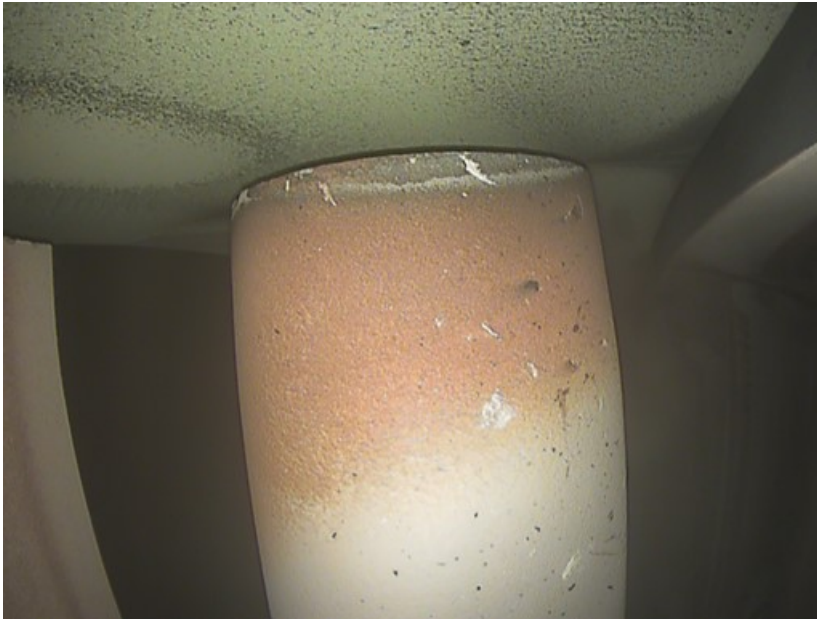
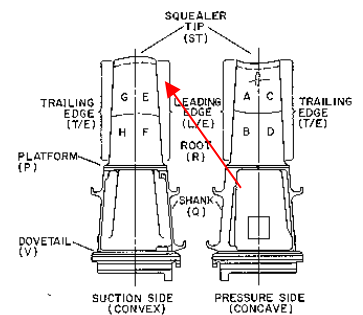
Top of bucket L/E pressure side

- At the Leading Edge no particularities of the blade
- At the Trailing Edge no particularities of the blade
- TBC Coating applied in 2015 some places coating cracked or moved
- Furthermore nothing special.

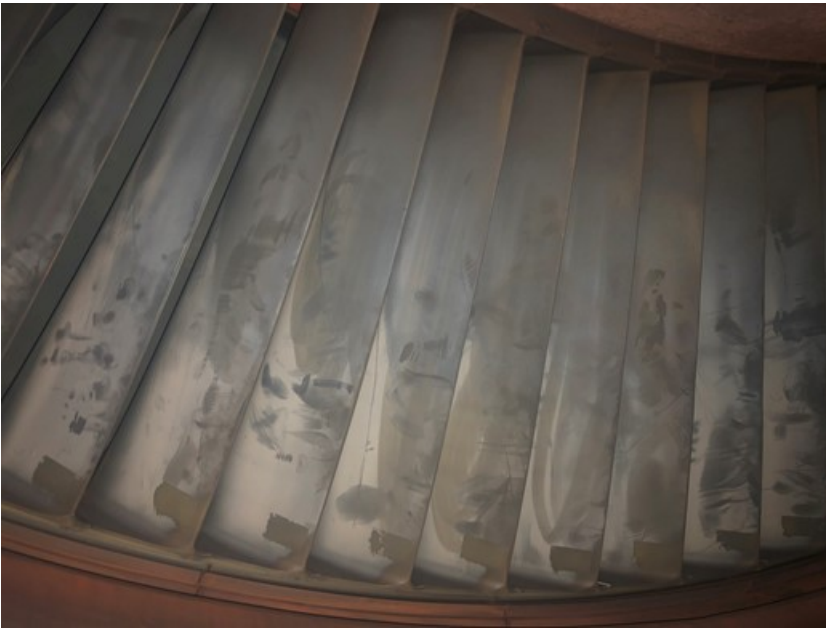
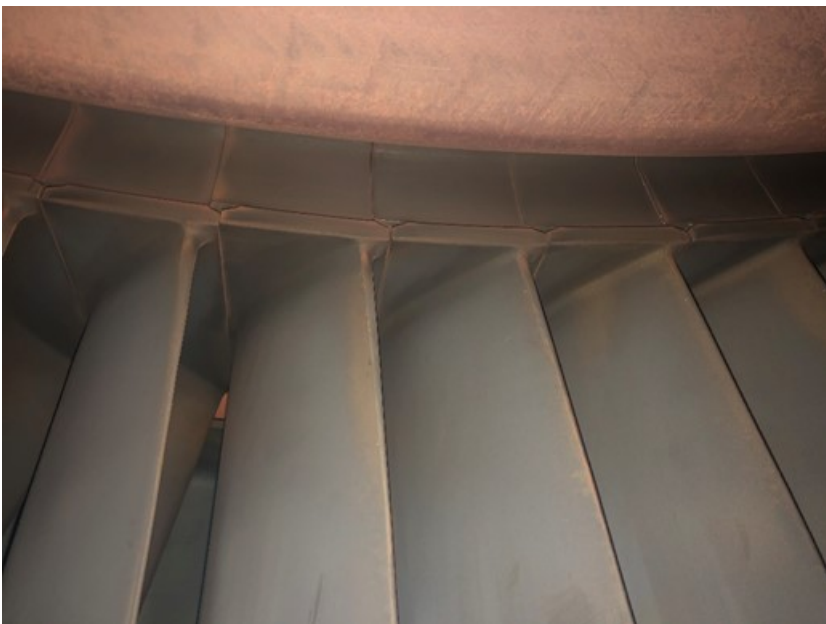
## Third Stage Buckets (Set 2)

- Inspected from the exhaust duct. Minor FOD at 3 blades.

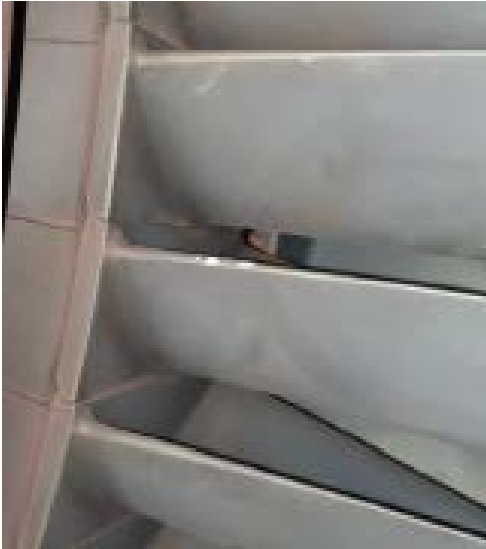
### Minor FOD, T/E 3e stage buckets

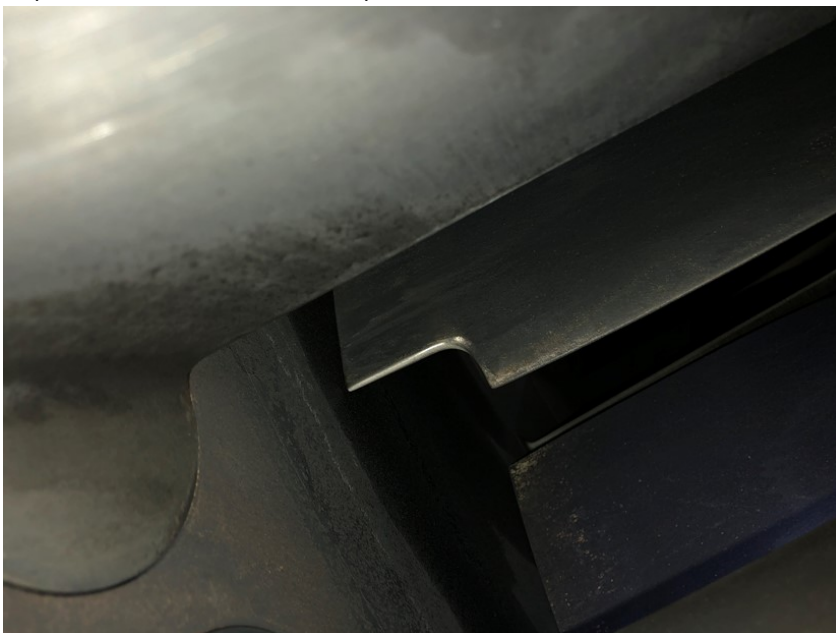
Inspection of IGV and 1e row compressor blades

- 1st row compressor blades show no damage to the blade tips, the adjustment (rounding) at some blades are still in the same condition as after the modification.
- The repaired intermediate strip is still the same as in the previous inspection.

View modification no difference with the inspection before (2019)
