GAS TURBINE INSPECTION REPORT

**EON ROTTERDAM HOT  
GAS PATH INSPECTION  
AND COMPRESSOR  
INSPECTION**

EON BENELUX NV

ROTTERDAM, Unit 3

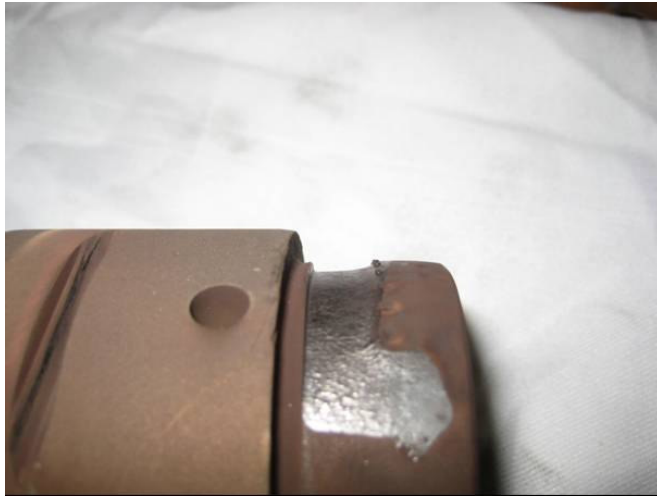
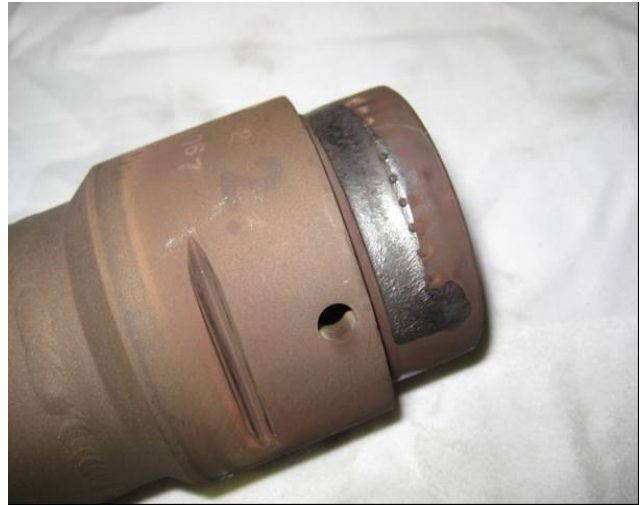
INNER CROSS FIRE TUBE COMMON DEFECT

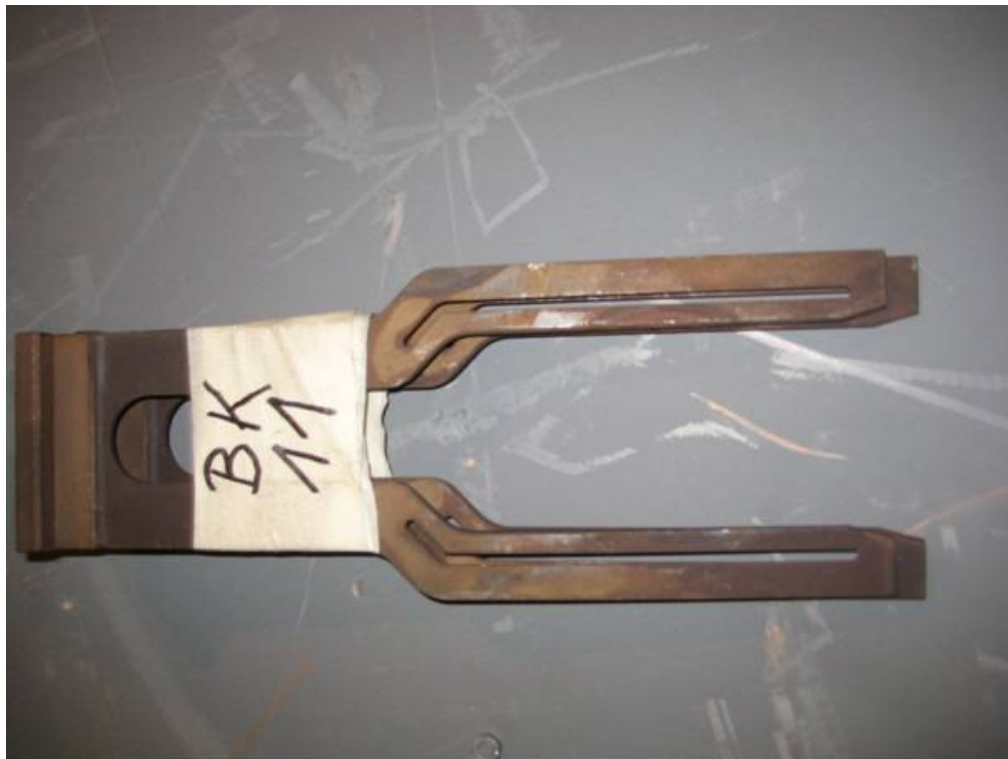
INNER CROSS FIRE TUBE RETAINER GENERAL CONDITION

Retainers whole set have been found worn medium while all cross fire tube collar were severely worn and body discoloration was showing evidence of hot spot.

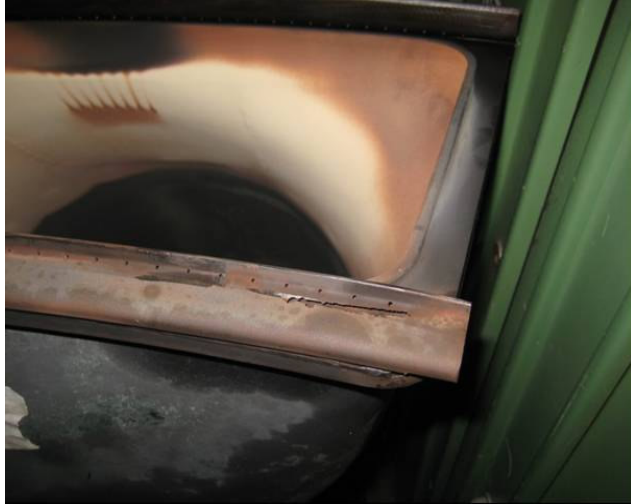
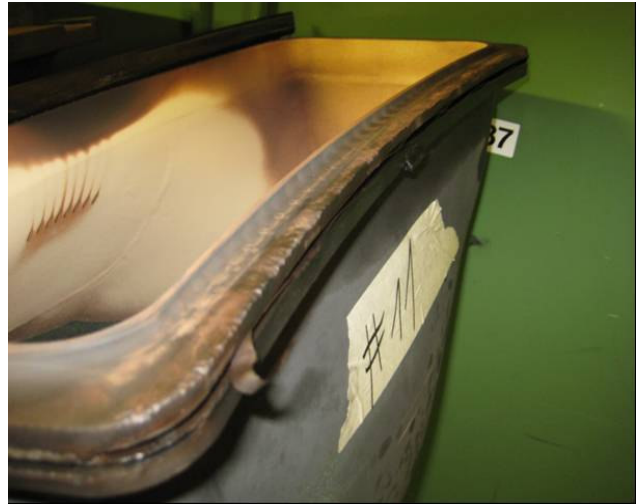
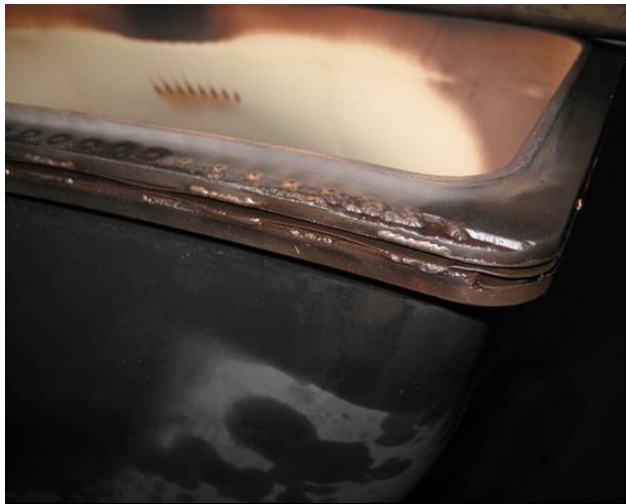
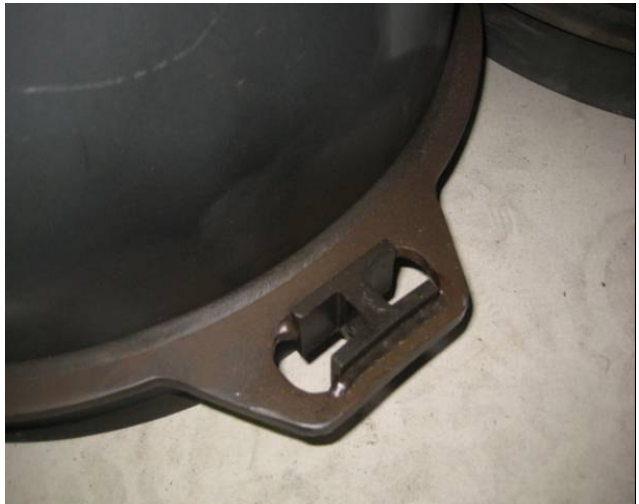
This component was visually inspected and found in a very poor condition heavy wear , missing material, burnt and warped. This is an indication about the fact that TP set back were apparently to tight in their slot and not on the same plane.

FLOATING AND SIDE SEAL SLOT HEAVY RUB EVIDENCE

We recommend checking them during the next combustion chamber and correct TP set back clearance if out of spec.

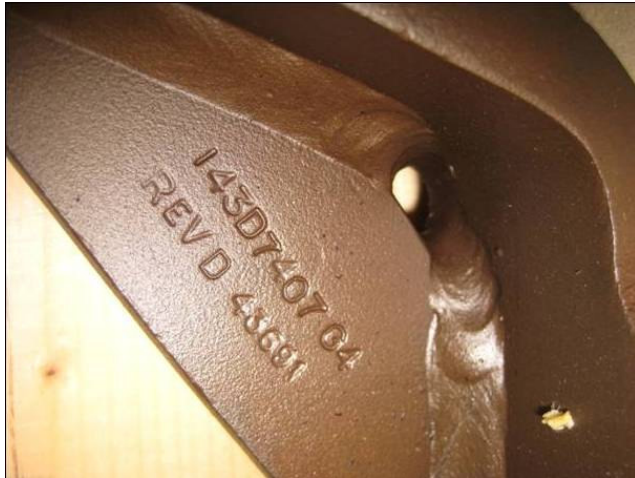
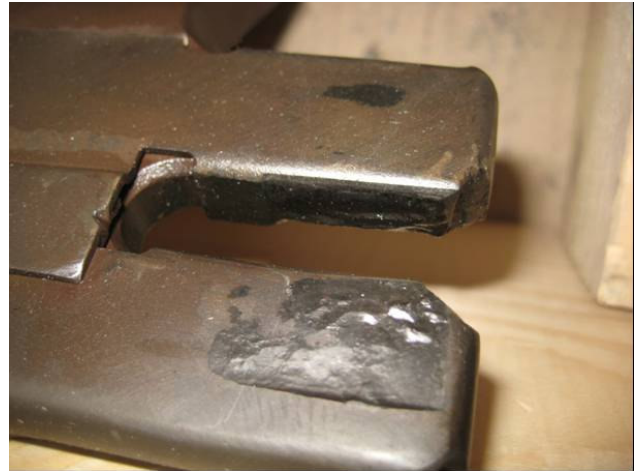
The forward support clamps (bullhorns) were removed and visually inspected. There was Heavy wear on the loaded faces of the support clamps, the components were replaced with Extensor Life Hardware. The transition piece hardware as well were replaced as per GE best practices

BULLHORN TYPICAL FRETTING WEAR

| All bullhorns show very severe rub and wear , we need to change them all since they have exceeded their service limit in term of thickness. | |

Check bullhorn general condition for the next planed combustion inspection because this defect may give indication about unproper TP set back clearance.

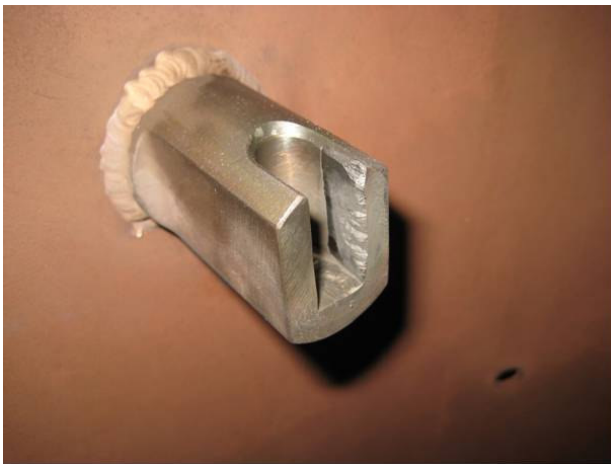
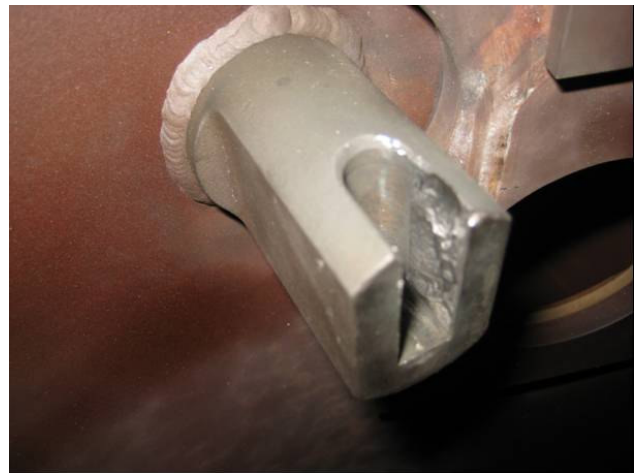
FLOW SLEEVES LINER STOPPER FIT FRETTING WEAR

Flow sleeves have been visually inspected and found without defect except fretting wear on the liner stoppers without any serious issue. Discoloration was to be noticed as well due to corrosion and deposit very light. By the way these flow sleeves will be repaired and returned back to the unit for another service until the next planned inspection

Check liner stops wear as well as all welding using Dye penetrant during the next planed combustion inspection.

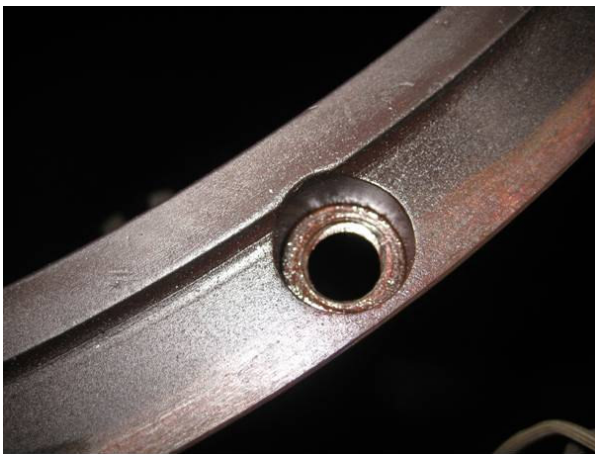
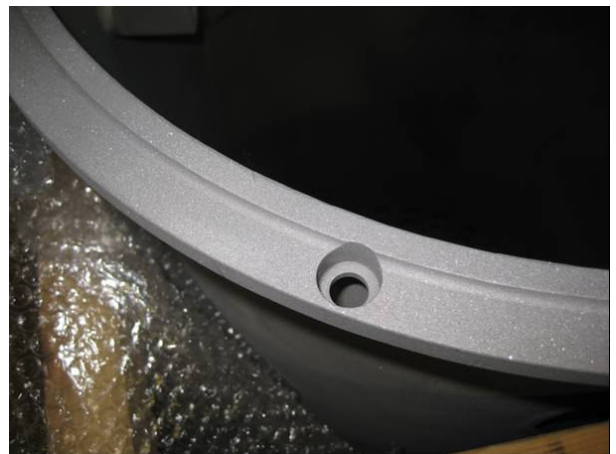
FLOW SLEEVES FORWARD FLANGE REPAIR BEFORE AND AFTER

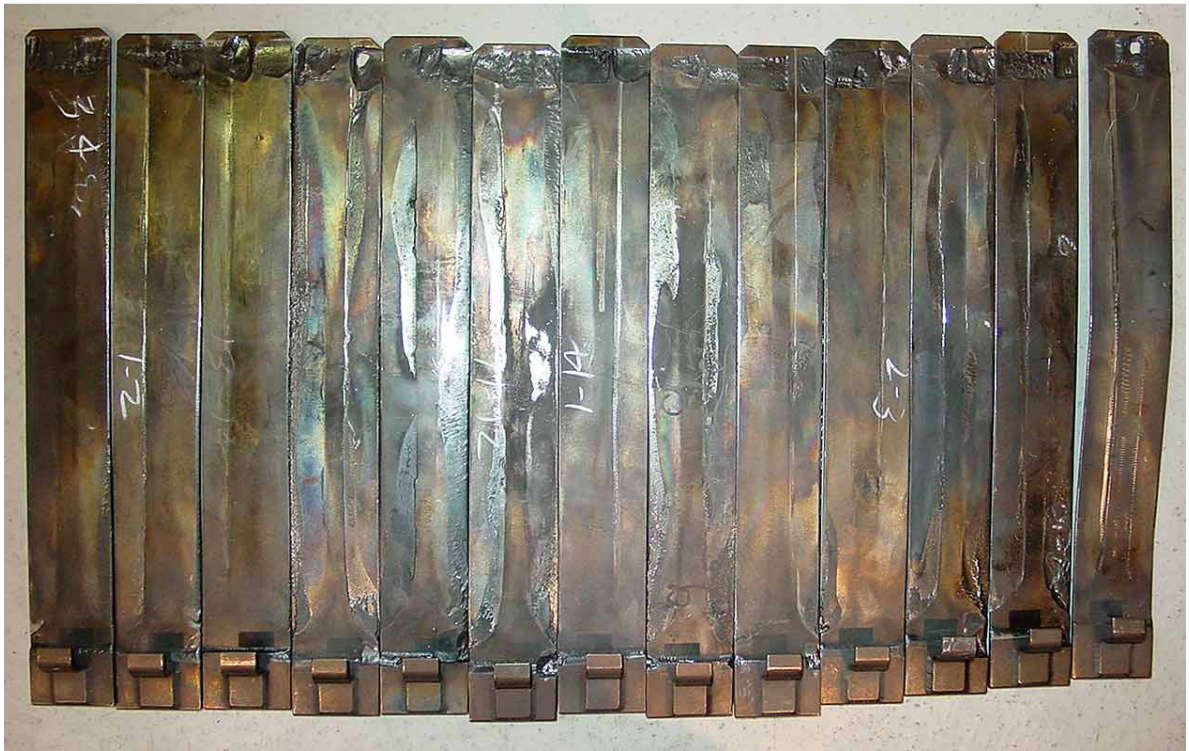
SIDE SEAL CONDITION

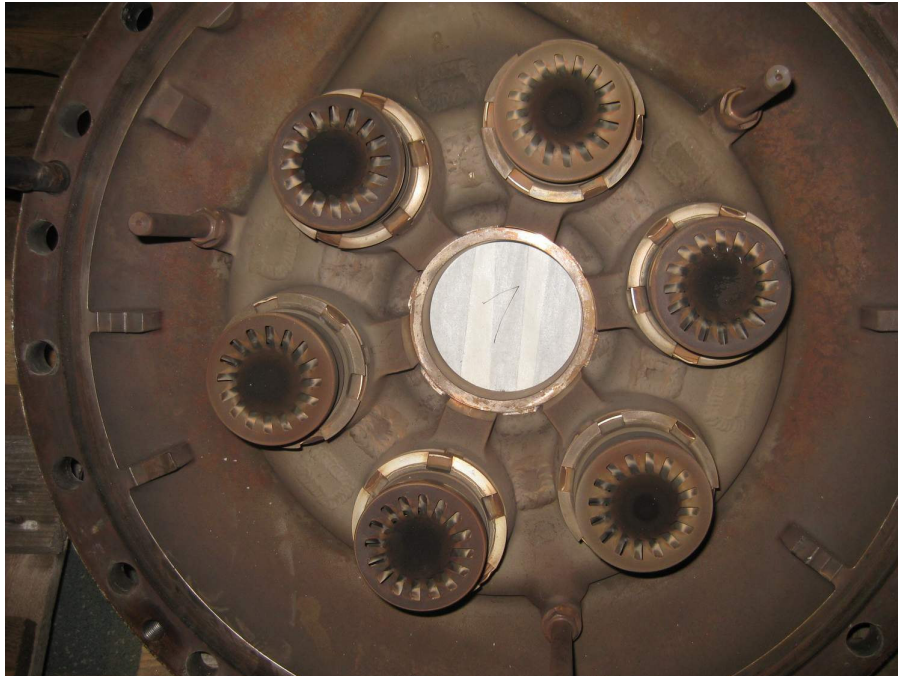
The removed components were visually inspected; there were light carbon deposits on The nozzle tips. No evidence of erosion or other damage. Components were replaced as part of the planned maintenance program. Serial numbers are recorded on the relevant Inspection sheet

PRIMARY GAS FUEL NOZZLE GENERAL CONDITION

Check fuel nozzle body to figure out for any potential liquid fuel leakage.

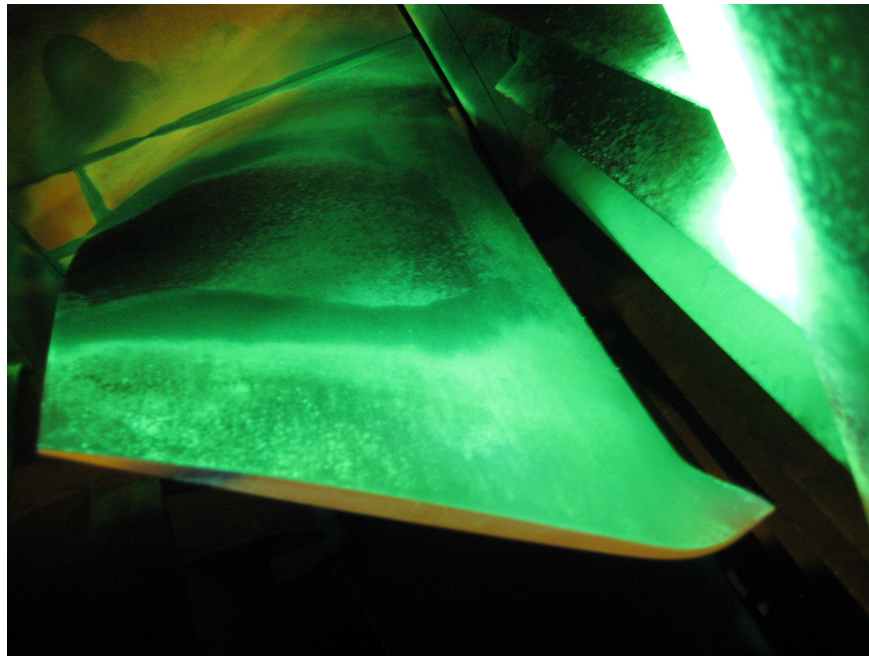
Fluorescent dye penetrant before GE repair

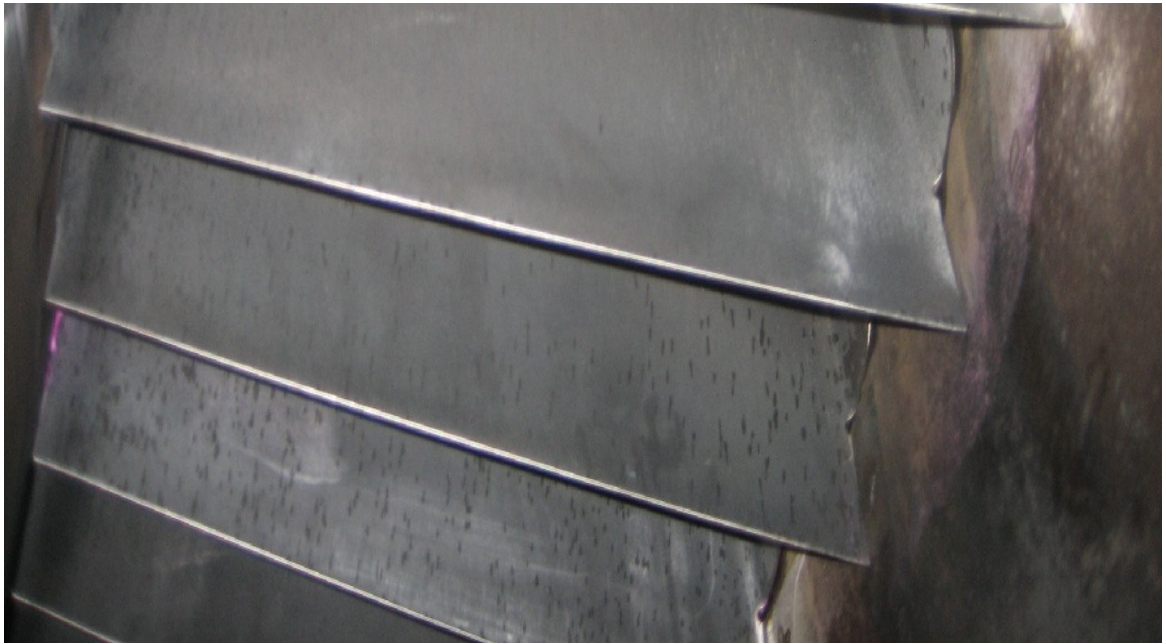
IGV GENERAL CONDITION

As per normal maintenance inspection check IGV clearance and their general condition in term of crack or FOD during the next planed HGPI or CI.

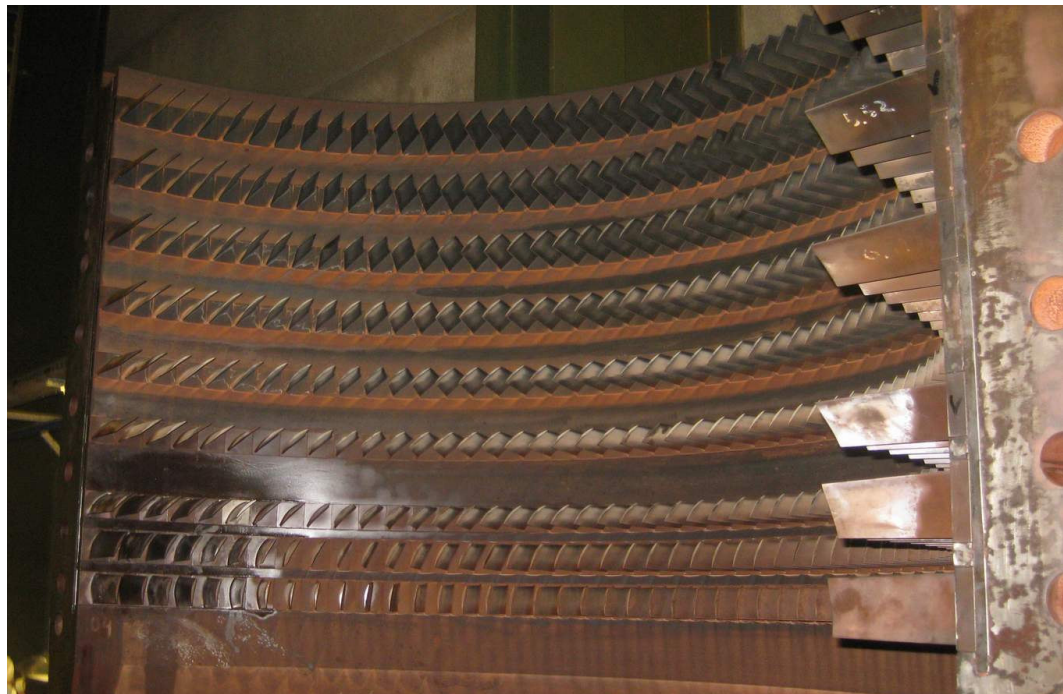
CDC COMPRESSOR STATOR VANE GENERAL GOOD CONDITION

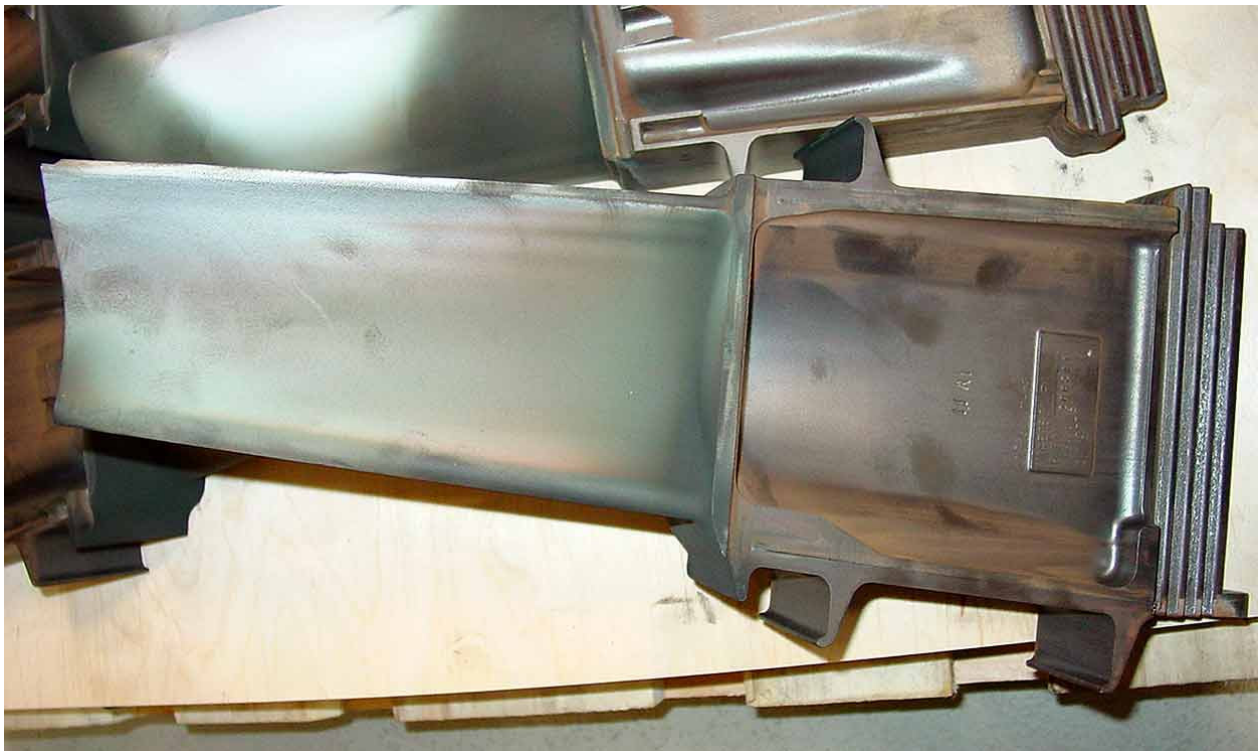
STG1 BUCKET DISCOLORATION AND HOT SPOT

STG1 BUCKET TIP RUBBING

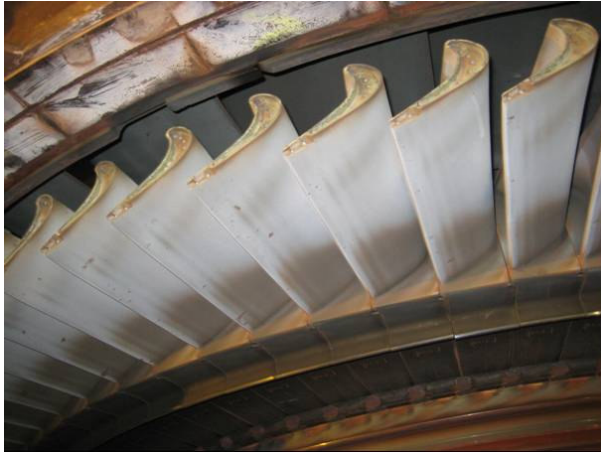
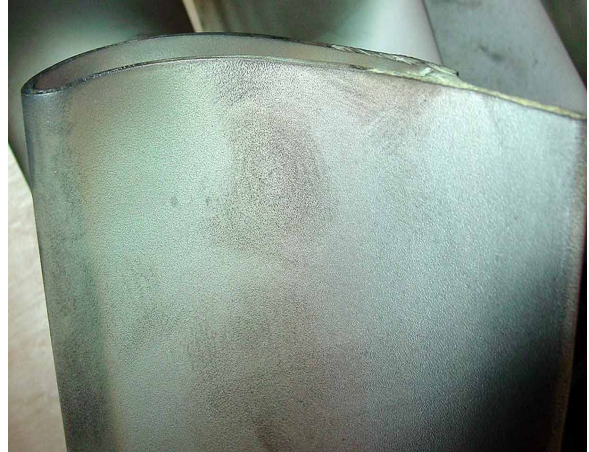
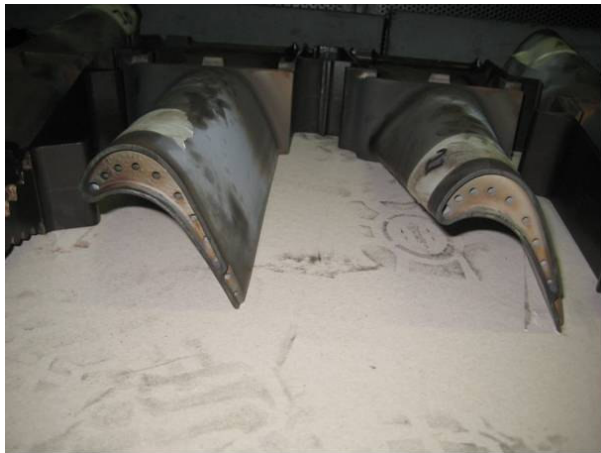
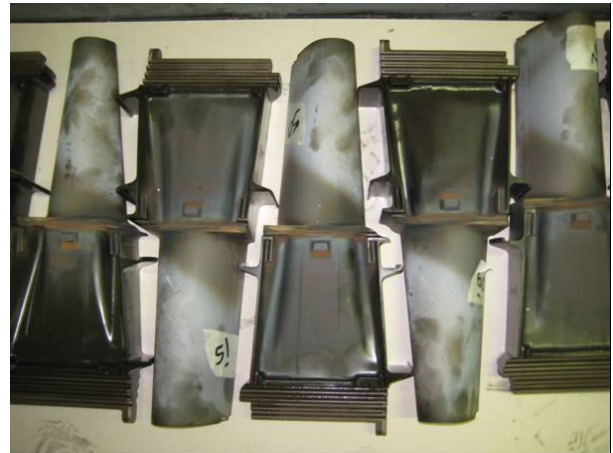
STG1 BUCKET TIP RUBBING  
AND GENERAL CONDITION

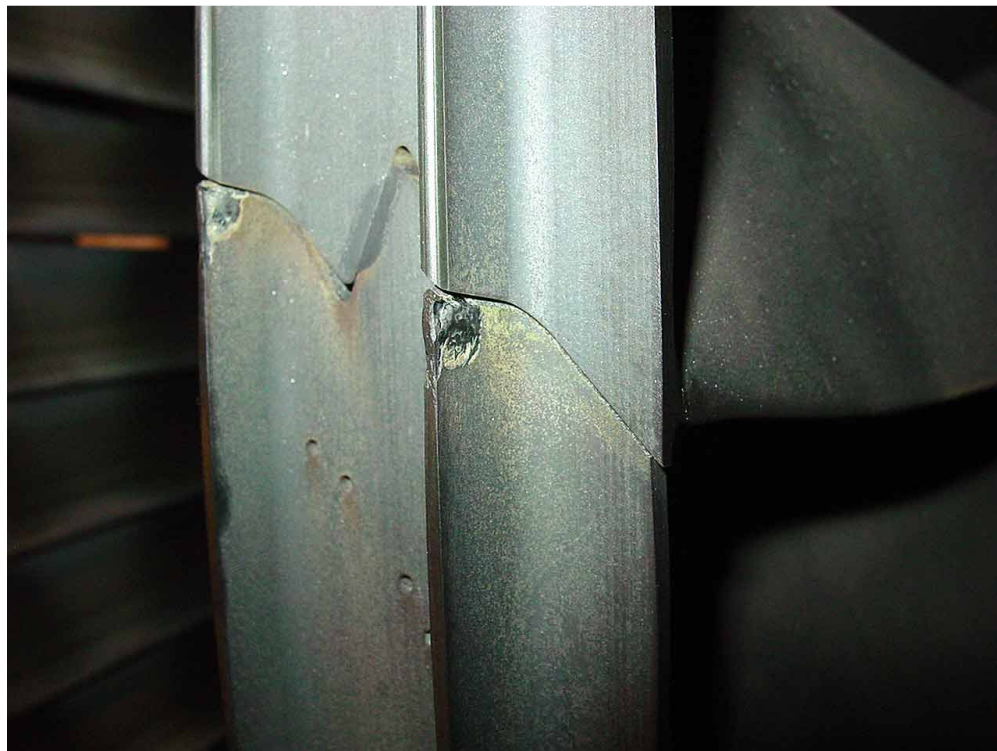
STG2 BUCKET SHROUDED TIP AND CUTTER TEETH DEFECTS

Check and Remove carefully lock pins and change all second stage buckets during the next planned HGPI also borescope inspection will be required to monitor bucket shrouded tip and cutter teeth condition during the next planned combustion inspection

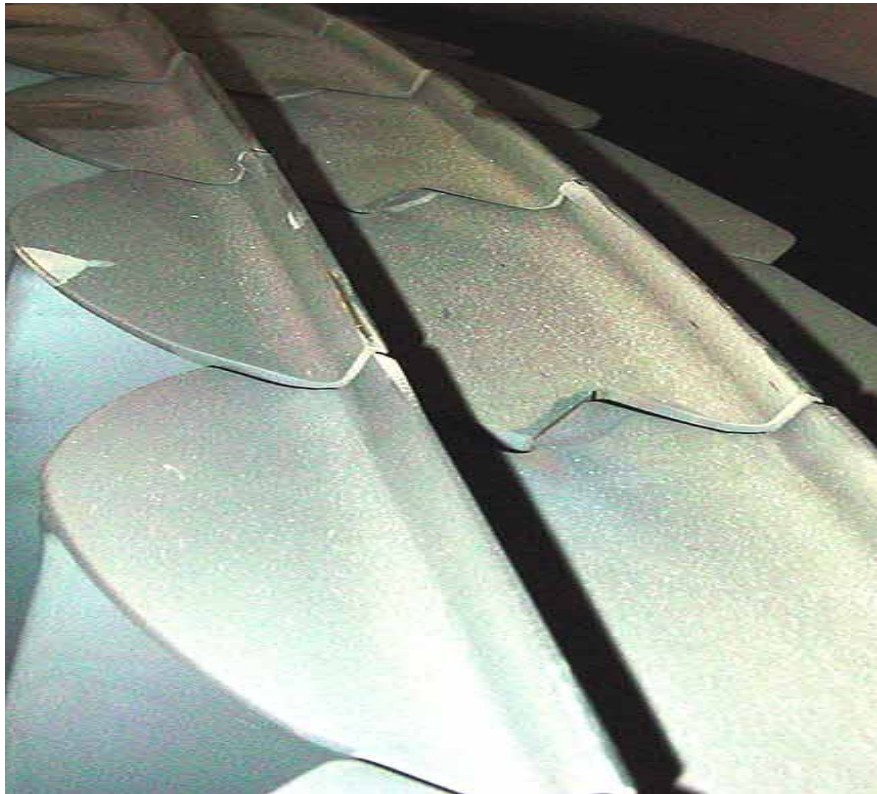
STG3 BUCKET SHROUDED TIP AND CUTTER TEETH WEAR

Bucket third stage found in a very pretty condition all over their pressure suction leading trailing dovetails and shank surface. However shrouded tips were worn and cutter teeth weren't sharp anymore. All set of third stage bucket is to be renewed as planned maintenance.

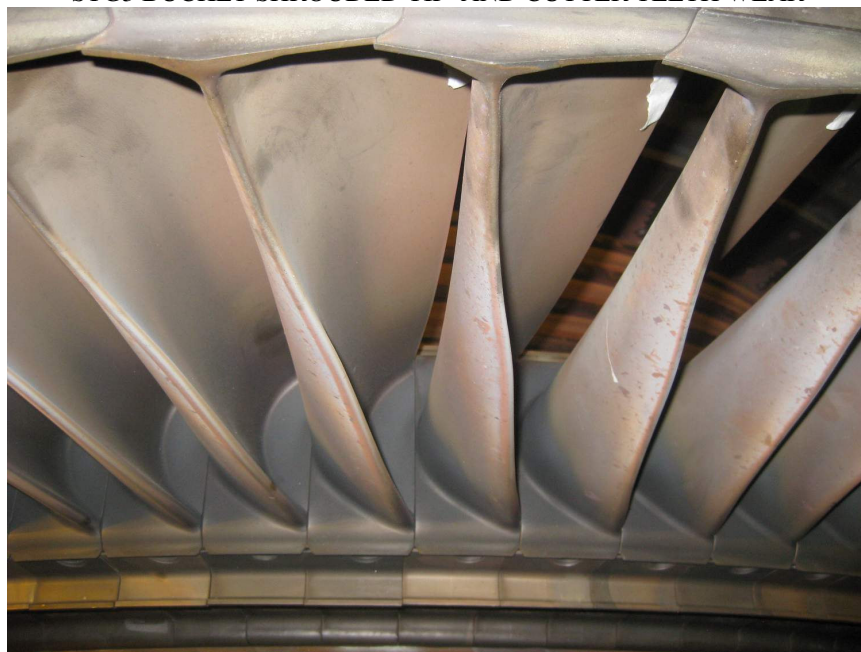
STAGE 2 BUCKET GENERAL CONDITION

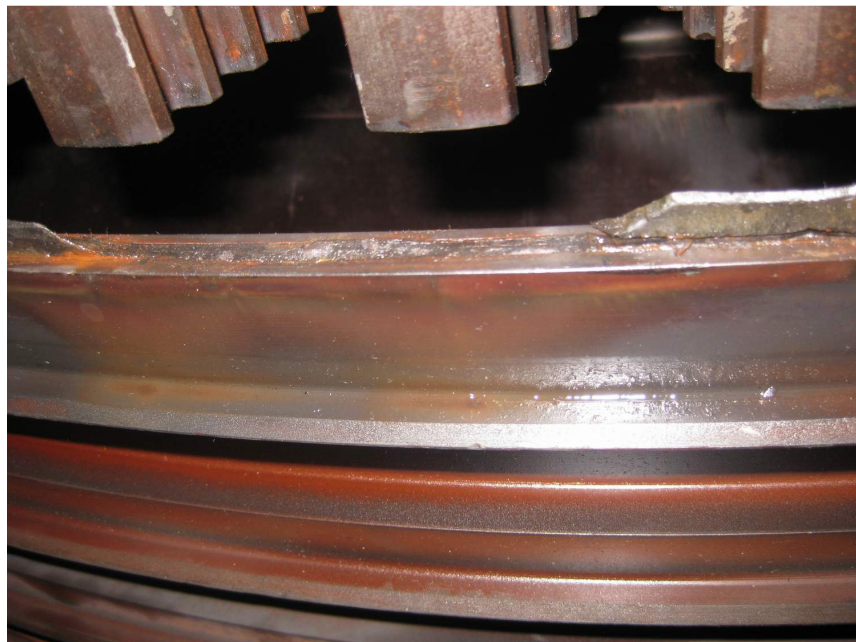
TURBINE ROTOR DISCOURAGER SEAL HEAVY DAMAGE , MISSING MATERIAL CORROSION , CRACKS

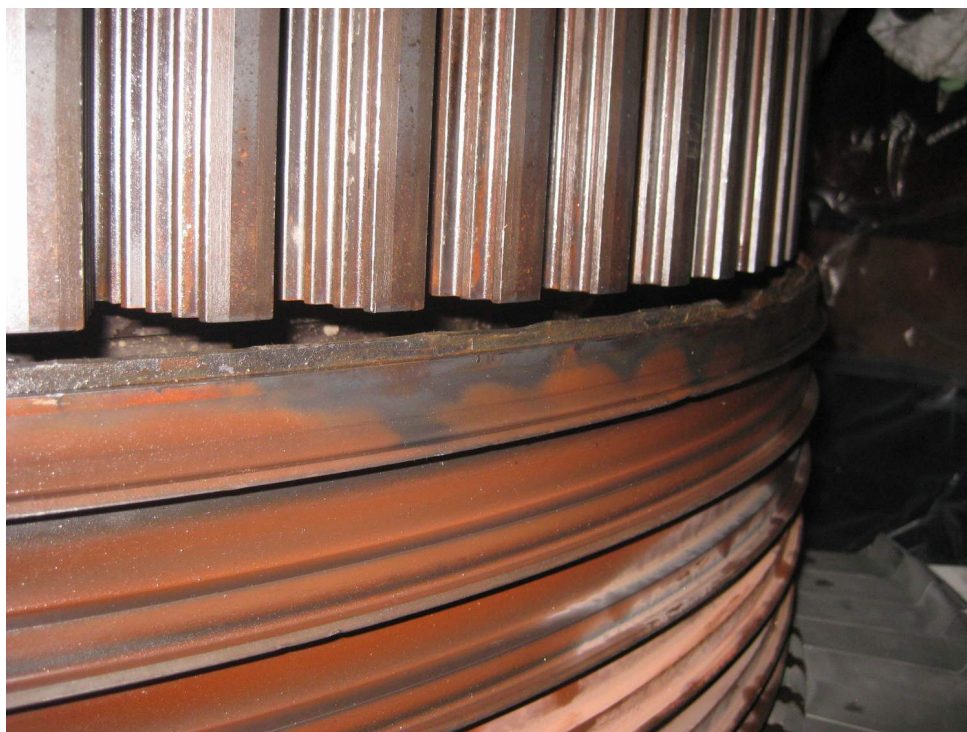
EVIDENCE OF HOT SPOT DISCOLORATION ON THE SPACER DUE TO FAULTY DISCOURAGER SEAL WHICH LEAKS HOT GAS

Check spacer condition during the next planned hot gas path inspection.

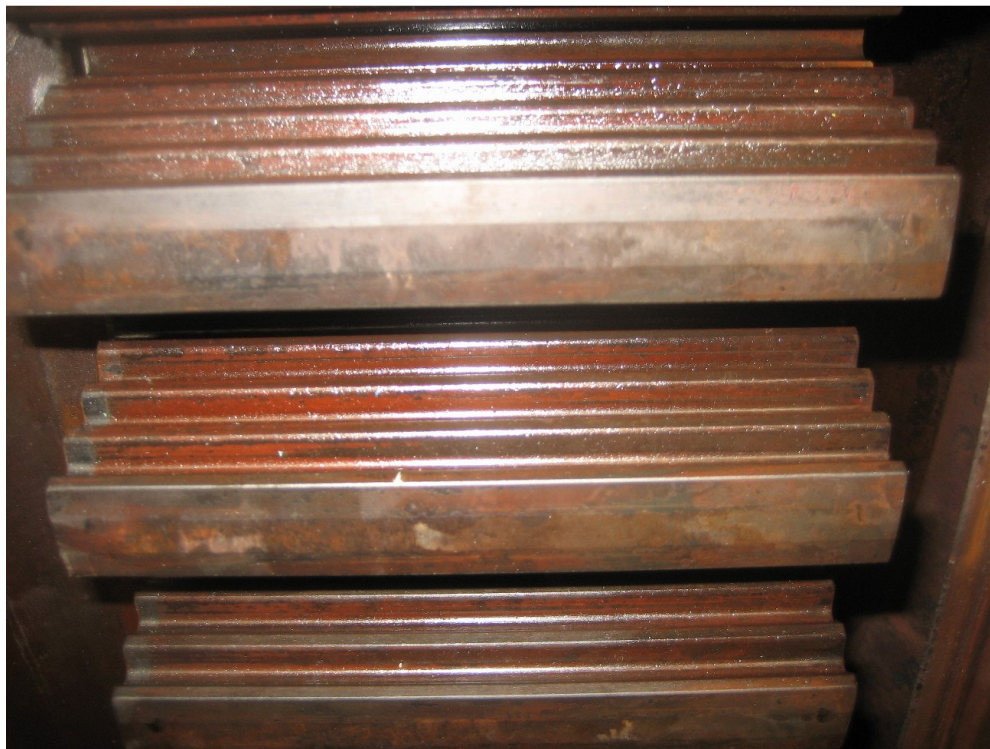
STG2 BUCKET DOVETAIL SLIGHTLY CORRODED

Inspect bucket dovetail condition during the next planned HGPI as well as bucket rock and platform mismatch check.

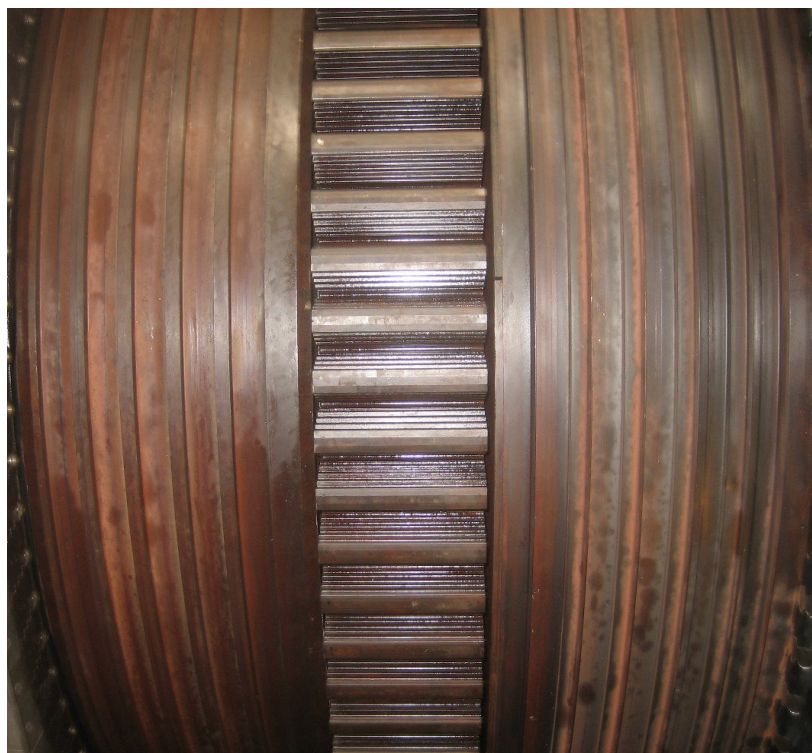
STG1-STG2-STG3 ROTOR SPACER GOOD CONDITION

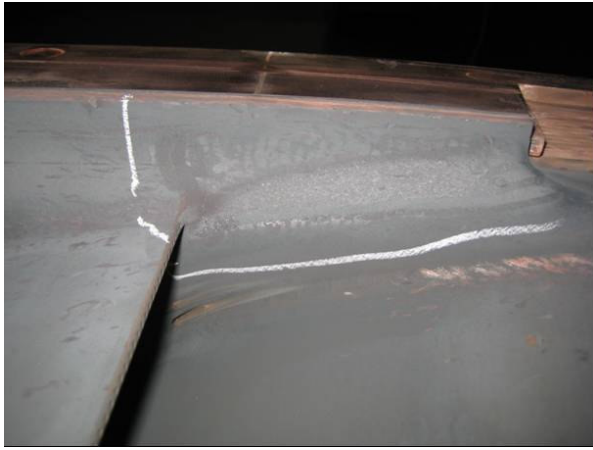
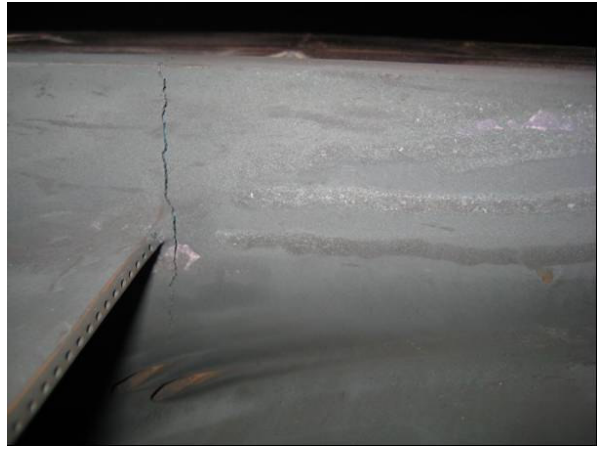
FIRST STAGE NOZZLE TYPICAL CRACK ON LEADING EDGE OUTER SIDE WALL  
SEVERE CRACK ON S1N INNER WALL

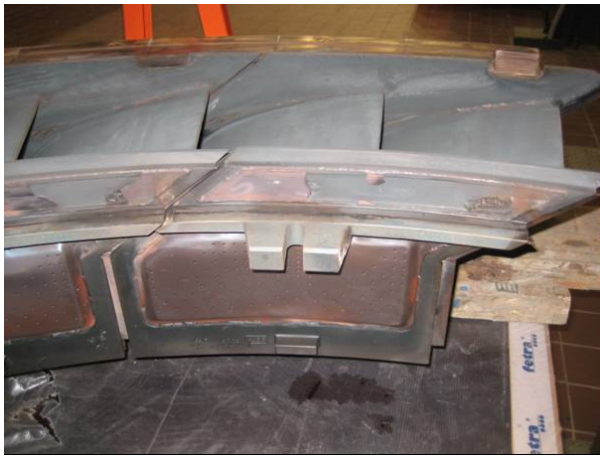
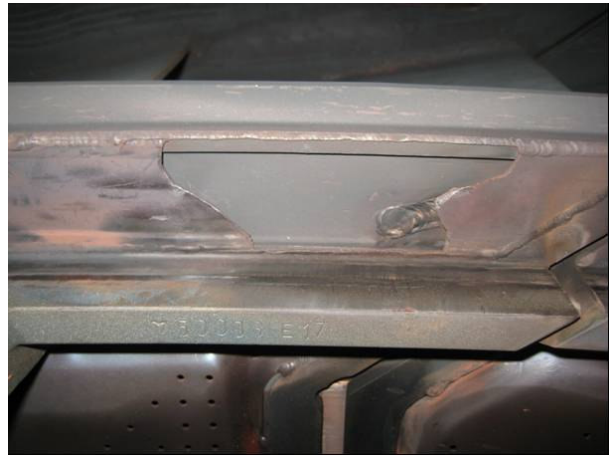
STAGE 1 NOZZLE IMPINGEMENT PLATE MISSING MATERIAL HEAVY CRACKS

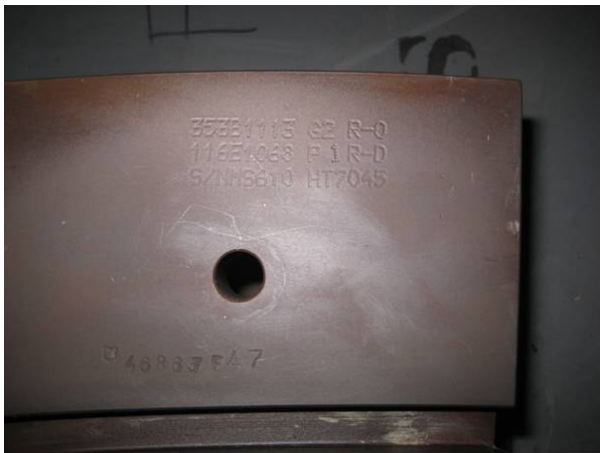
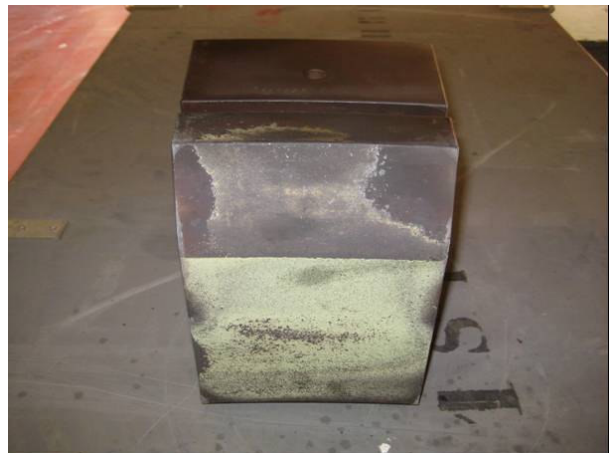
STAGE 1 SHROUD BLOCK ABRADABLE COATING GONE PLUS EVIDENCE OF AFT FACE OVERHEATING

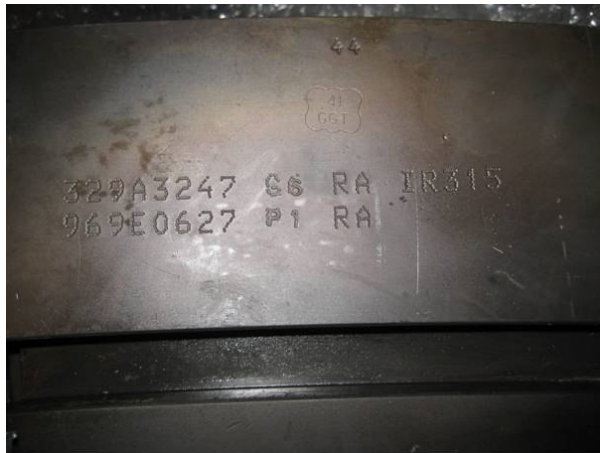
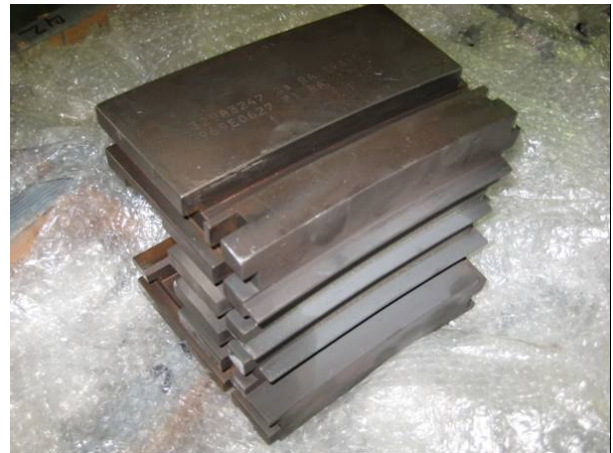
SATGE 2 SHROUD GENERAL CONDITION WITH EVIDENCE OF HOT SPOT AND OVERALL OVERHEATING

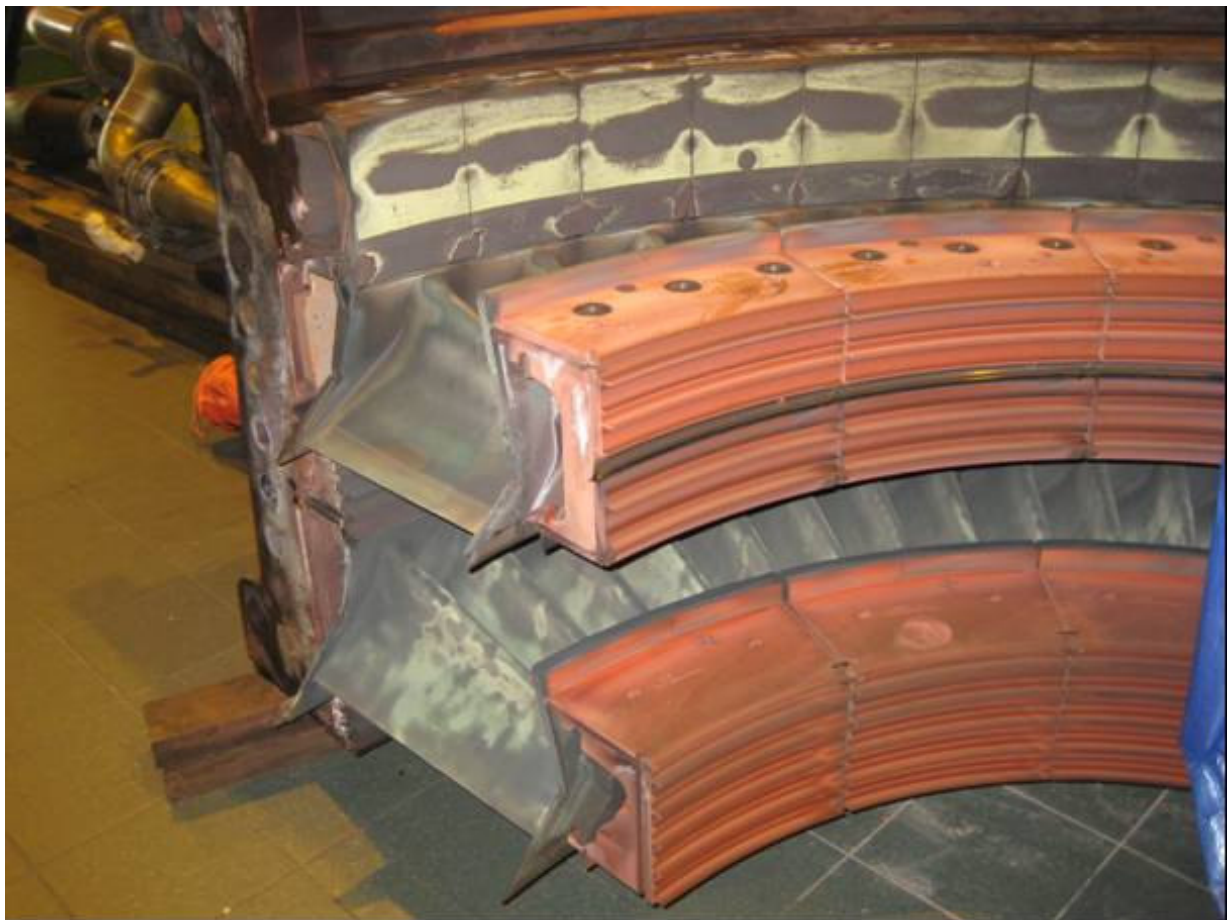
TURBINE CASING UPPER HALF AS FOUND ONCE TAKEN OFF THE UNIT

Check Turbine casing carefully during disassembly for any crack or defect emanating from the casing cooling and shroud pin holes.

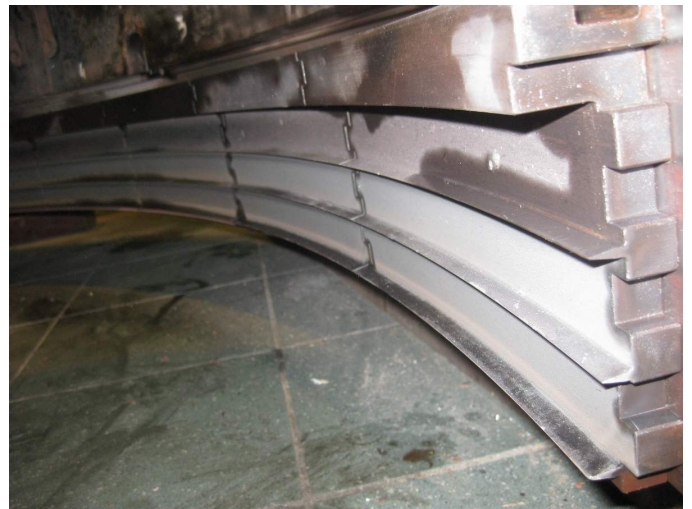
THIRD STAGE SHROUD GENERAL GOOD CONDITION

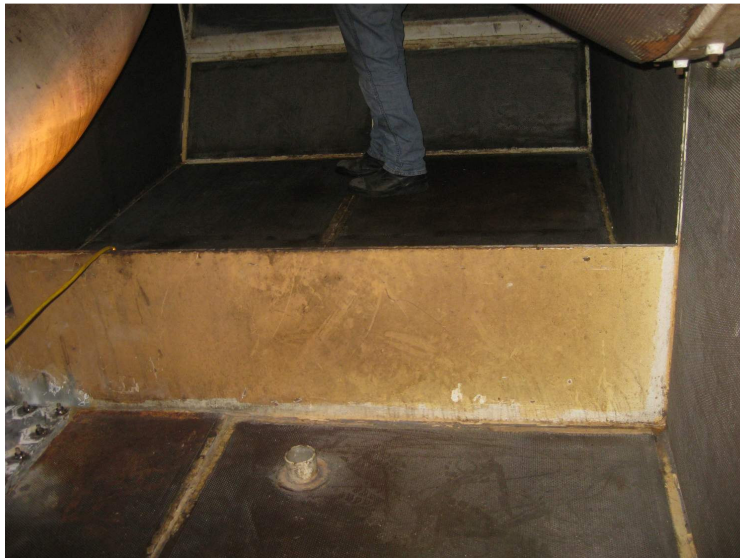
Inlet plenum was cleaned with vacuum cleaner .No problems were found all surrounding inlet plenum wall and inlet bell mouth were cleaned as well with rags , ready for operation

INLET PLENUM ONCE CLEANED WITH VACCUM CLEANER

Check inlet plenum cleanliness during the next planed outage and clean if necessary.

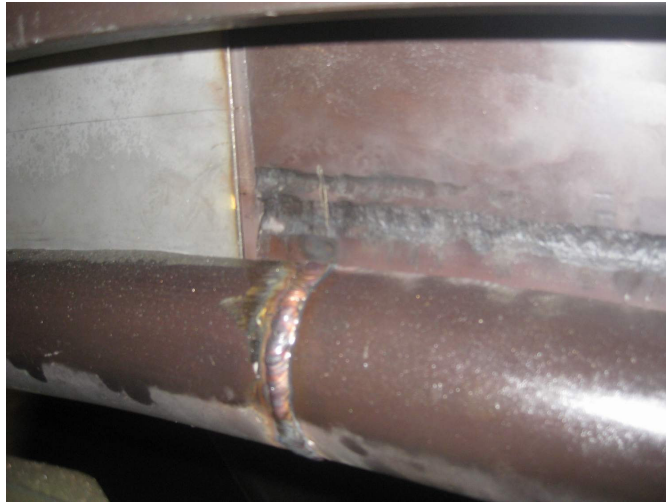
EXHAUST FLEX INTERNAL FLEX SEAL REPAIR BY EON

Check flex seal forward and aft condition and change them if necessary during the next planed HGPI also if possible correct this big mismatch of inner thermal shield at the first opportunity.

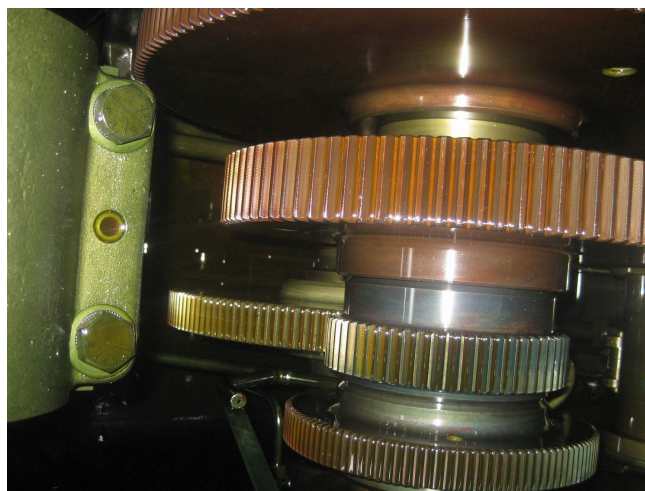
GEAR GENERAL CONDITION WITH NO INDICATION
