# INSPECTION REPORT

**EON RoCa3**

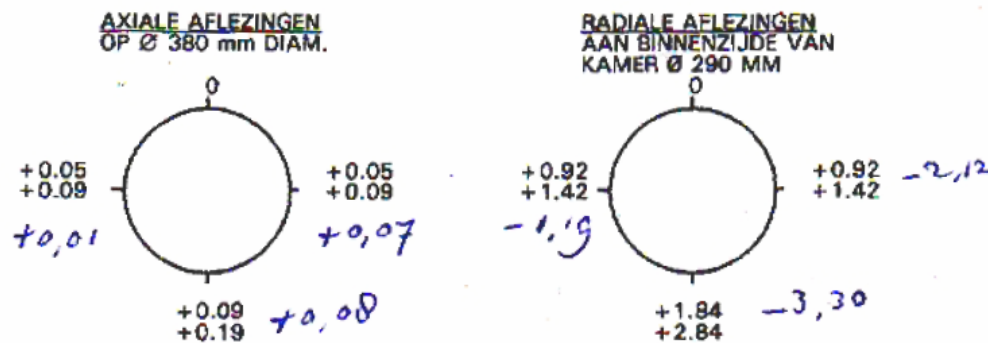
**Figuur 5, Toelaatbare klokwaarden-gebied bij correcte uitlijning**

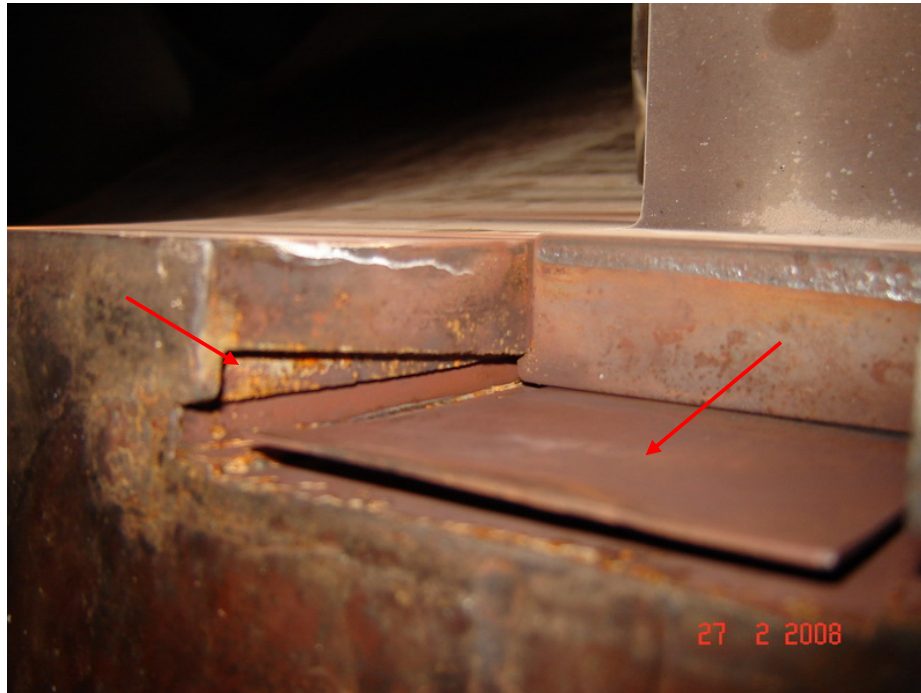
*Damage slot for EGV's and formerly installed shim plate*

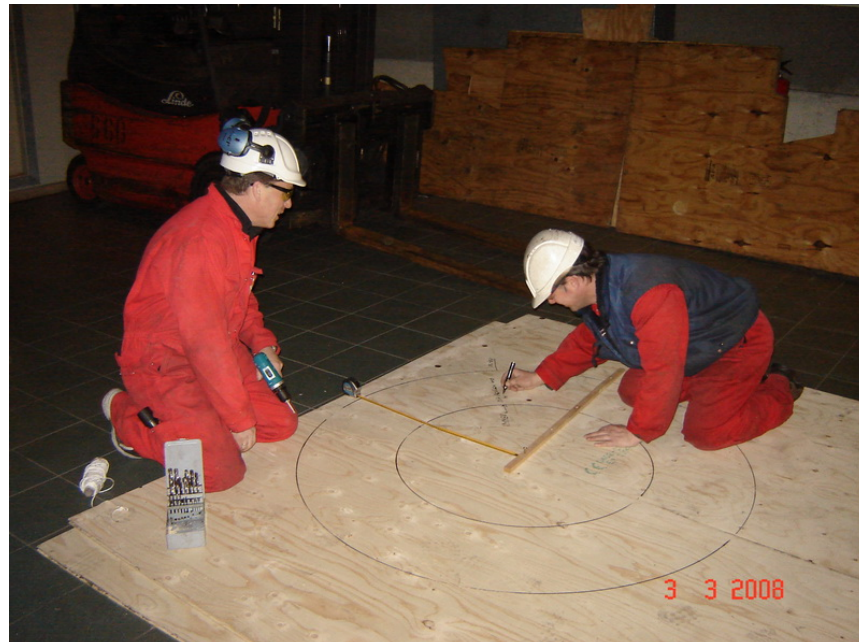
*Fabrication of plywood tools for removal of bottom half of inner barrel*

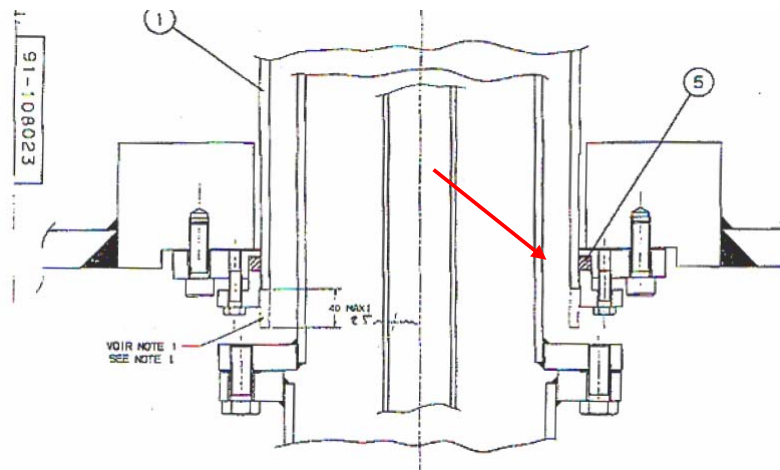
*Packing rope was installed at position 5*

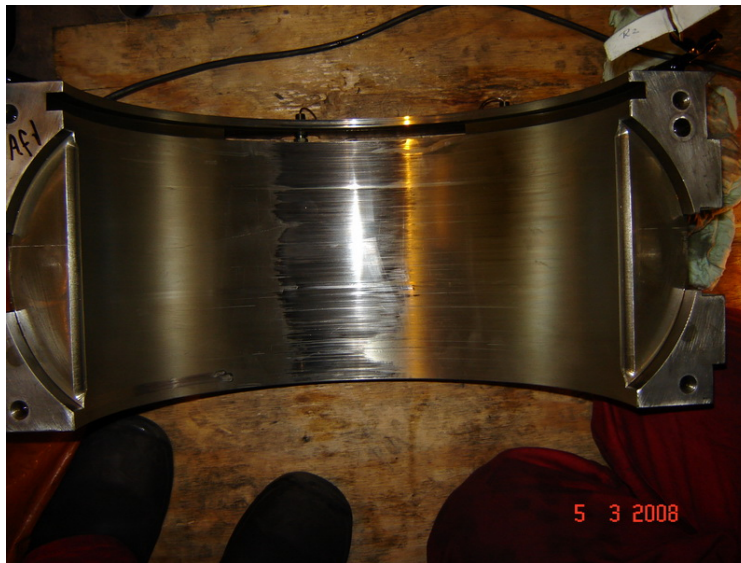
*The bottom of bearing #1 after removal*

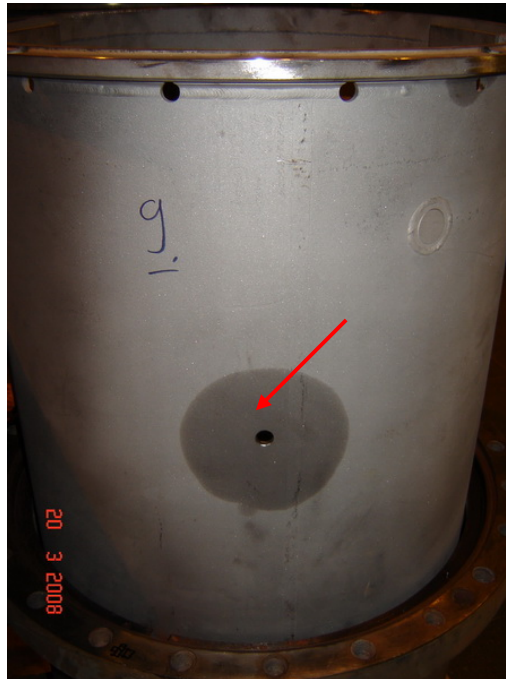
*A newly drilled holes for the dynamic pressure probe*

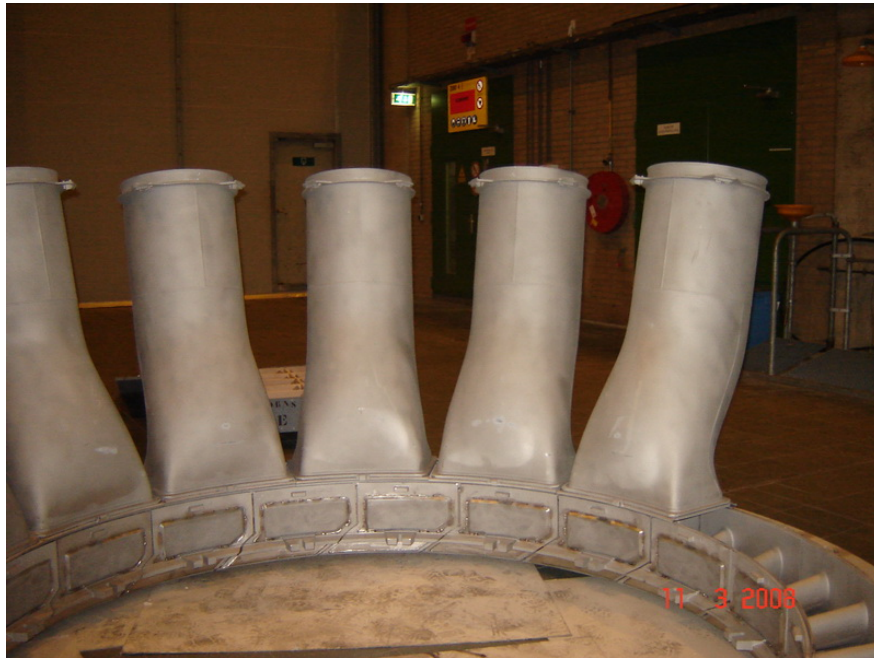
*Fitting of transition pieces on the nozzle*

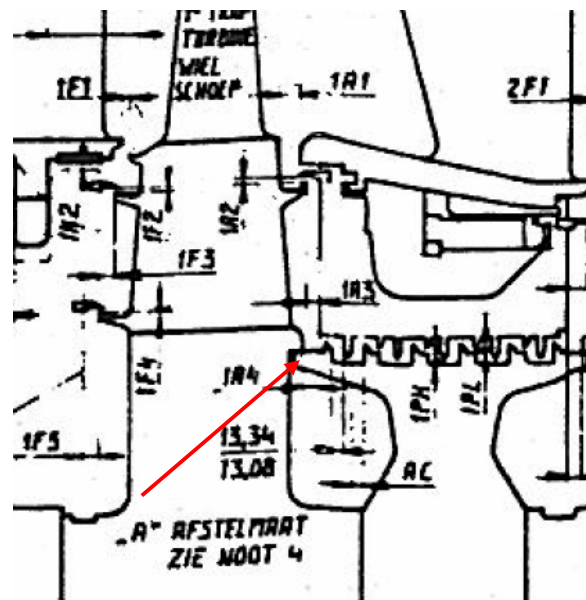
The "A" set value according to the old method (tolerances 13,08 mm – 13,34 mm)

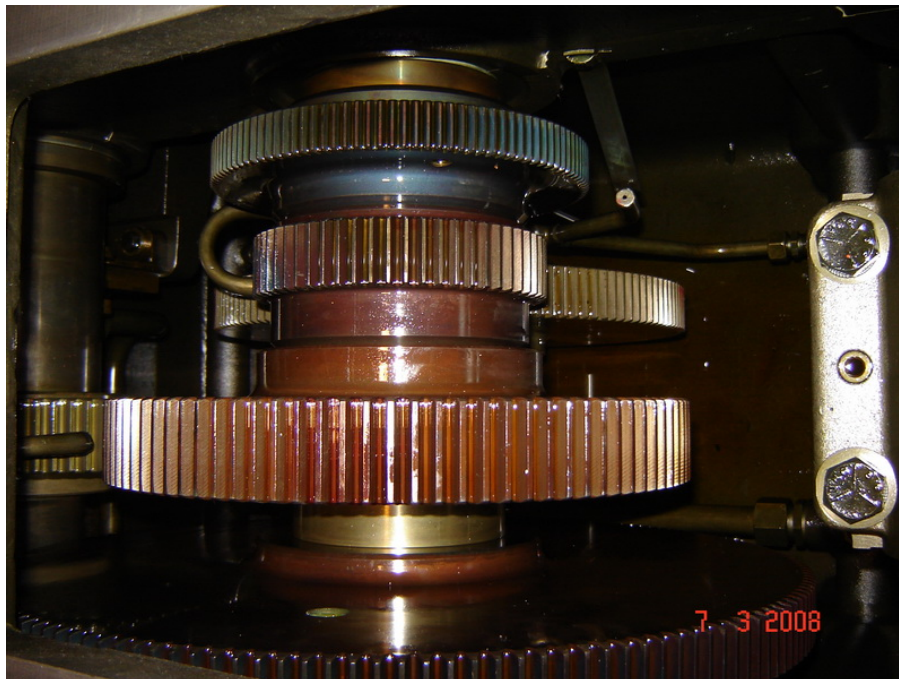
*View from the top at shaft #1*

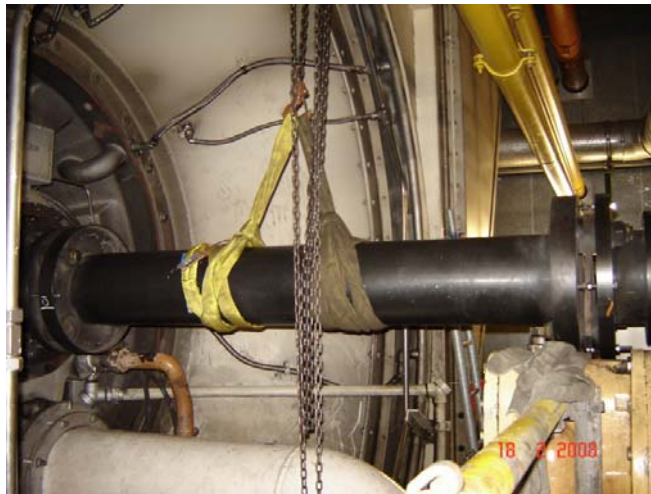
*General view at accessory coupling*

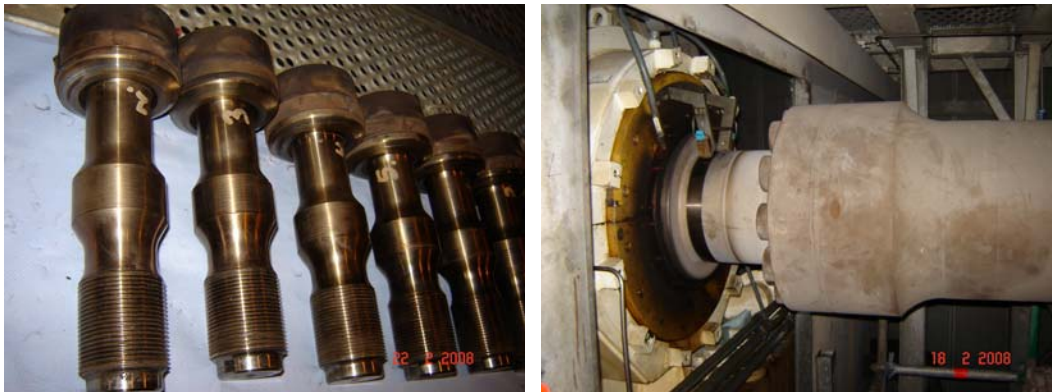
*General view at coupling bolts and coupling*

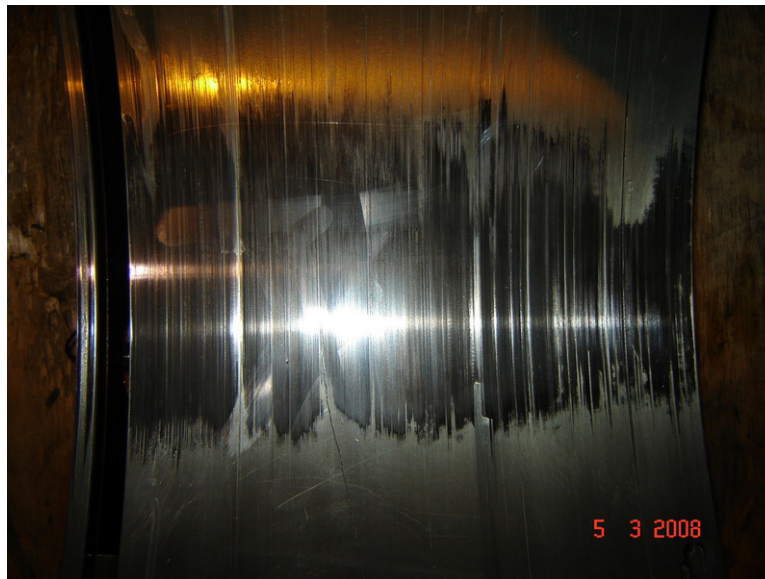
*A view at the damaged bearing after removal*

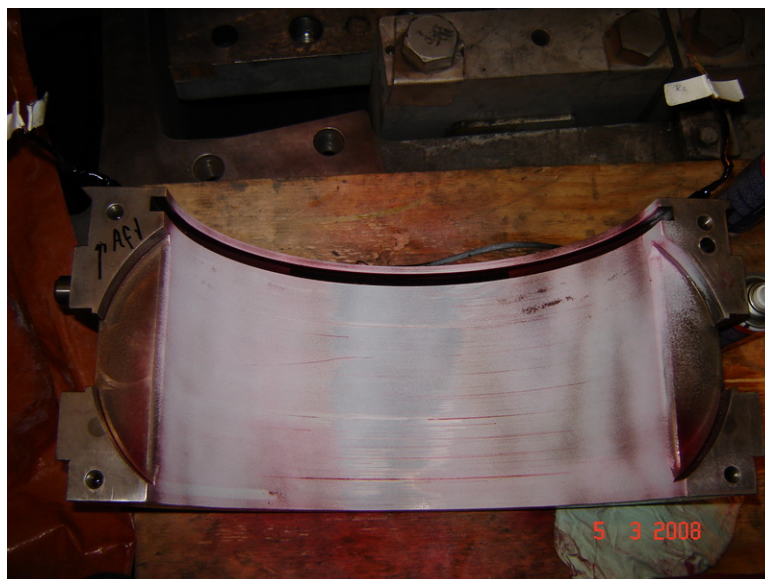
*Tangential grooves are visible during dye penetrant check*

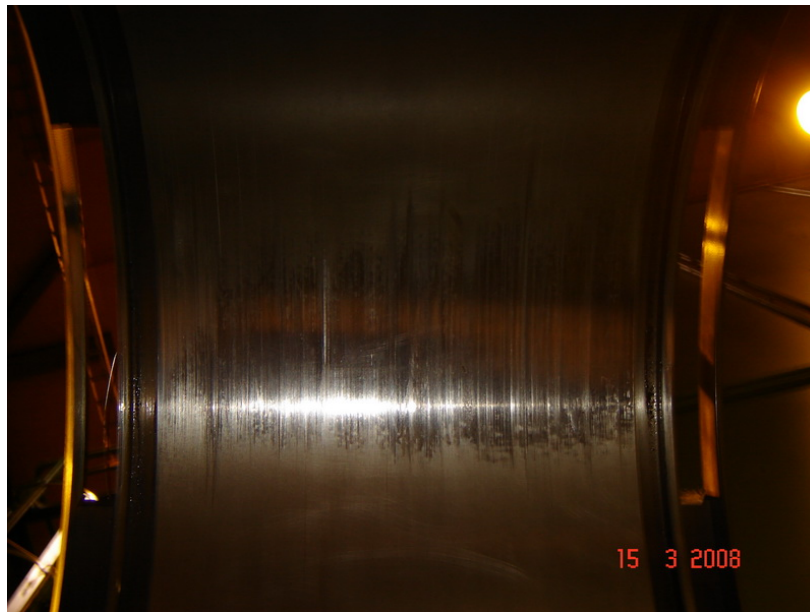
*A view at the quite normal wear patterns of the renewed bearing*

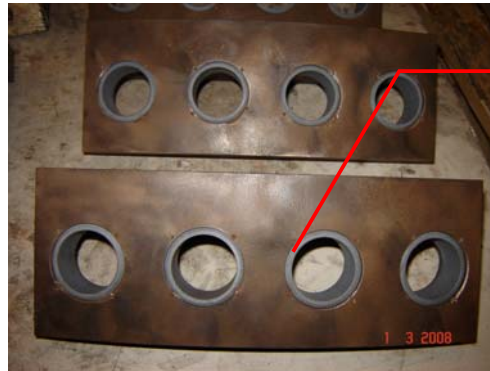
*New inner bushings were installed*

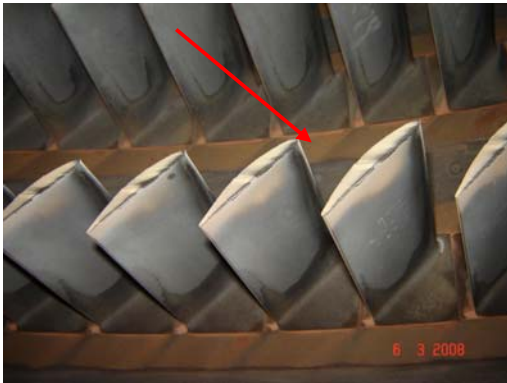
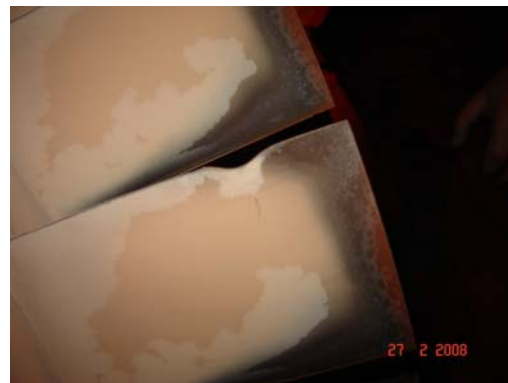
*Rubbing marks which were blended and old damage of R17 blades*

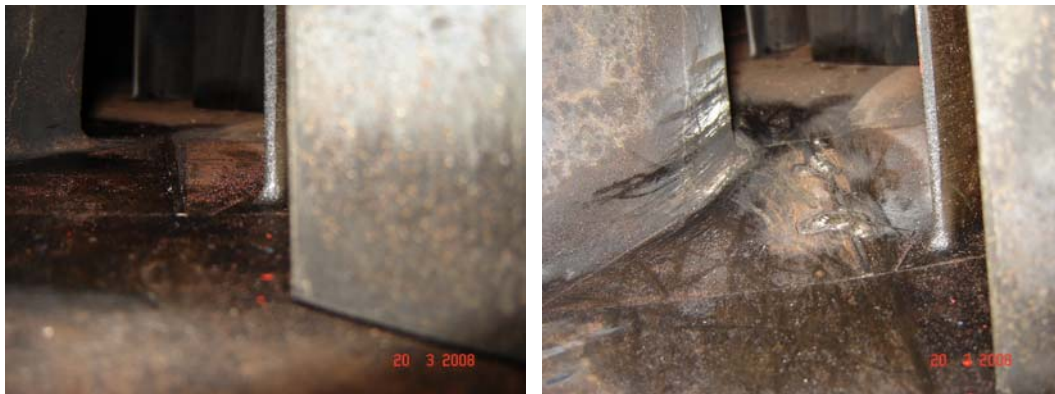
*The shim before and after welding*

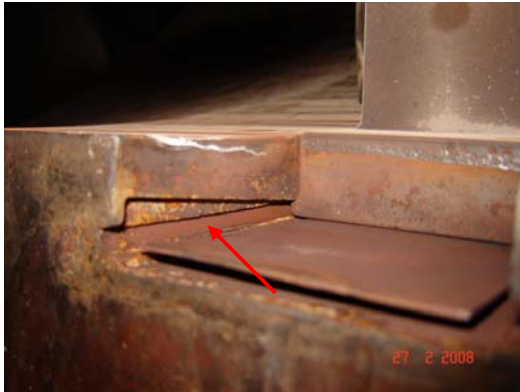
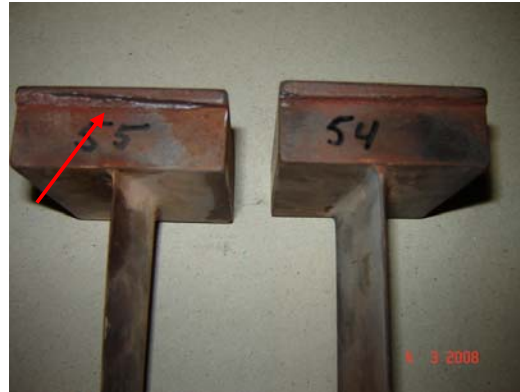
*The damaged slot and one of the worn dovetails*

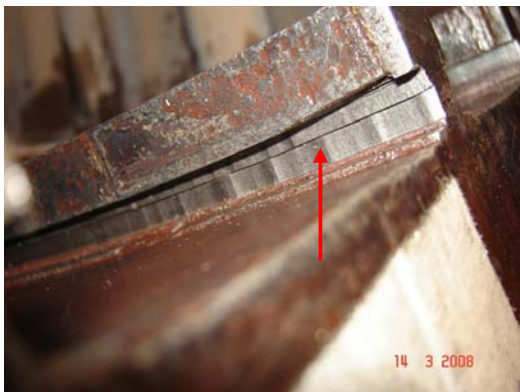
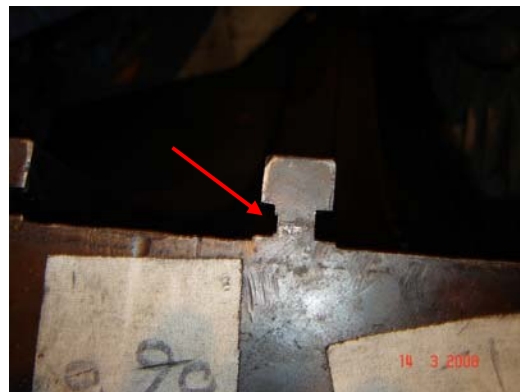
*The machines slots*

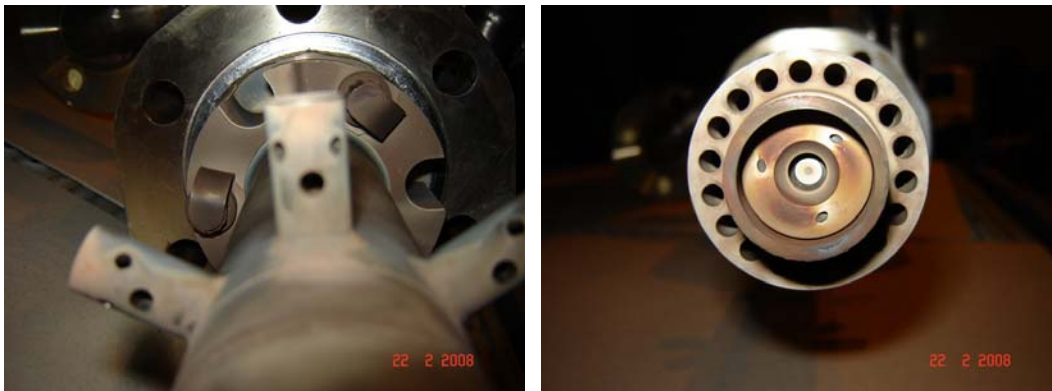
*Detail of secondary fuel burner (left) and transfer burner tip (right)*

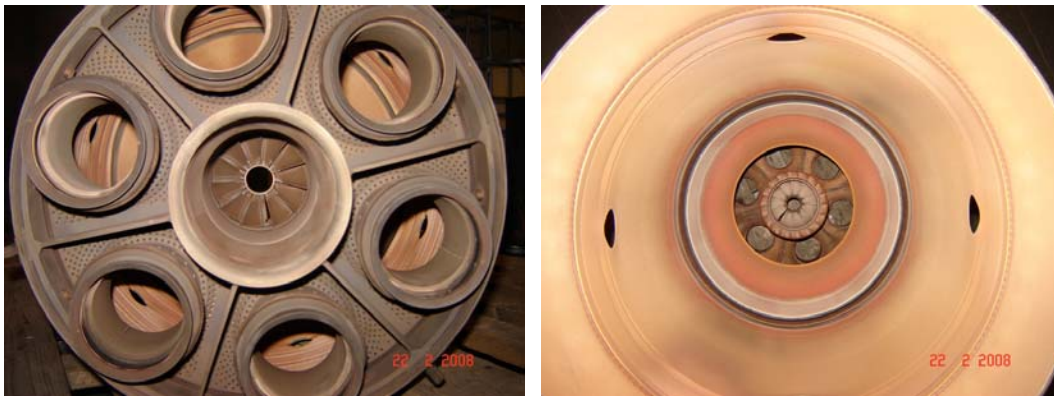
*Liner caps and coating were in relative good condition*

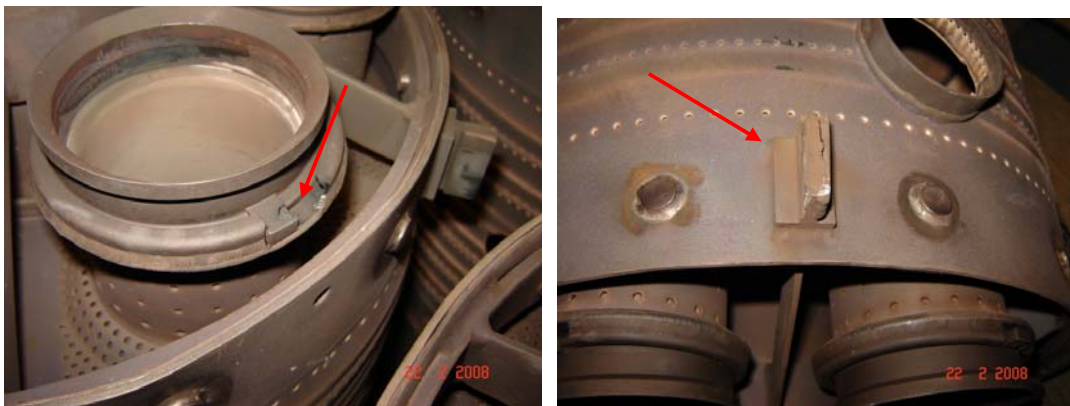
*Some wear at the burner collars and liner stops*

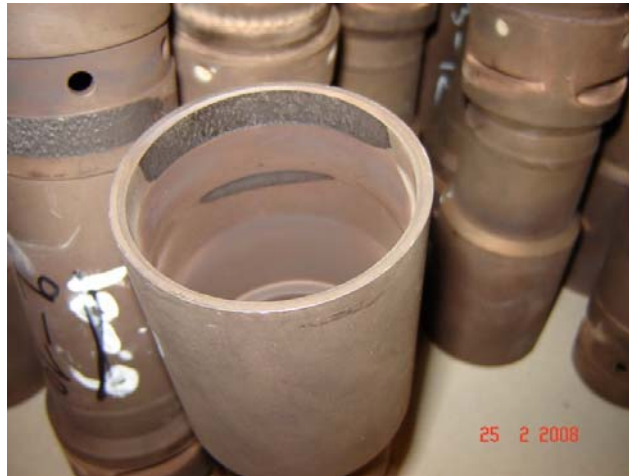
*Light wear of crossfire tubes*

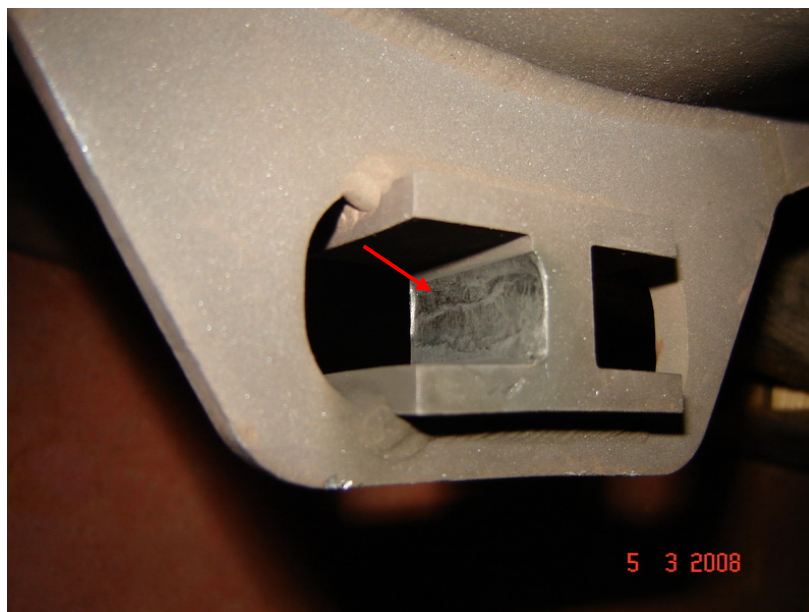
*Light wear at "H" bracket*

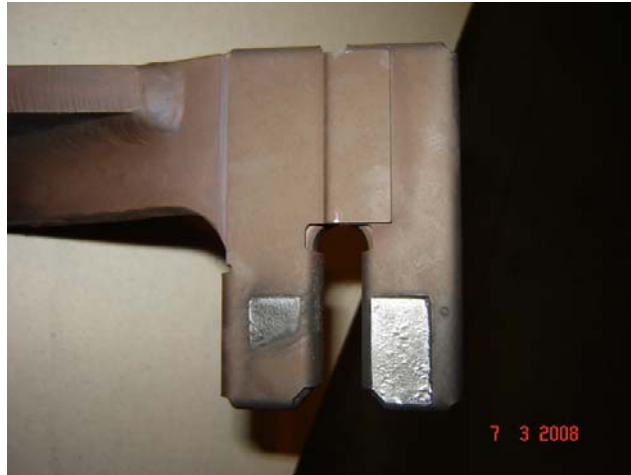
*Wear of the hard metal contact surface*

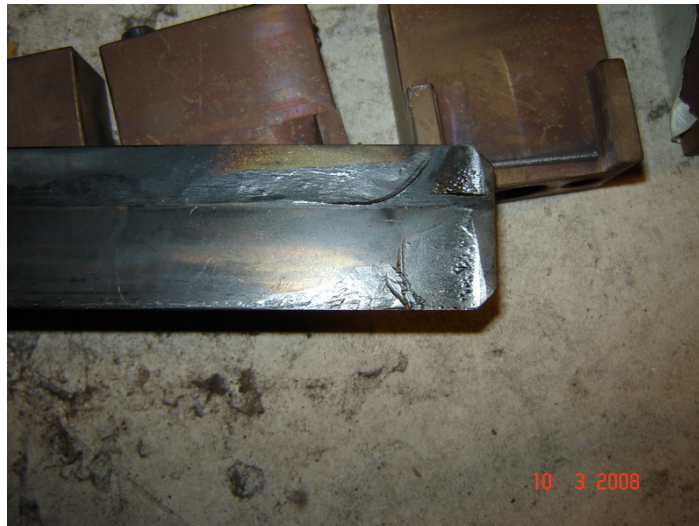
*Wear at the tip of a side seal*

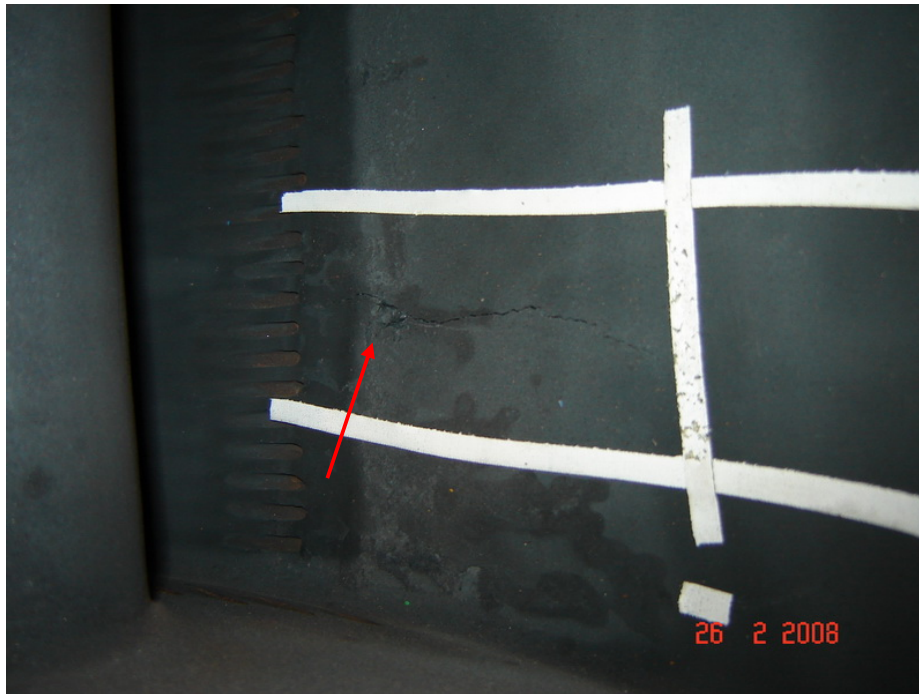
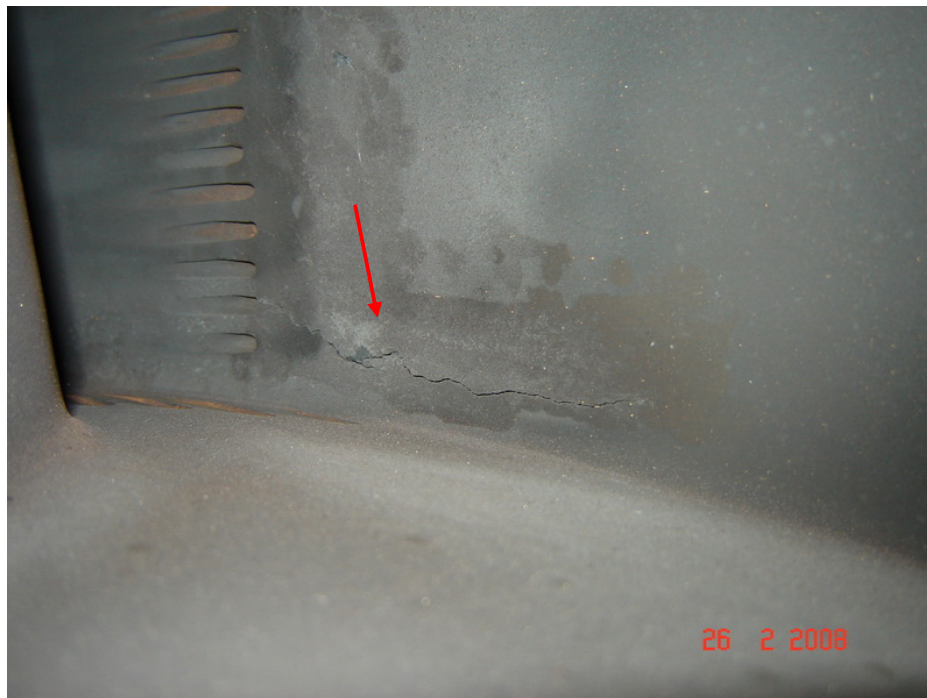
*Some of the cracks in the vanes*

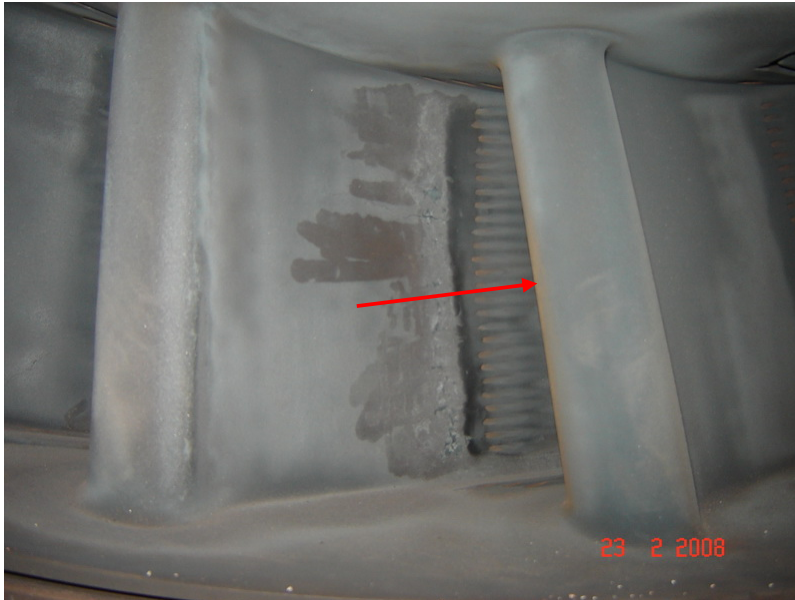
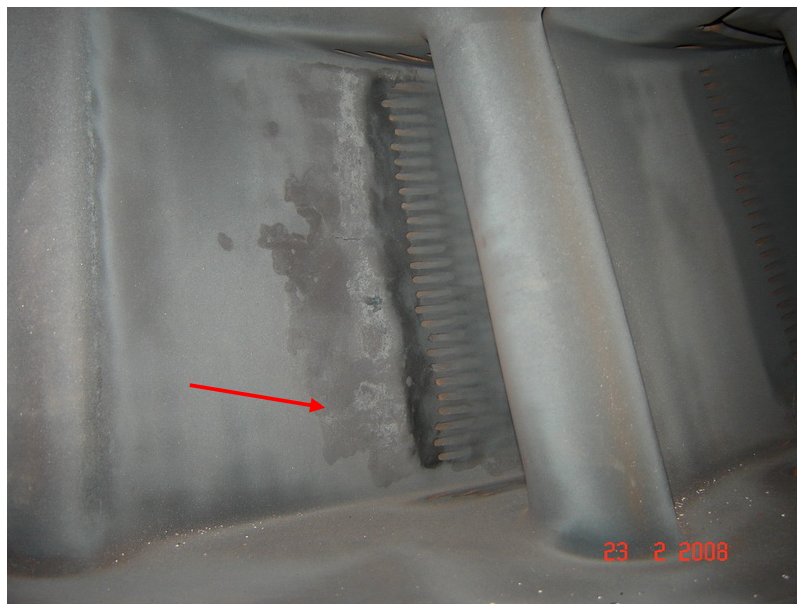
*Erosion and cracks at the pressure side of the nozzle vanes*

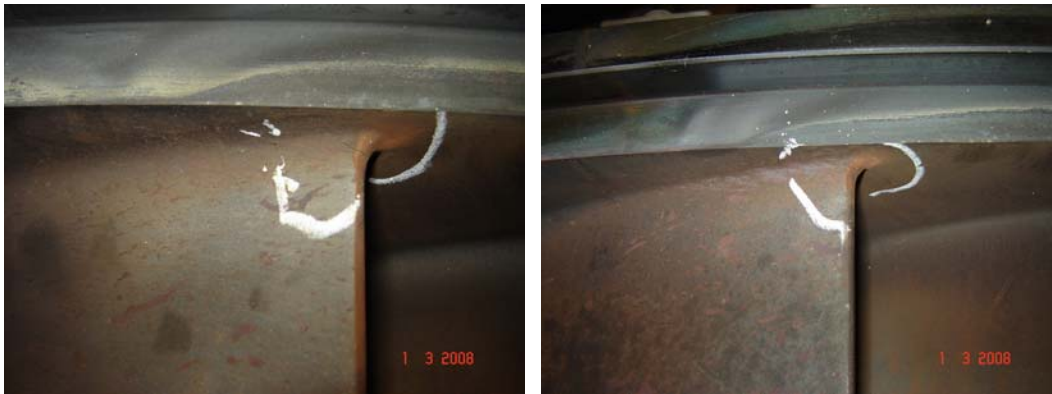
*Light cracks at the corner of the vanes*

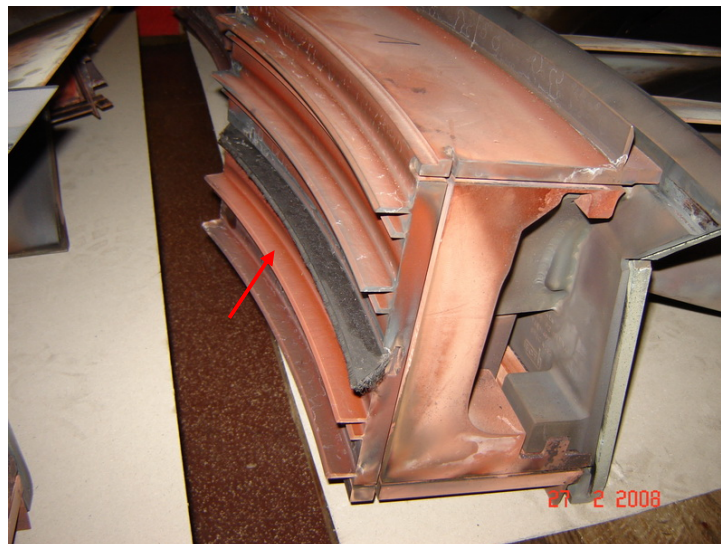
*One of the disassembled nozzle segments with brush seal in the diaphragm*

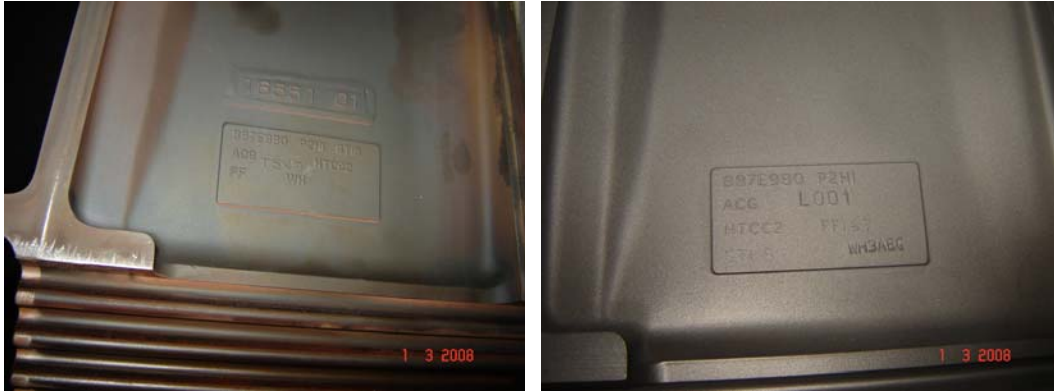
*Detail of one disassembled and assembled bucket*

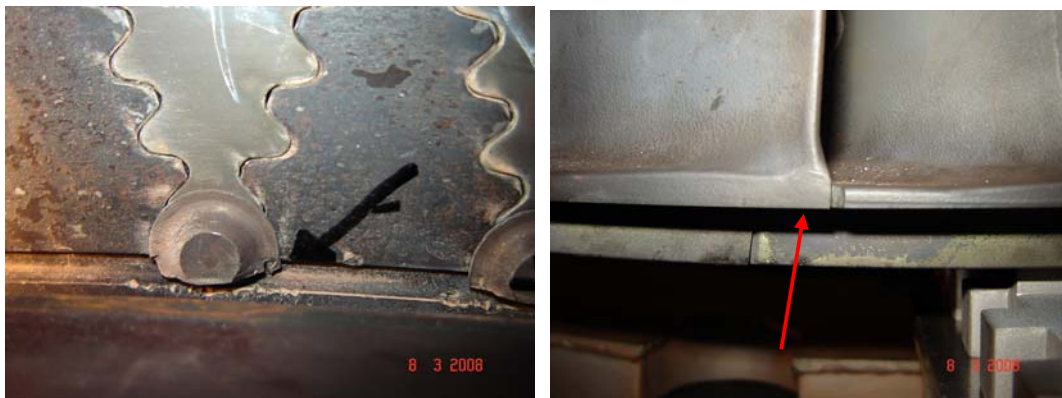
*Detail of formerly damaged twistlock and no severe deflection noticed at tips*

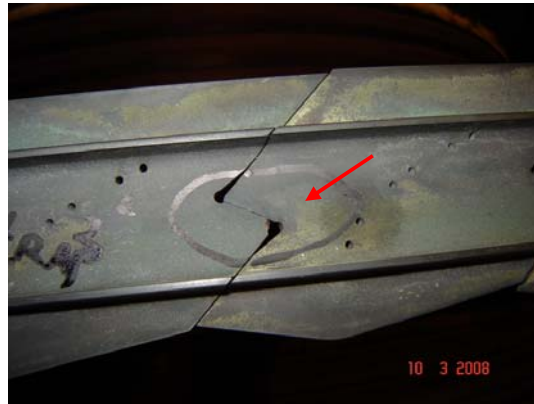
*Material loss at shrouded tips (3 locations)*

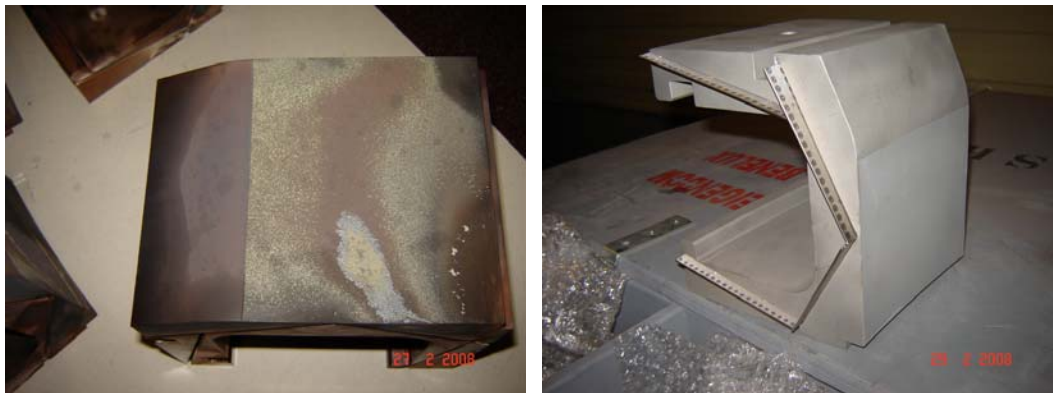
*A disassembled and an assembled shroud block*

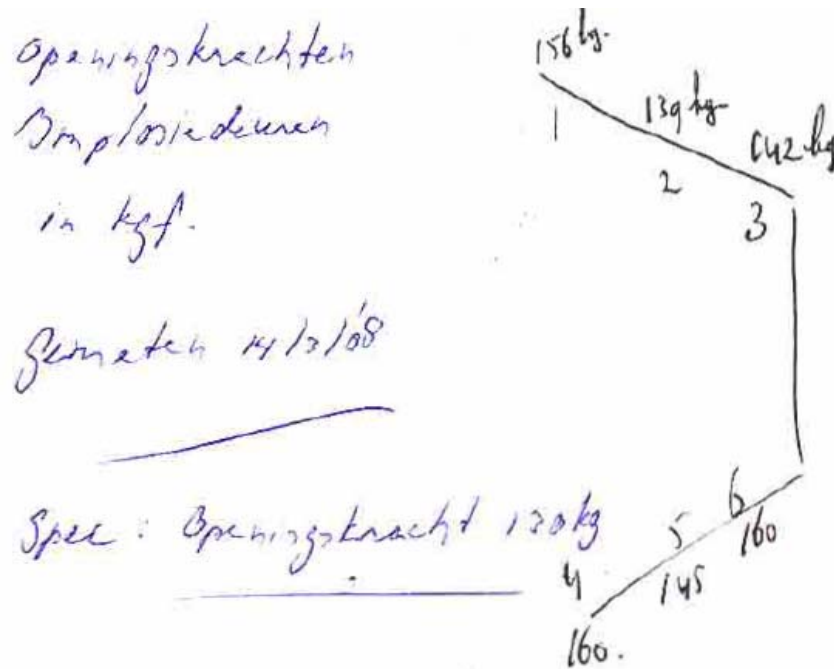
The water separators were cleaned under supervision of EON personnel. Upon final inspection of the clean air space of the filter house, it was noticed that there were heavily corroded spots underneath the filter cartridges on the floor. The loose debris was removed. It is recommended though at a future stop to remove the corrosion and scale from these spots with a needle hammer and put a new coating on it.

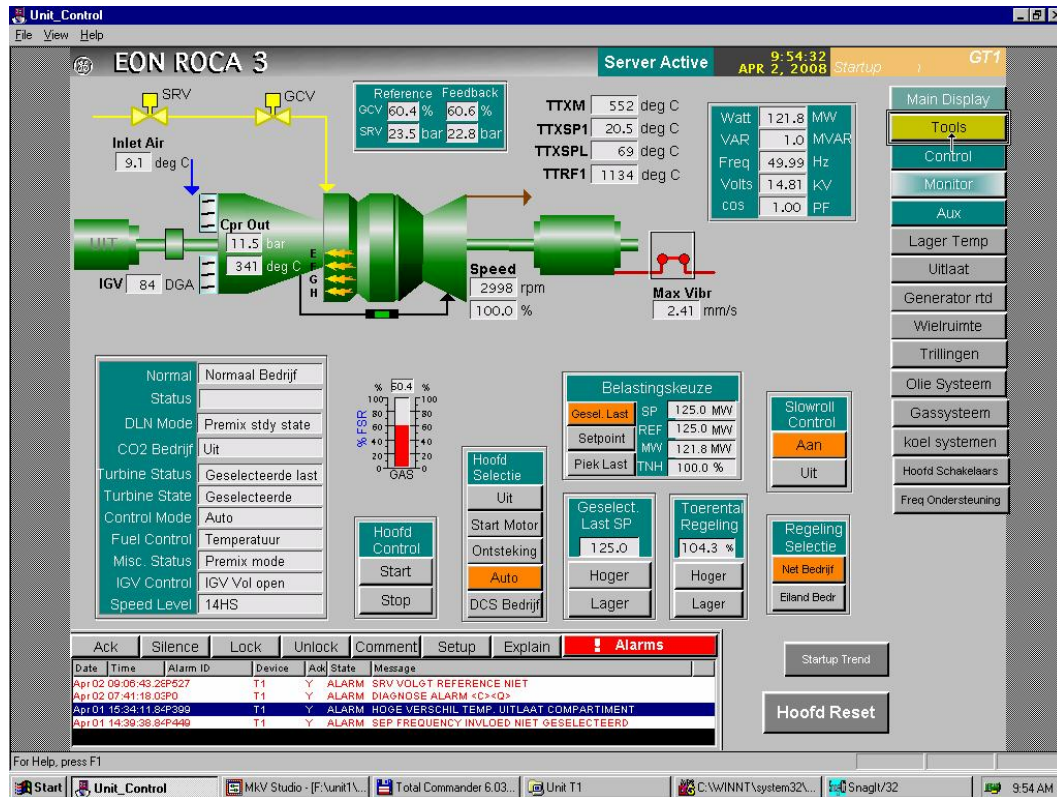
## SPEEDTRONIC IMAGES AT BASE LOAD
