## Fact Finding Report

| Report-No.: | 80051273 |
| Plant: | RoCa Power Station |
| Unit #: | RoCa 3 |

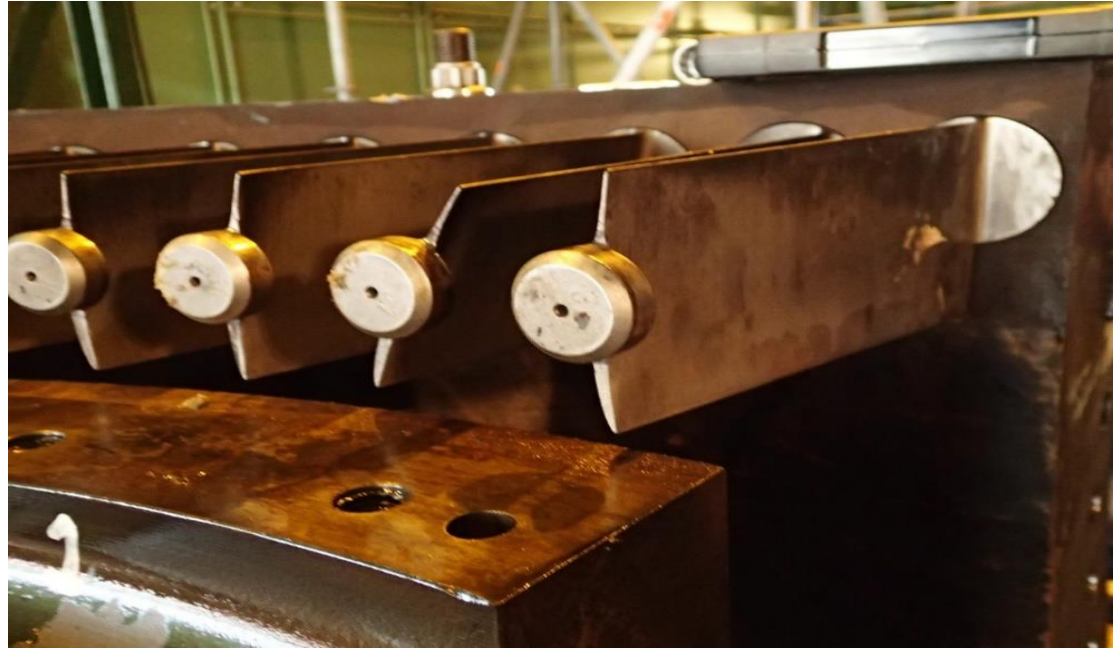
IGV Dismantling

All IGV's were disassembled, cleaned and Dye Penetrant checked, no indications found. All Chemloy and Inner/Outer Bushings were replaced with new Components. New Gears and Rack were installed. IGV's are drilled for the third and last time now. Mechanical Stops are on 90deg, and 32deg. IGV actuator was overhauled by Customer due to leaking of Actuator Stem.

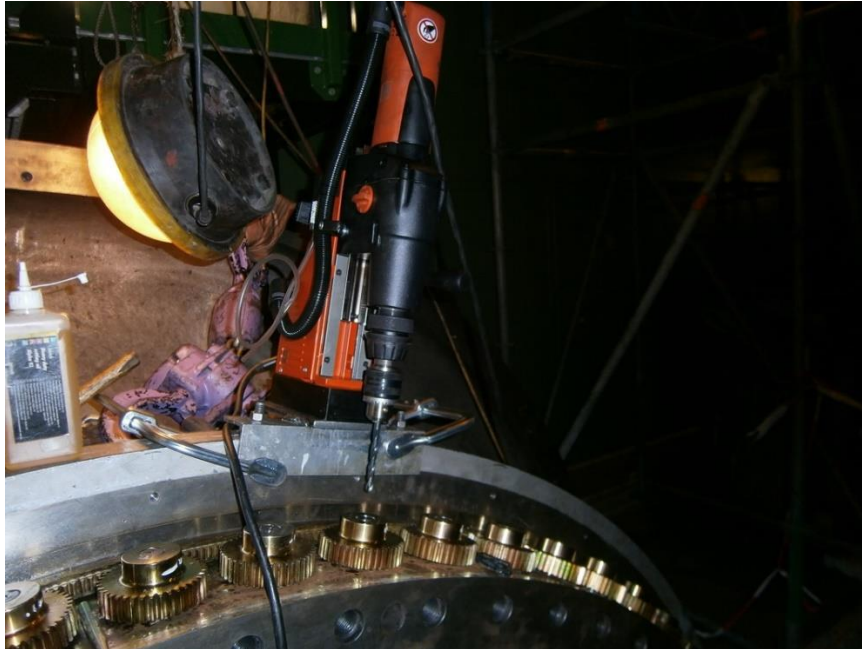
Drilling of IGV's with new Gears and Rack

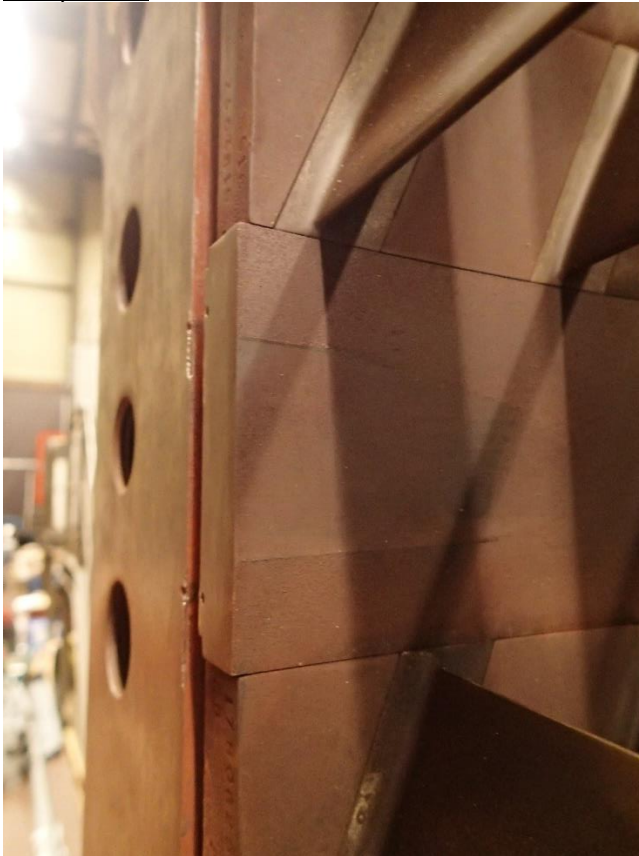
Quit heavy, old Rub Marks on Upper Half Compressor Casing R11

Compressor Casings Upper Half were Visually and Dye Penetrant checked. Row R14 gave some indications. After removal of 9 Vanes, and checking those Vanes, it turned out to be some scaling, probably formed during the rubbing of compressor Blades and Casing. After cleaning and checking, no indications were found, and Vanes were returned to Service.

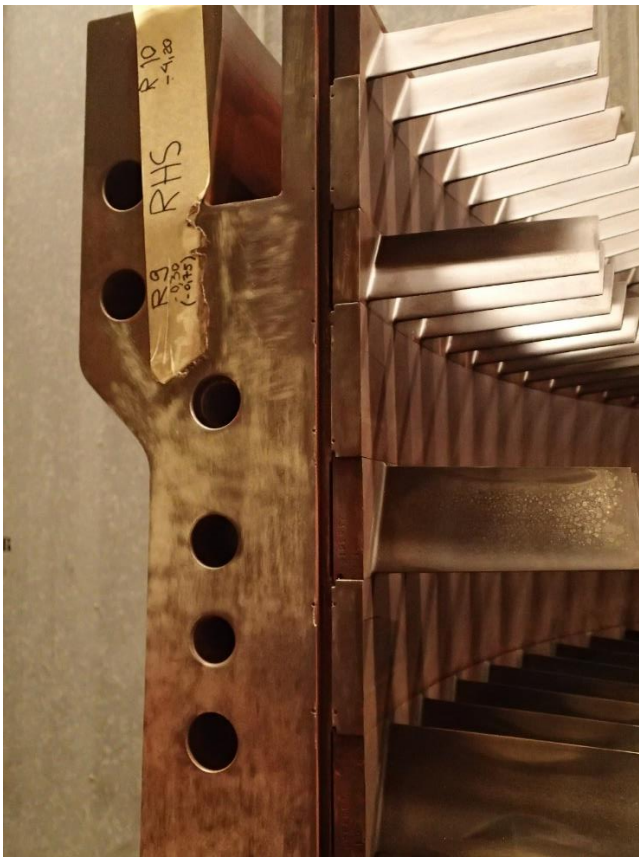
Compressor Casing Upper Half RHS before Shimming

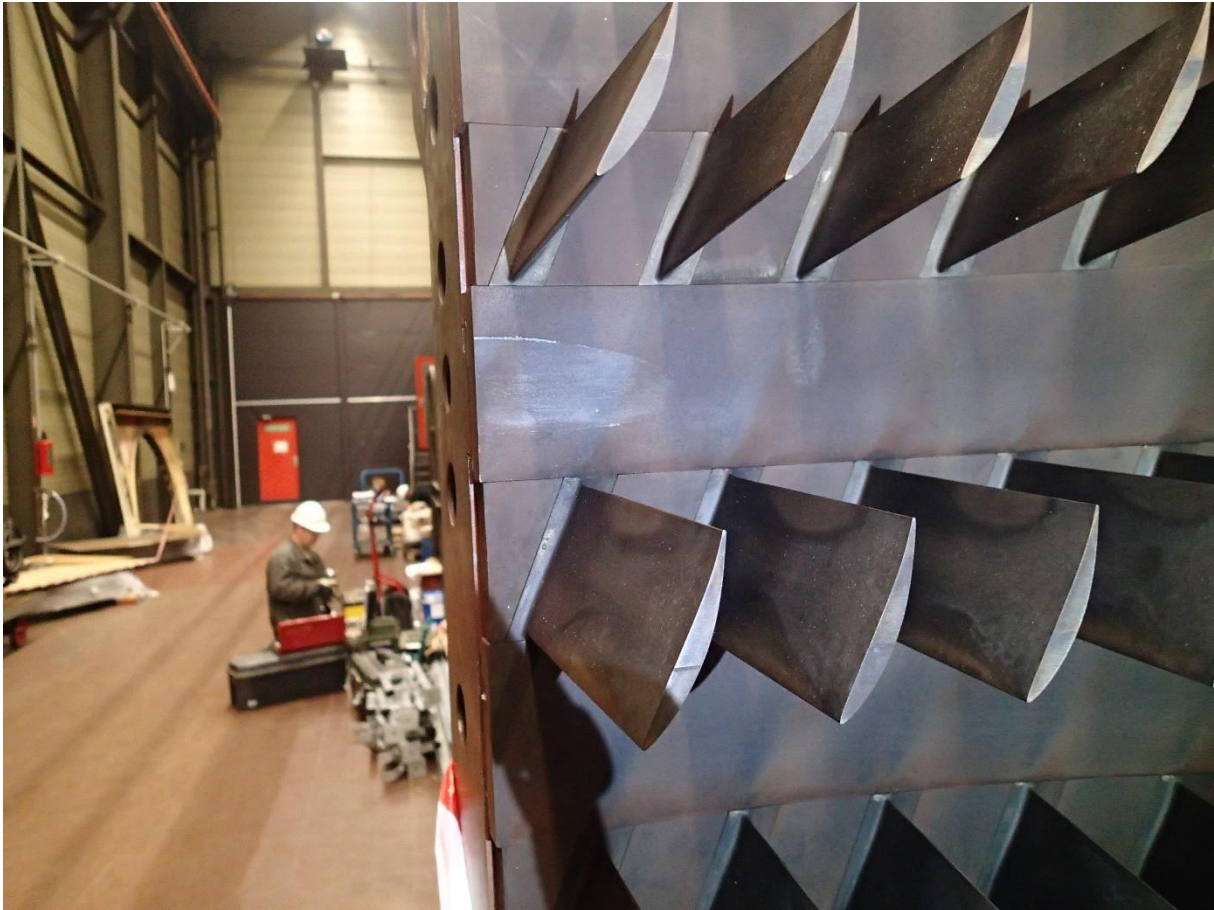
Compressor Upper Half RHS before Shimming. Notice Rub Marks R6 and S7

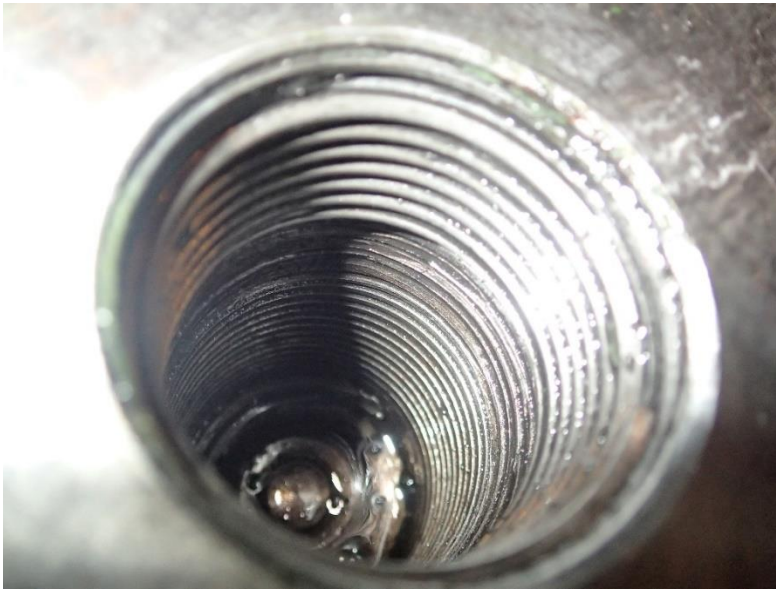
Damaged Thread Bearing #1

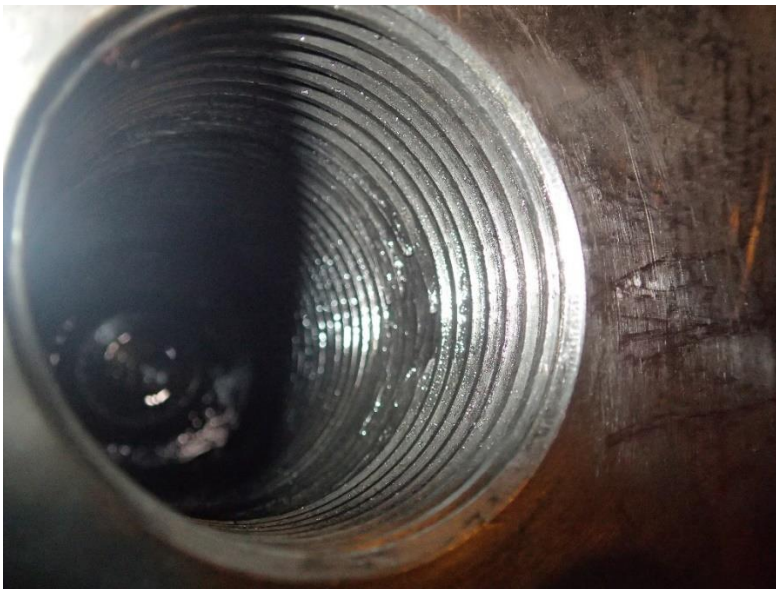
Another Damaged Thread Bearing #1

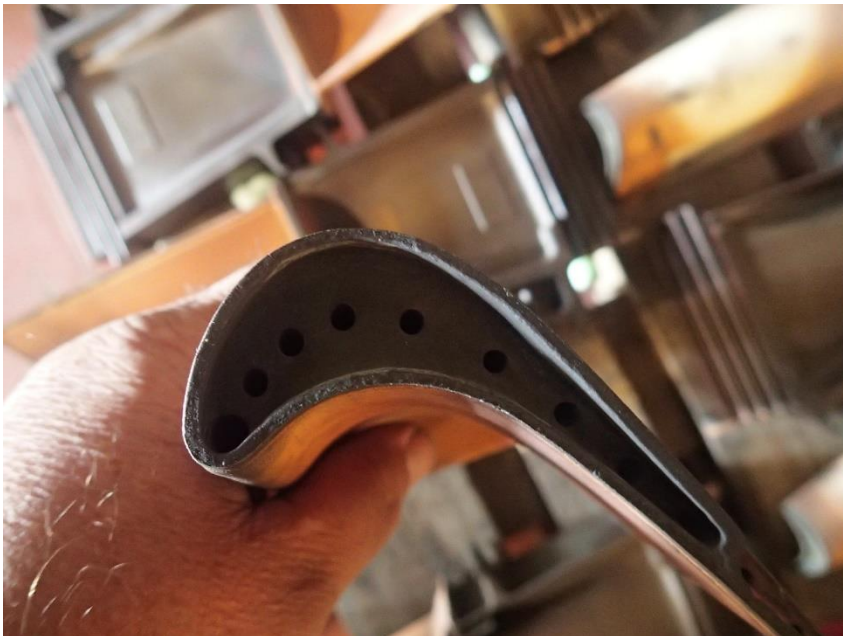
Some Minor Damage of Squealer Tip

Buckets were removed because of running hours. TBC was still OK, some Minor Damage of Squealer tip was observed. Refurbished set was installed with new Hardware. Refurbished set was compiled with some Buckets from another set. During installation these buckets gave some problems because Trailing and Leading Edge of Buckets interfered quite heavy. See Photo

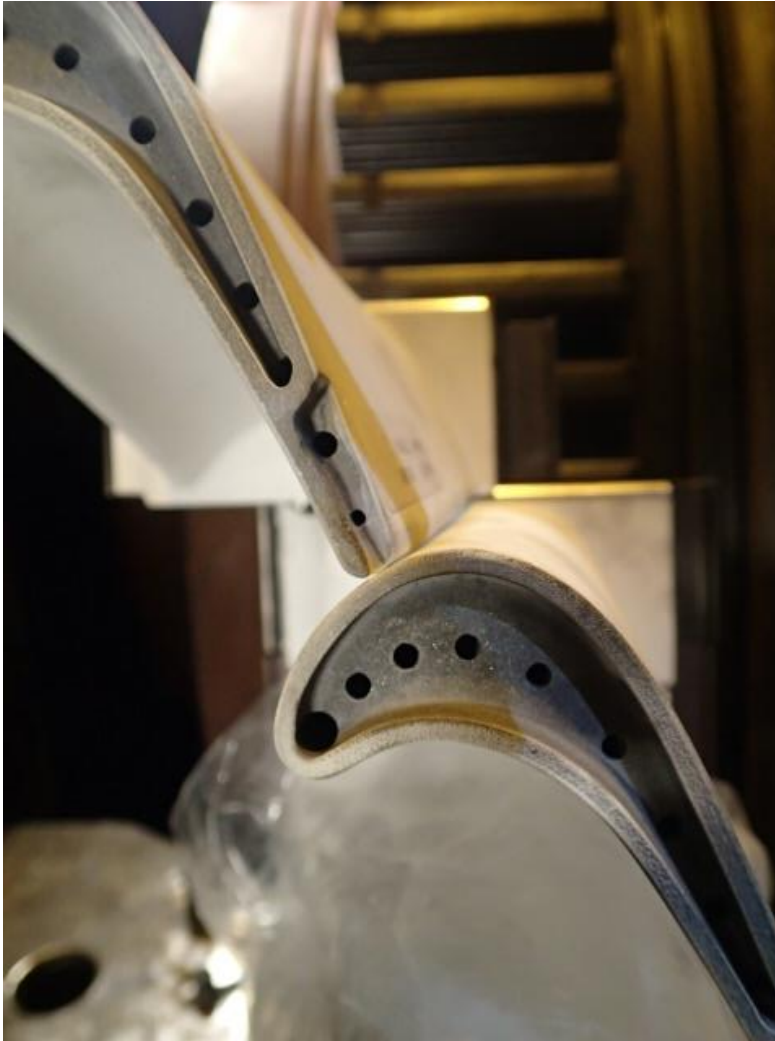
Misfit of 1<sup>st</sup> stage Buckets

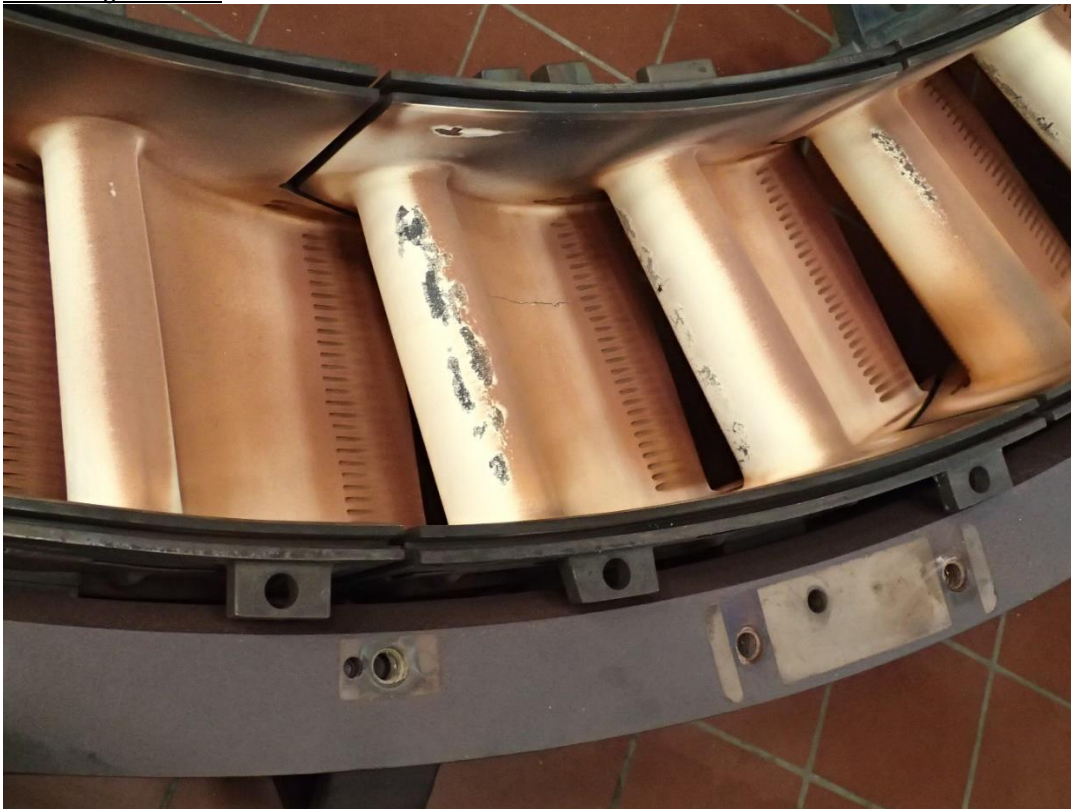
Loss of TBC Leading Edge

The 1<sup>st</sup> stage Nozzle was replaced because most partitions showed medium cracks and loss of Thermal Barrier Coating. Refurbished nozzle was installed, and adjusted. No modification of eccentric Pin needed.

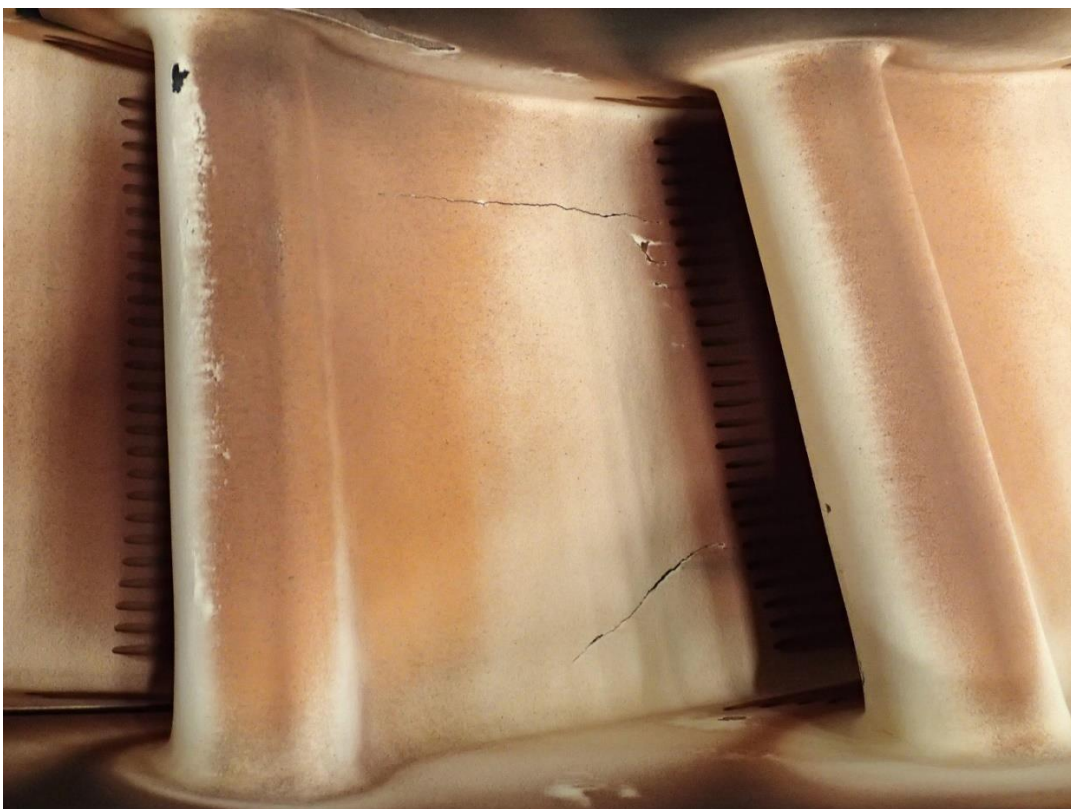
Cracks on Leading Edge

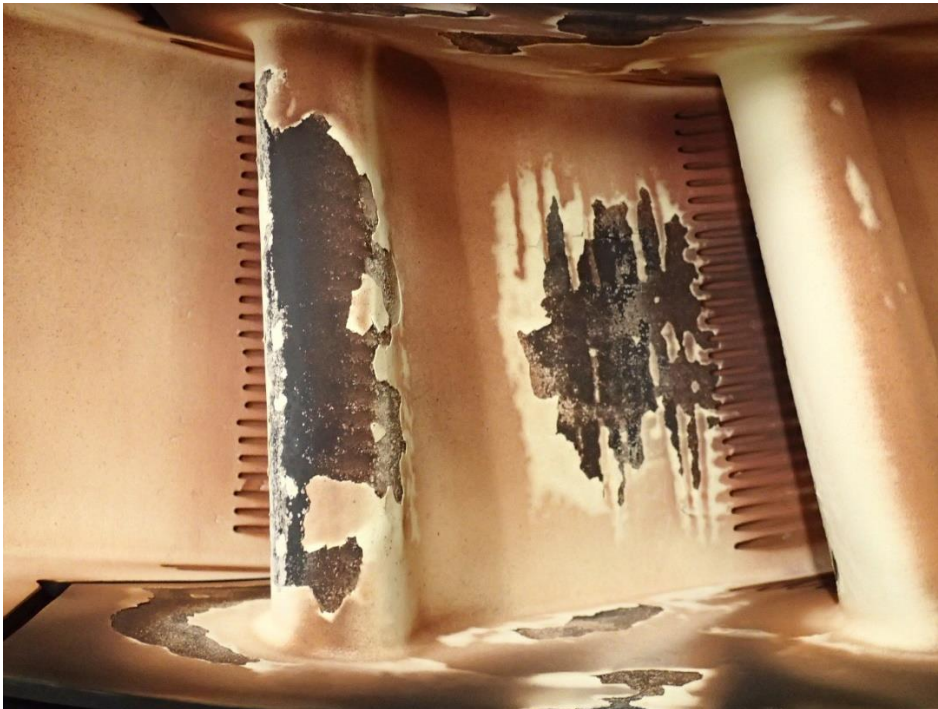
Massive Loss of TBC on Leading Edge

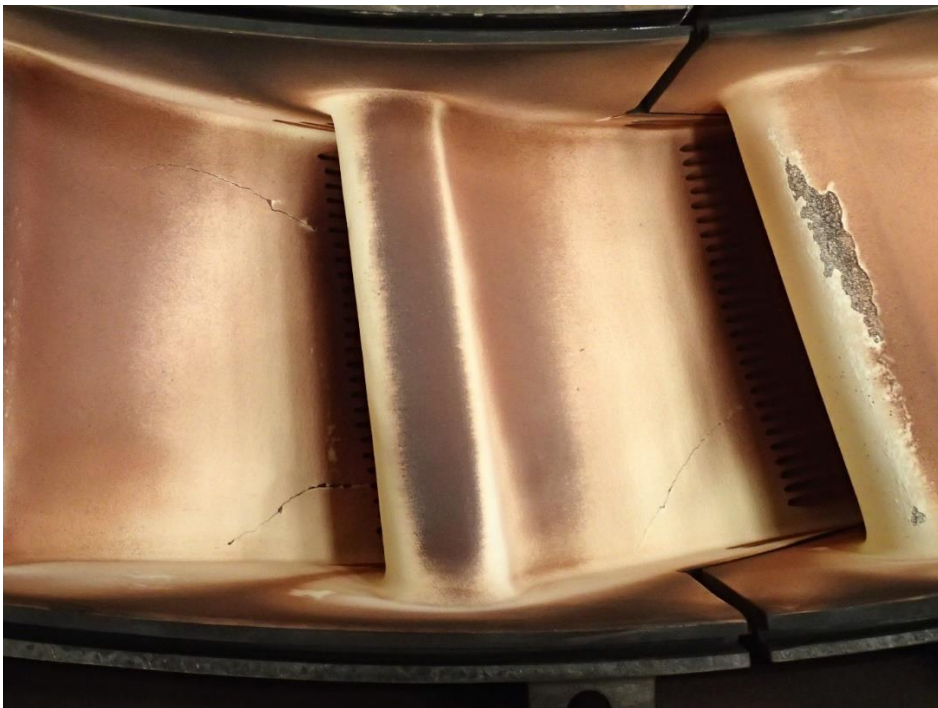
Medium Cracks on 1<sup>st</sup> Stage Nozzle partition

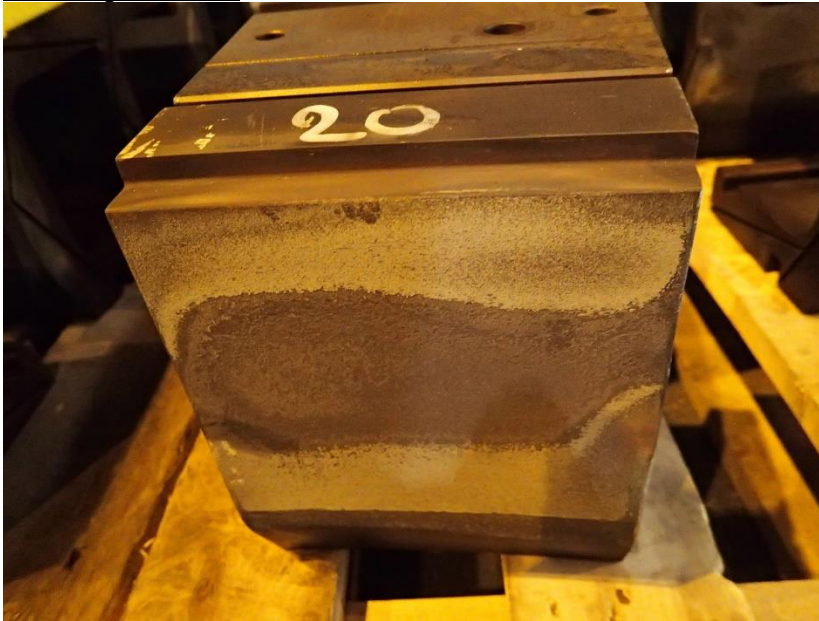
Light Erosion of TBC

Shrouds were replaced with a refurbished set and new hardware. This set was pre-drilled and fitted flawless

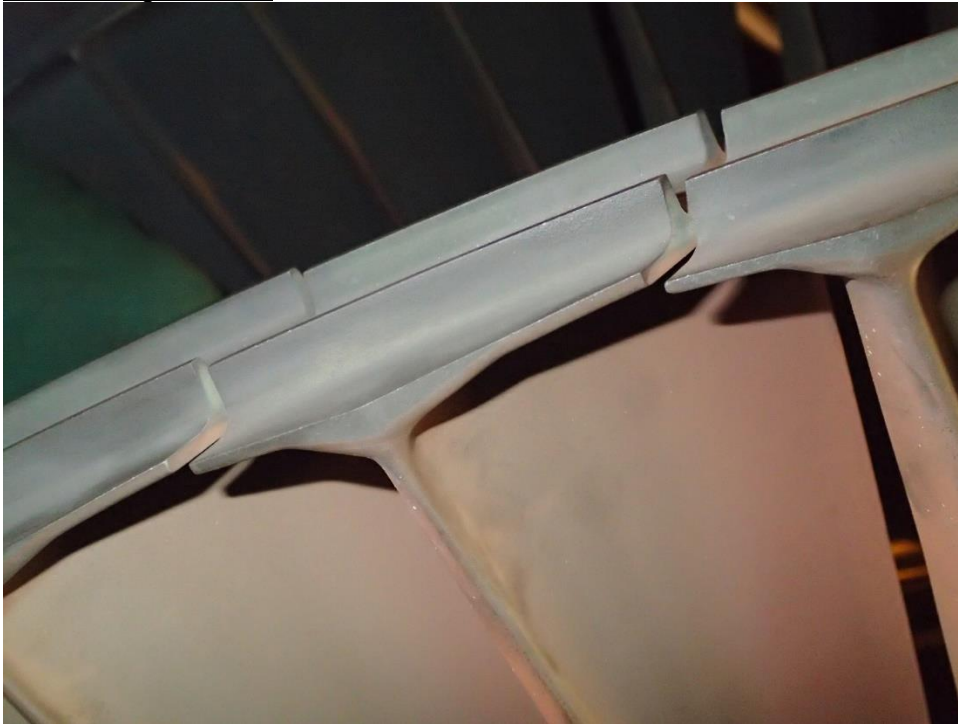
Medium Z-notch deflection

All 2<sup>nd</sup> Stage buckets were replaced with a refurbished set according the given Moment weight chart.

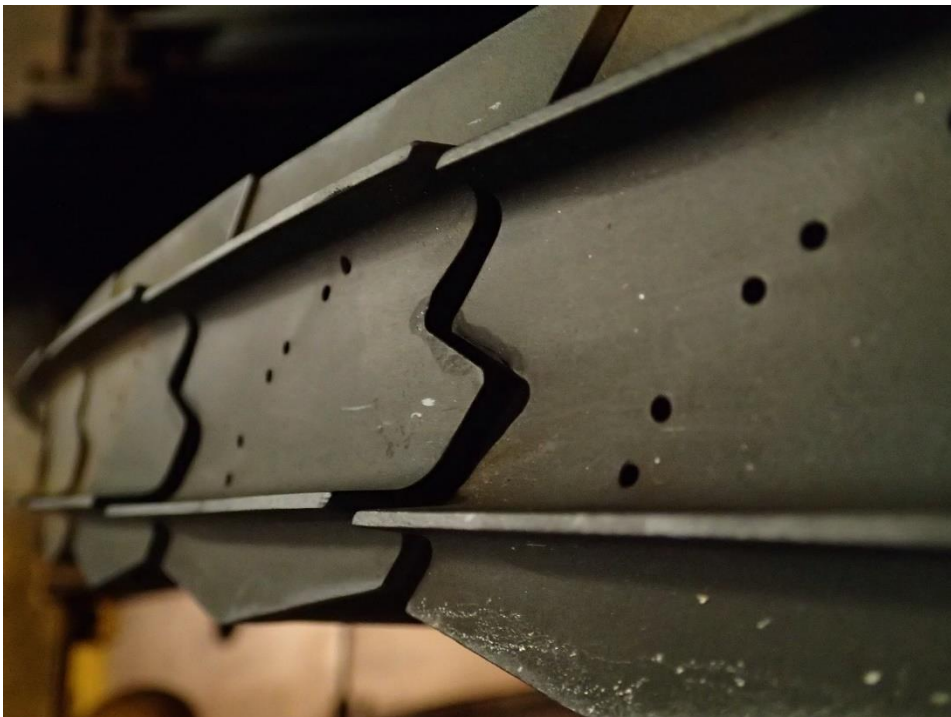
Deflection of Z-Notches 2<sup>nd</sup> stage Buckets

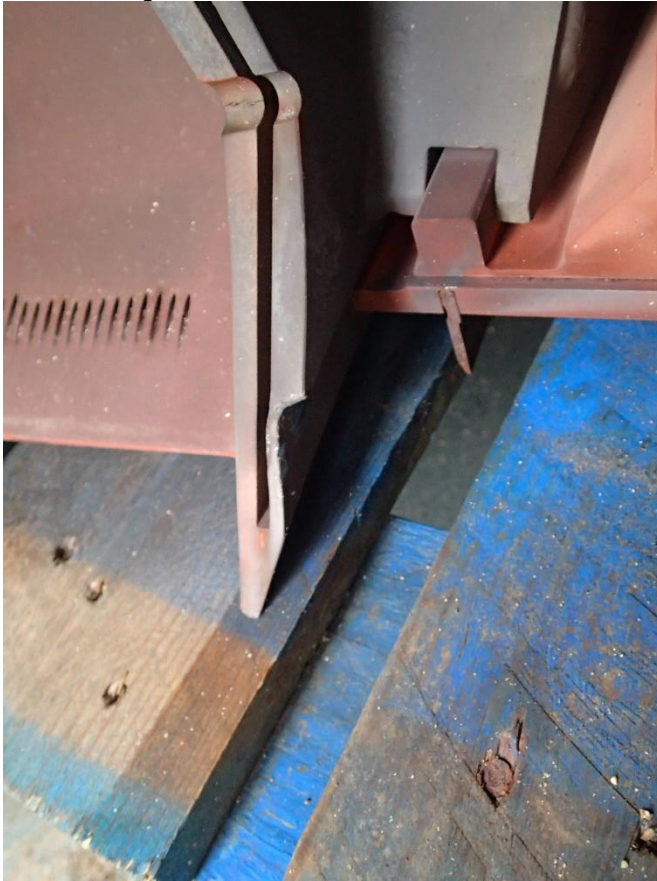
Damaged Seal Area

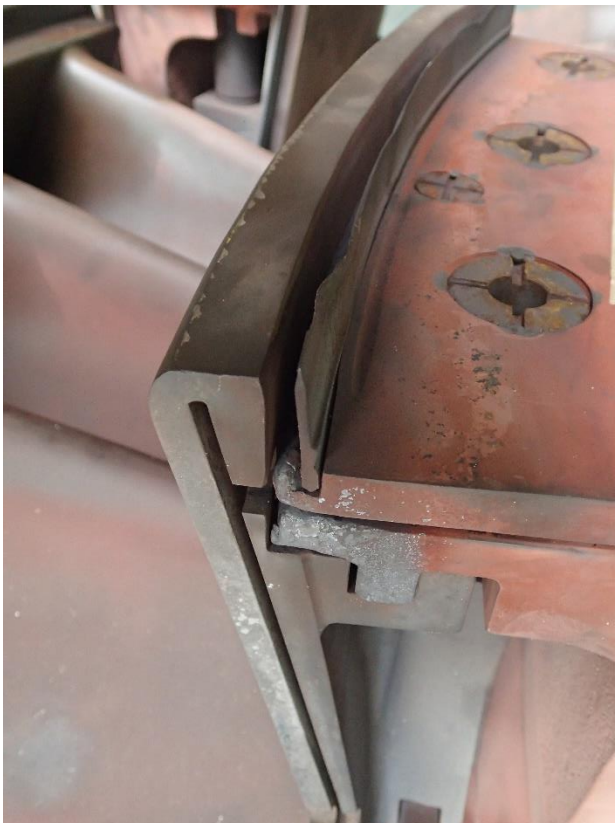
Burned Seal and Diaphragm area because of installation failure

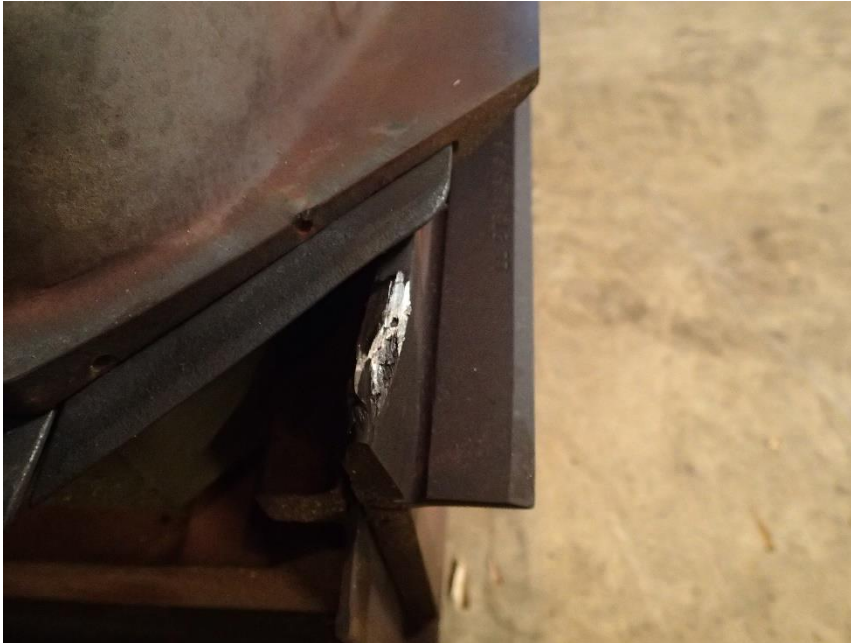
Damage of 2<sup>nd</sup> Nozzle because of misalignment during former installation

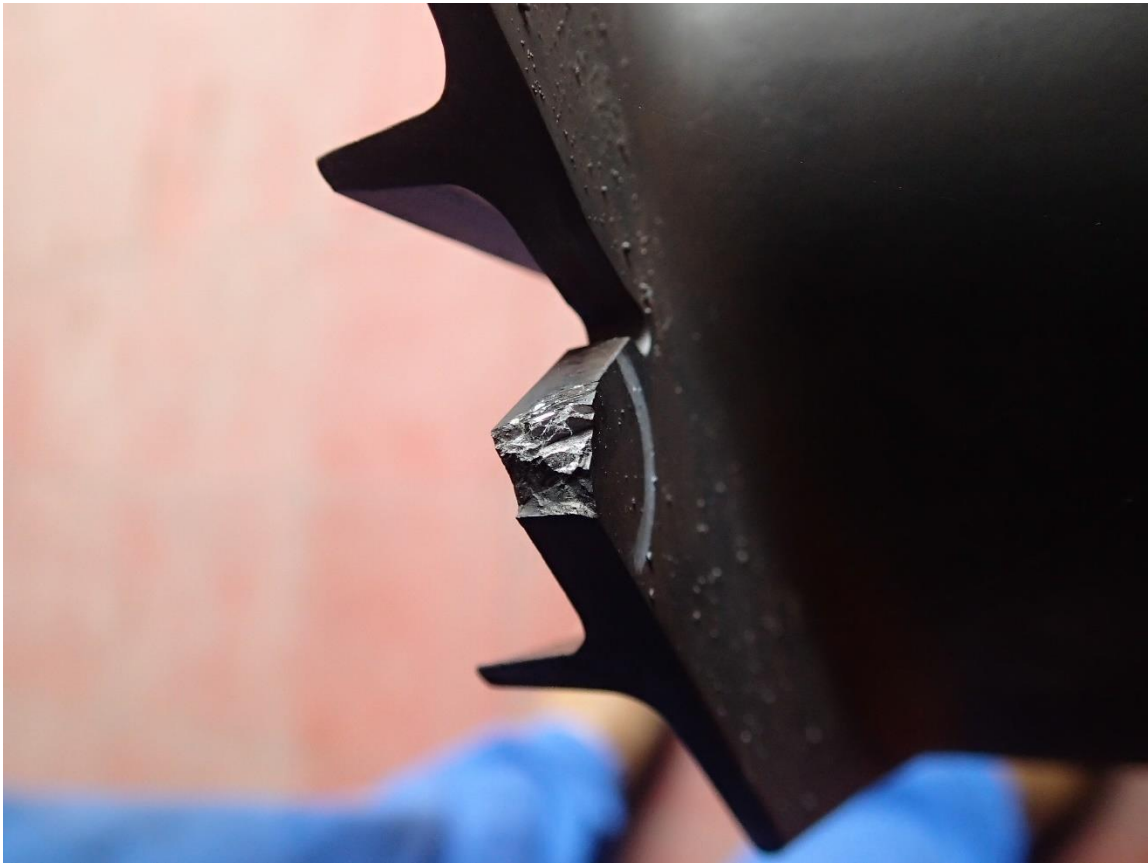
During Removal of the 3<sup>rd</sup> stage Buckets it became clear that some 30 buckets had damaged Z-Notches. It also was clear that there was some existing damage, and some new damage. New damage happened through to rough disassembly of these Buckets. A refurbished set was installed according the given Moment Weight Chart

New damage 3<sup>rd</sup> stage Bucket

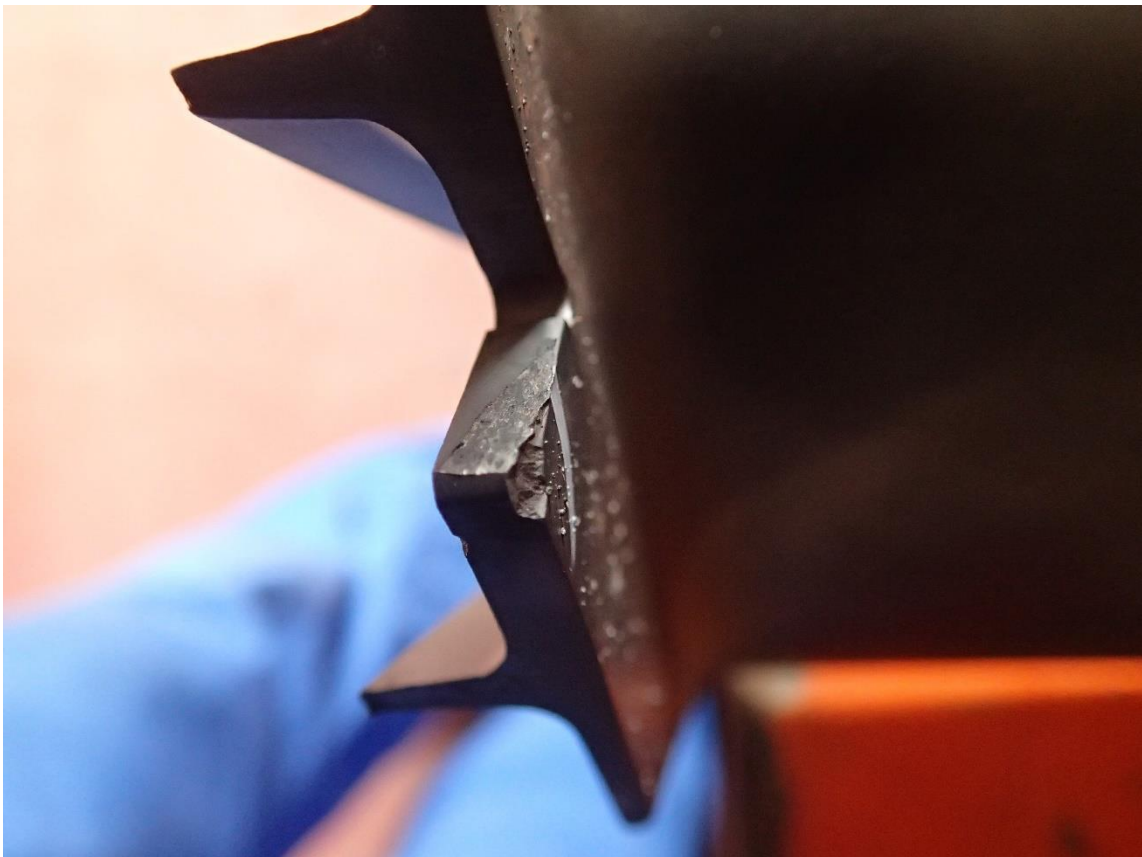
Existing damage 3<sup>rd</sup> stage Buckets

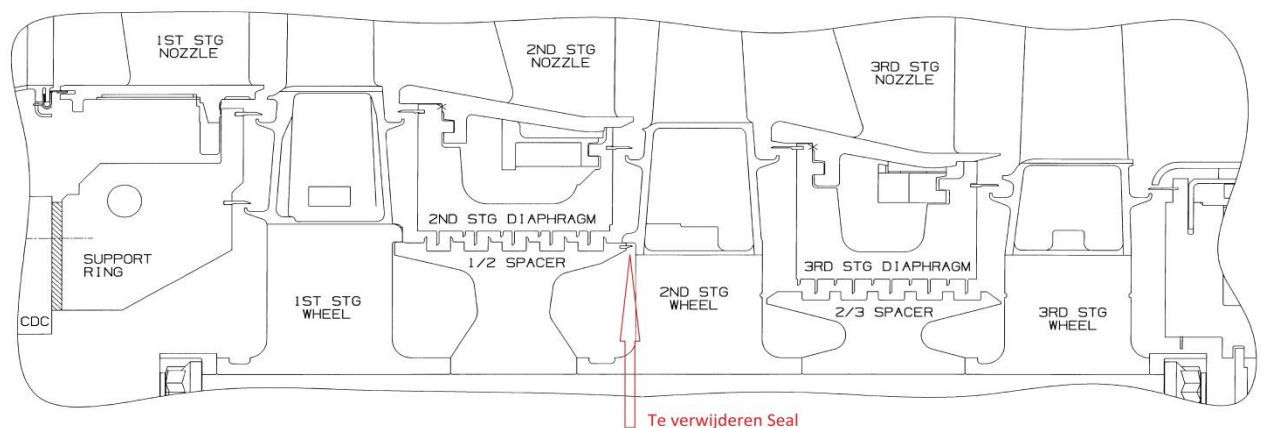
After removal of the Second Stage Buckets, it became clear that the Discourager Seal was in a far more bad shape than was expected. Rough indication showed that almost 20% of the seal had disappeared, and some pieces could be broken by hand from the remaining seal.

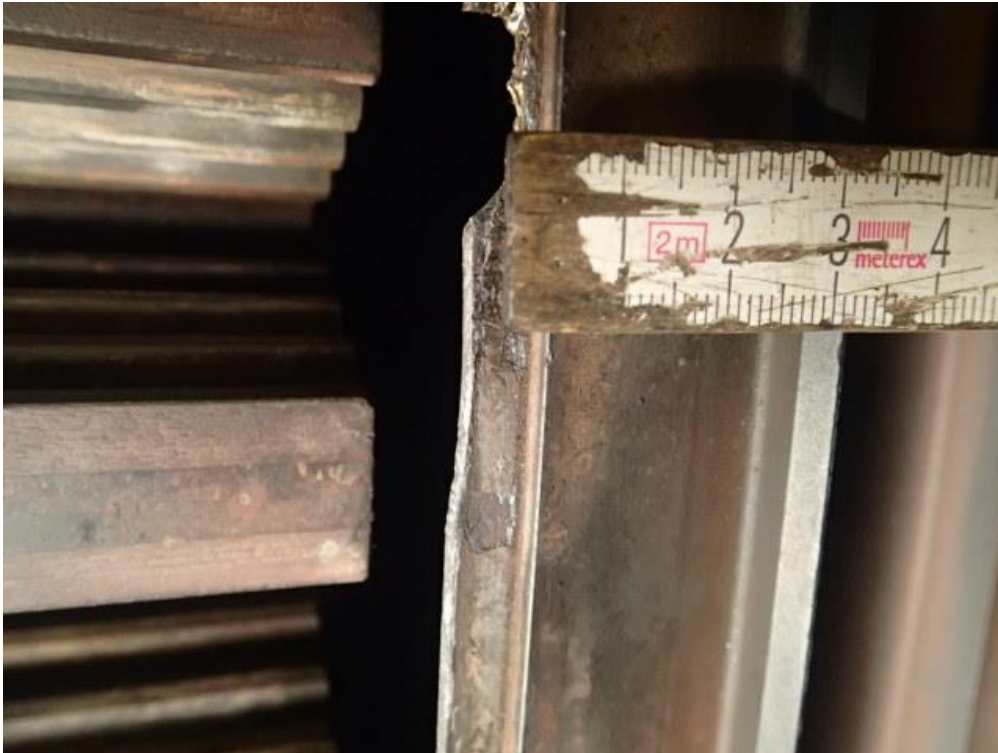
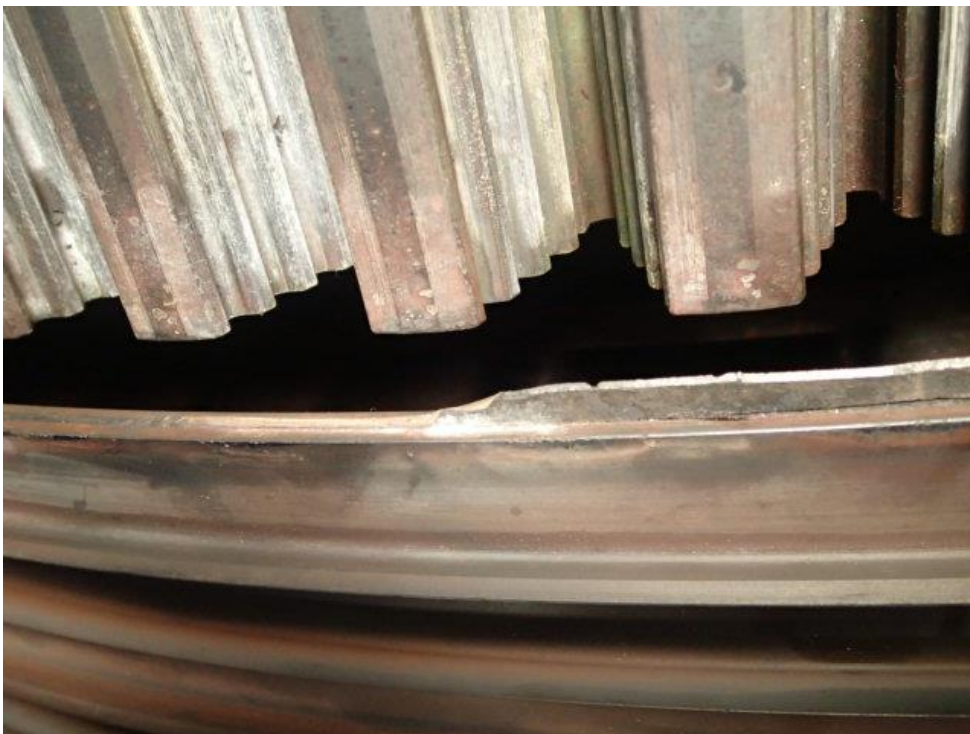
Damaged Discourager seal

After several attempts to remove this seal by hand, Furmanite was invited to site to remove this seal. They could not do it. In the meantime a local company "Onsite Machining" showed up, and they would give it a try. After adjusting their machine, removal of this seal went straight forward, and after cleaning of the groove from pieces of old seal, the new seal was installed and locked by peening.

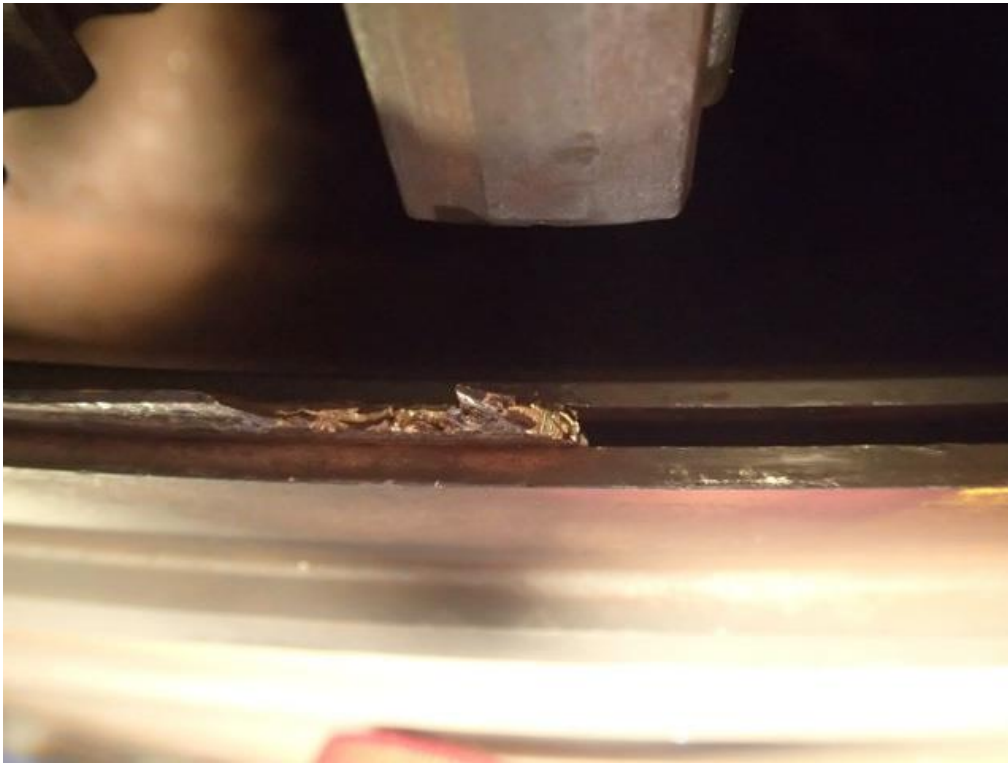
After attempt to remove seal by hand.

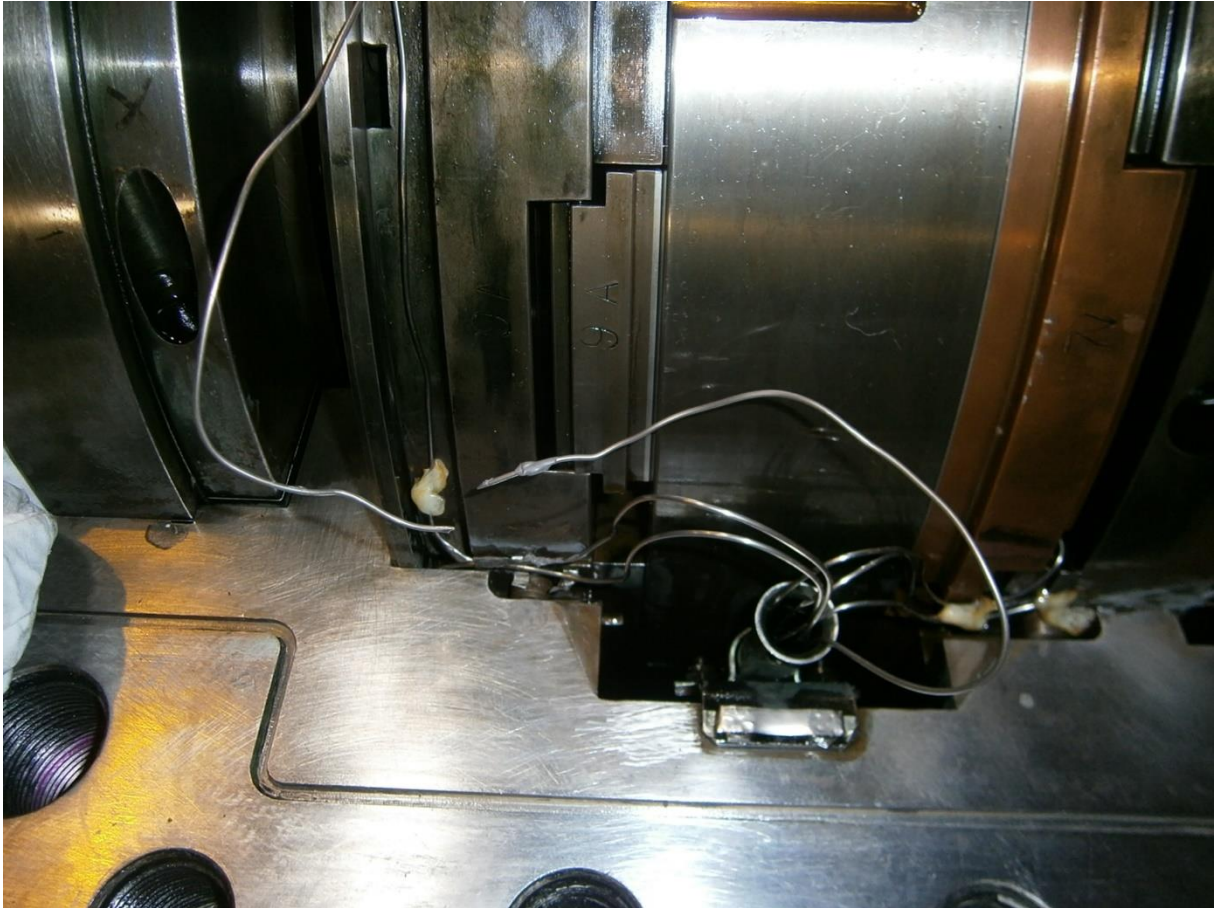
Broken Thermocouple Wire Bearing #1

All Lower halves of Bearings were removed, with the rotor In Situ, which made it a bit of a challenge. The Bearings were cleaned, Ultra Sonic and Dye Penetrant checked. Because no Spare Bearings were present, a dimensional check was not possible. During installation a Lead Wire check was made, which were in Tolerance, except for Bearing #3 which was of the 5 pad design, and therefore gave erratic values. For detailed information check Protocols and NDT reports.

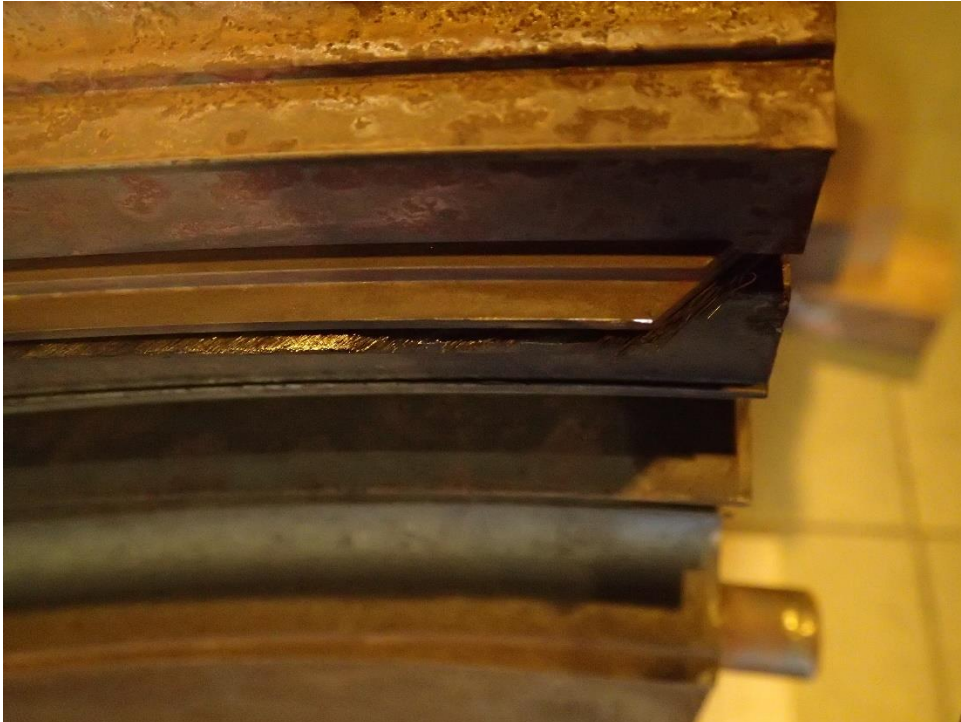
Inner Barrel Damaged Brush Seal Left Hand Side

From the Upper Half Inner Barrel LHS one part of the brush seal was damaged. EBX had some undamaged parts available which was replaced the damaged one.

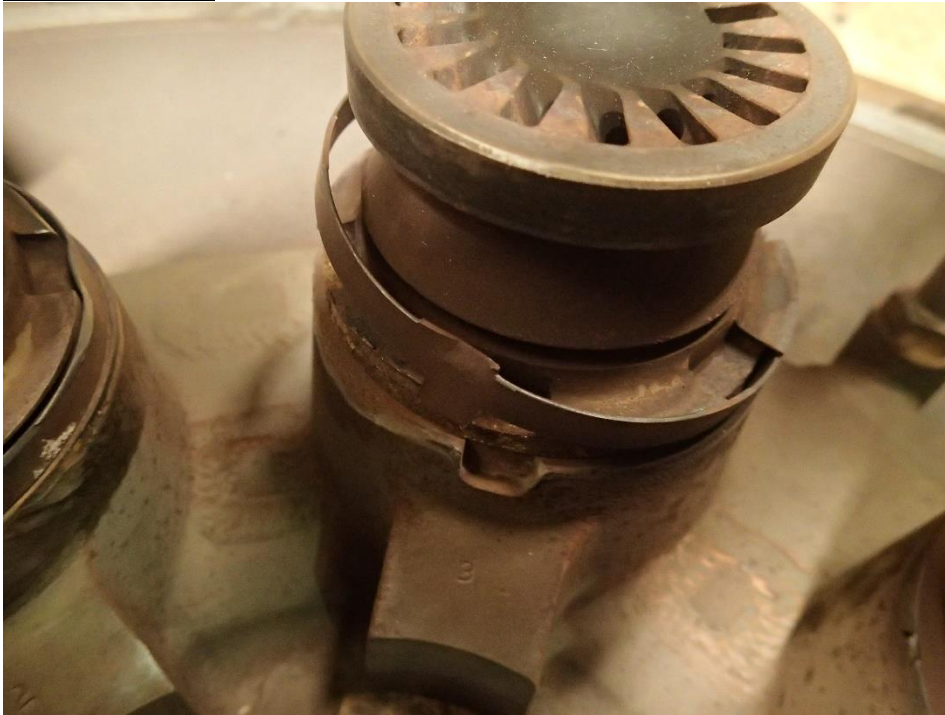
Loose Locking Ring Primary Burner
