## PROPERTY RISK EVALUATION REPORT

### TILBURG UNIVERSITY

| Premises: | Tilburg University (Stichting Katholieke Universiteit Brabant) |
| Date Visited: | 25 November 2020 |

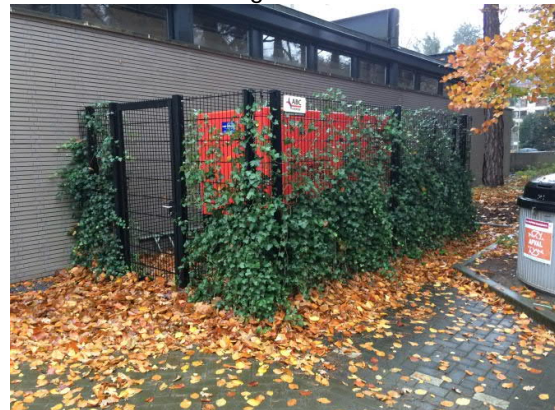
Emergency power generator next to building S

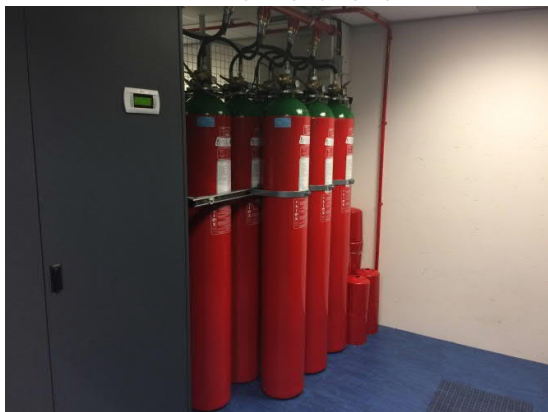
The main equipment rooms in building G (Goossens) and building S (Simon) have been provided with local gaseous extinguishing systems in the rooms Argonite (S) and FM-200 (G).

Argonite gas extinguishing system building S

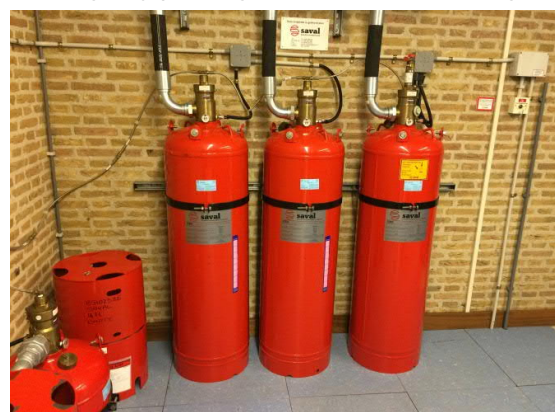
FM-200 gas extinguishing system building G

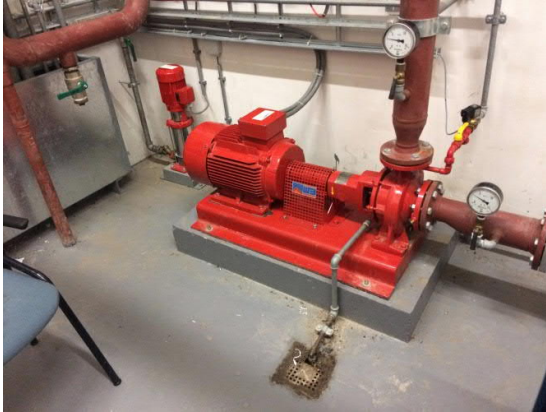
Building T (Tias) have been provided partly with a wet sprinkler system to meet equivalence in accordance with the building legislation.

Sprinkler pump building T (Tias)

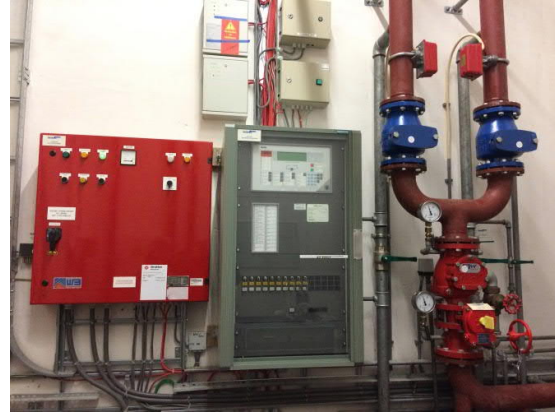
Sprinkler valves building T

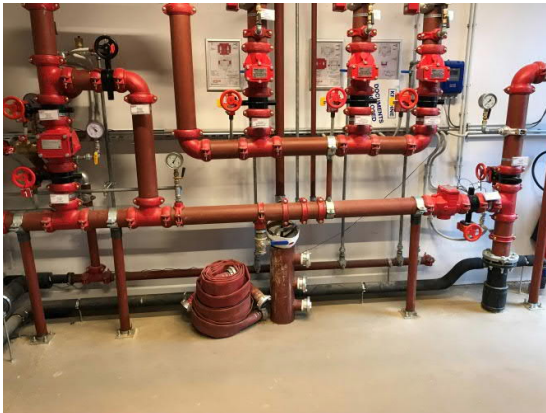
Only buildings Cube and T (Tias) have been provided with a (partial) wet sprinkler system, designed and installed in accordance with VAS 1987, in general this system is considered adequate. This sprinkler system is installed for life safety purposes.

Alarm valves building Cube

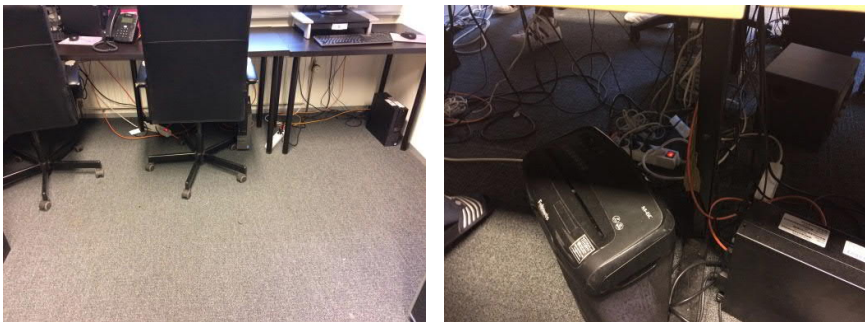
| 2017-03 | | Electrical office equipment | |
|---|---|---|---|
| Description | <p>In buildings E (Esplanade) an overload on extension cords and connected extension cords was found. These cords are a serious risk when you take into account that 54% of all fire causes is these overloaded cords.</p> <p>We recommend installing more wall mounted sockets and reduce the extension cords. Also starts every study year with a workshop about fire safety, especially about these items and old household appliances as found here.</p> | | |
| 2019 | <p>On-going even worse. Due to expected dramatically increasing premium of the PD/BI insurance we recommend solving this recommendation before renewal of the insurance policy 2020. Electric installations are recognized as source of fire in case of 55% of all investigated losses. Immediately action is required now.</p> | | |

| 2017-03 | | Electrical office equipment | |
|---|---|---|---|
| 2018 | <p>On-going and even worse. We strongly recommend installing mounting rails along the walls with wall sockets for 'Wieland' connectors only and delivering extension cords with 'Wieland' connectors. All other extension cords have to be removed and are prohibited in the future.</p> <p>We recommend maintaining this by self-inspections rounds monthly.</p> | | |
| 2020 | Recommendation is solved | | |
