# Provincie Utrecht

Provinciehuis Utrecht

*Underwriting information*    **PROPERTY DAMAGE  
BUSINESS INTERRUPTION**

| Date | 05-09-2021 |

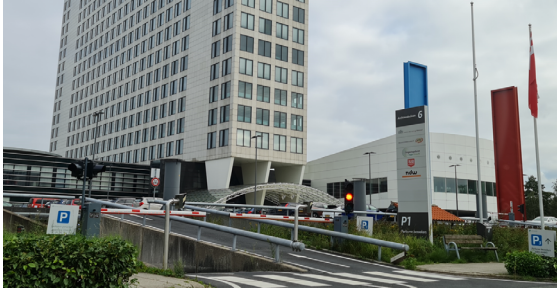
Parking entrance (south view)

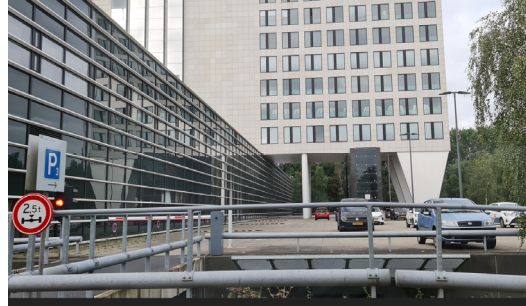
There is an impact risk at ground floor level due to a visitors parking in front of the main entrance. Vehicles drive directly along the glass façade without any mechanical protection.

Main entrance

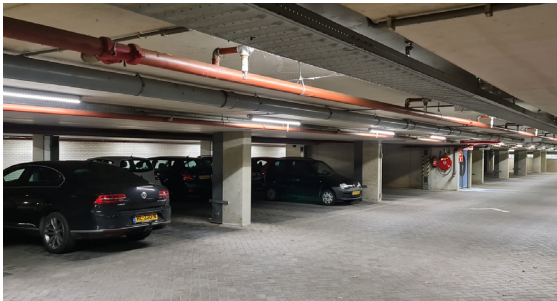
Parking

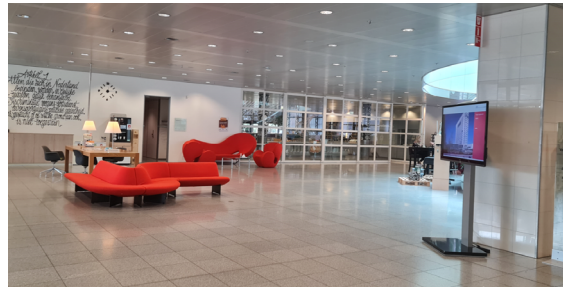
Ground floor

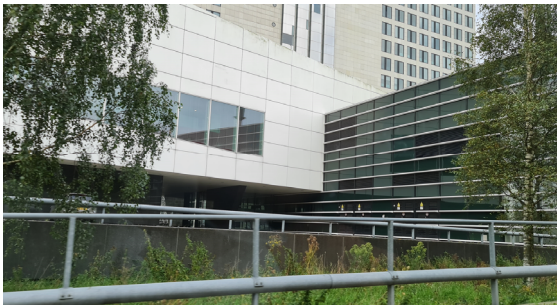
View from east side

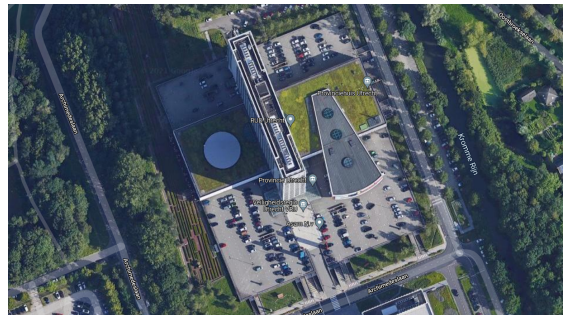
Aerial view
