# Risk Engineering Report

**STICHTING NHTV INTERNATIONALE HOGESCHOOL BREDA**

**Site Name:** Breda University of Applied Sciences

**Survey Type:** Property All Risk - Resurvey

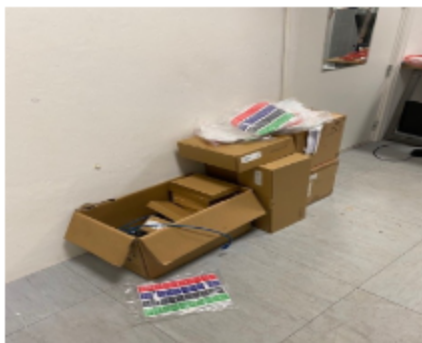
Note 2021: During the visit there were still some combustible storage in the server rooms and technical rooms.

Server room storage

Remove combustible materials in the electrical switch room and develop and implement a housekeeping program that establishes regularly scheduled inspections of all (technical) facility areas to indicate issues.

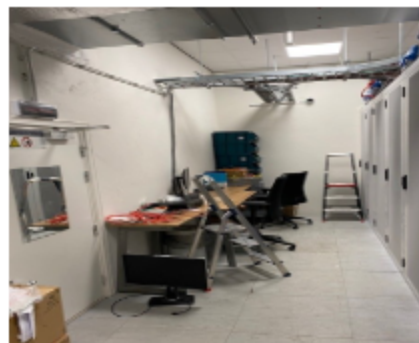
Server room storage

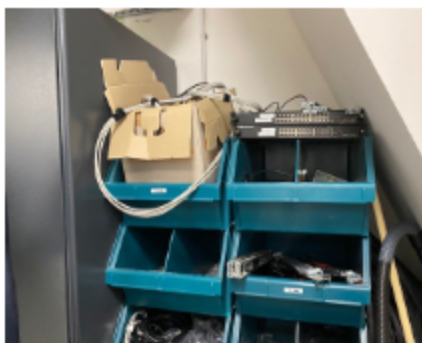
Technical room storage

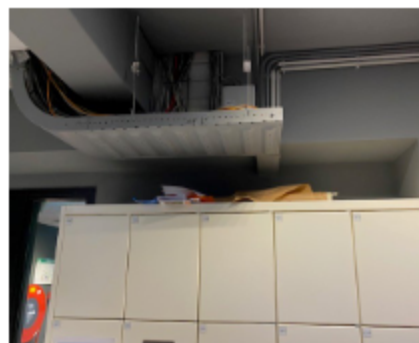
A fire involving the combustible materials may contribute to a rapid fire and smoke spread and eventually could lead to an uncontrollable fire. Implement an effective recorded housekeeping program to reduce the potential for fire or conditions that can lead to increased loss due to fire.

Storage over electrical cabinet

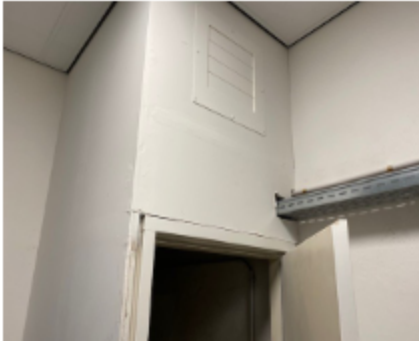
During the surveys it was noticed that the server room had a new back door connecting to a small closet with lot of openings. This could compromise the effectiveness of the suppression system. It is recommended to conduct a room integrity testing to the required NFPA 2001, BS ISO 14520 and BS EN15004 methodologies.

Server room

The server room protected by gaseous suppression system needs to have a room integrity test conducted.

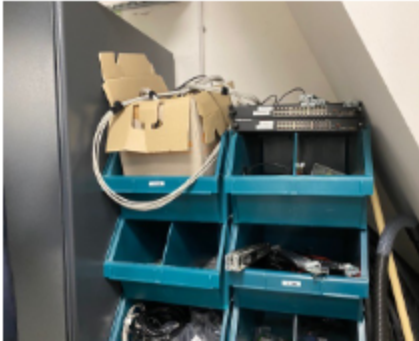
Waste storage close to outlets

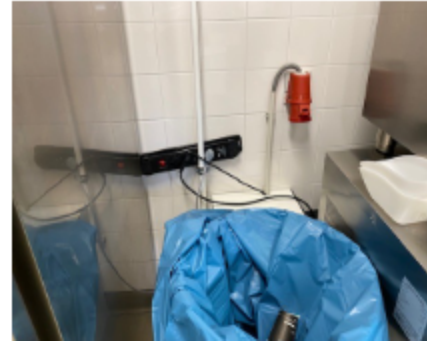
Storage in Electrical room

Overall good housekeeping procedures in public accessible areas. There are some deficiencies observed during the tour in non-public technical areas like the electrical low tension rooms (storage of combustible materials, see risk improvement).

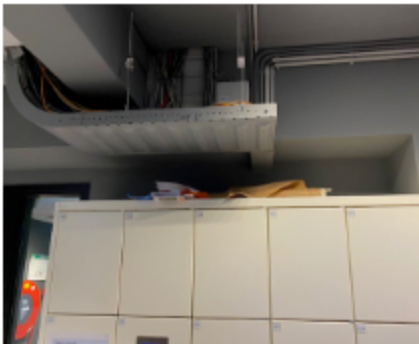
Storage close over electrical cabinets

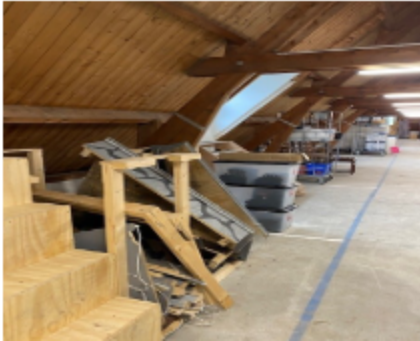
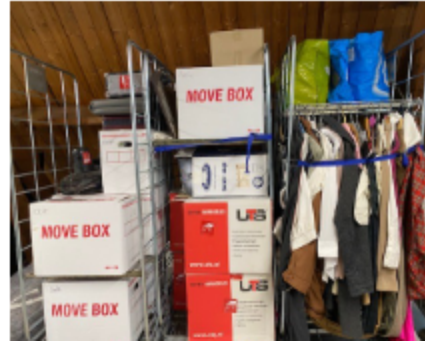
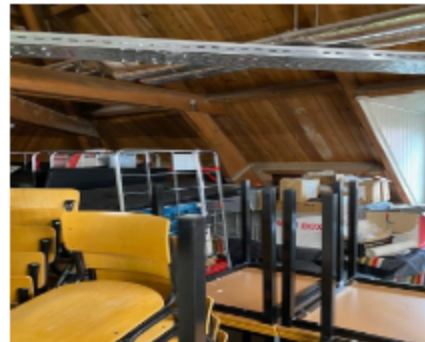
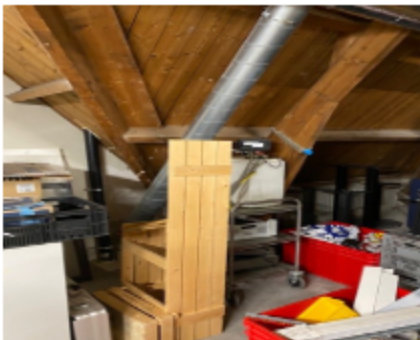
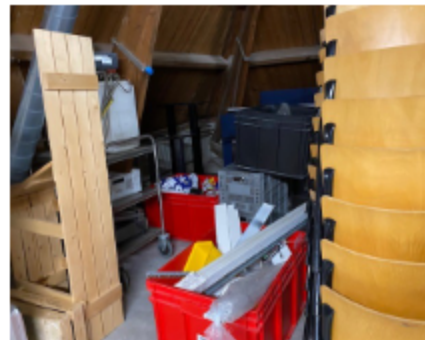
The Wooden attic of monastery building is currently used to store office supplies and storage of equipment for events. The area has a very high combustible load with no adequate protection. In combination with the combustible roof, a small fire in this area could lead to a complete loss of the building.

Storage Wooden attic

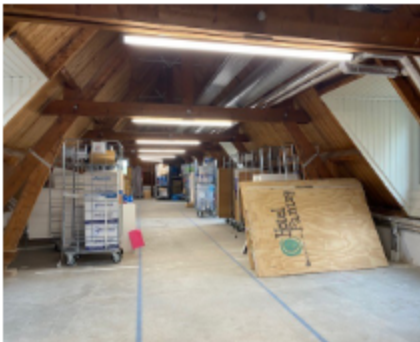
Wooden attic of monastery building
