**Hogeschool Inholland**  
**Hogeschool Inholland**  
**Delft, Netherlands**

**Risk Control Report**  
**Property / Multi-Discipline**

**Location:** Hogeschool Inholland  
Rotterdamseweg 141  
Delft 2628AL  
Netherlands

**Date On Site:** 15th June 2017  
**Consultant:** Sander Verboog

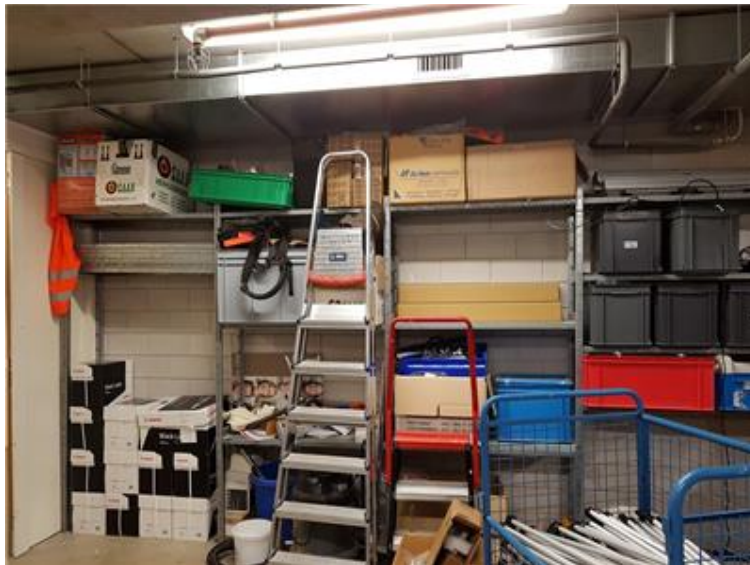
Een brand in een onordelijke ruimte kan zich snel voortplanten en in het geval dat de opslag te hoog is kan de werking van het sprinklersysteem aangetast worden. De kans dat brand ontstaat in onordelijke ruimten is groter dan in ordelijke ruimten. In verband met de aanwezigheid van ontstekingsbronnen en het feit dat technische ruimten goed toegankelijk dienen te blijven voor onderhoudsmensen, dienen dergelijke ruimten te allen tijde vrij te blijven van enige vorm van opslag. Een kleine lokale brand kan vitale bedrijfsinstallaties buiten werking stellen.

Verwijder alle incurante materialen uit de sprinklerpompruimte en de facilitaire ruimte (ruimte K58). Zorg er voorts voor dat de goederen in de laatst genoemde ruimte ten minste 50 cm onder de sprinklerkoppen opgeslagen worden.

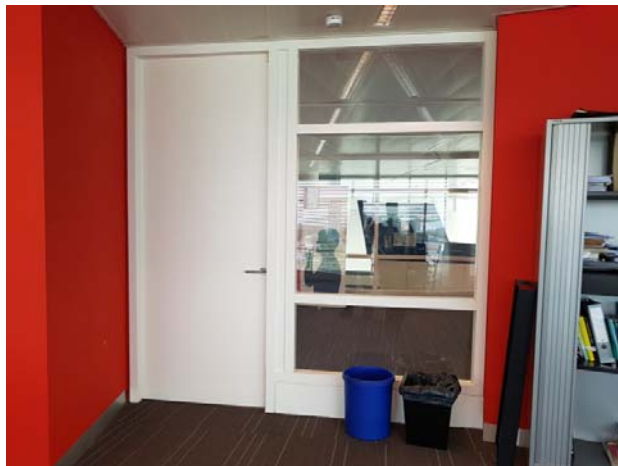
Fire Resistive Wall

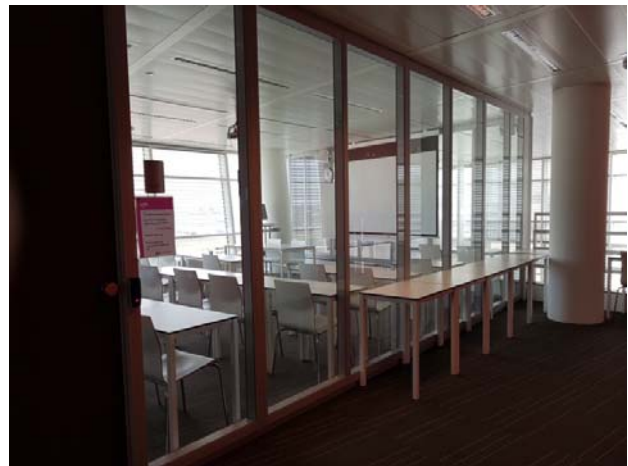
Non cut off Class Room

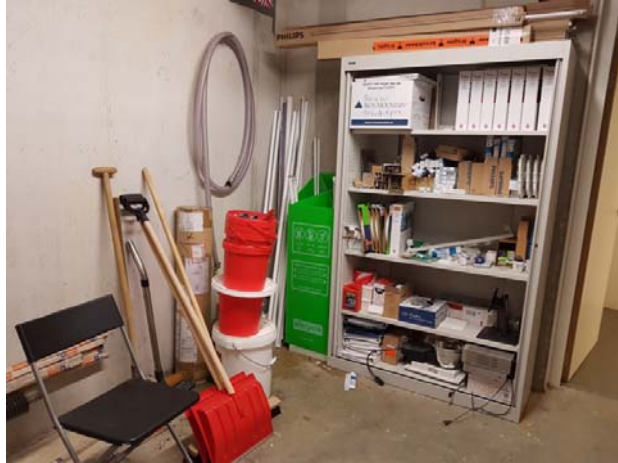
Housekeeping Sprinkler Room

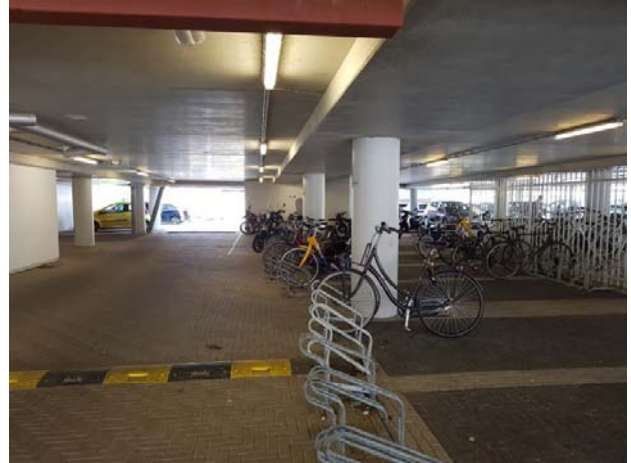
A limited number of cars is parked in the area underneath the building. It is not likely that a fire in this area would spread into the building due to the presence of a heavy concrete fire resistive construction. However, if a car fire would ignite the timber skywalk, a fire could spread into the building and could overtax the sprinkler protection. The fire load inside the building adjacent to the skywalk is low. Secondly a fire originating on a low roof level could spread into the building and overtax the sprinkler system. Roofs are probably combustible and the current hot work procedure is considered inadequate.

Car and bicycle parking in Basement

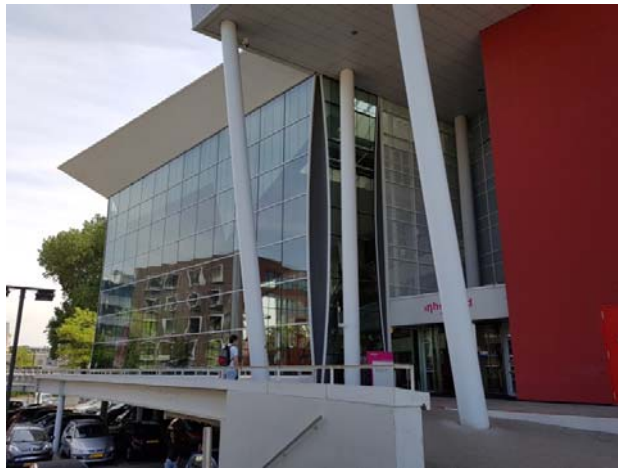
Een storm kan de constructie van de glazen gevels onder druk zetten waarbij de bevestiging het begeeft door een gebrek aan onderhoud. Een grote stormschade zal het gevolg zijn.

The atrium consists of two large glass panel walls whereas the construction of the walls in 2008 represented a world premiere of this prototype wall structure. The steel cables supporting the entire wall structure are annually inspected. The fixation of the wall with the concrete supporting structure is not inspected. A risk improvement has been submitted to include this fixation in the existing preventive maintenance program. Wind storm could result in a large damage.

Large glass panels atrium

Implementeer de bevestiging van de glazen gevels van het atrium aan de dragende constructie in het preventief onderhoudsprogramma. Deze wanden zijn destijds als wereldwijd prototype geïnstalleerd en vanuit de fabrikant is er geen onderhoud bekend.

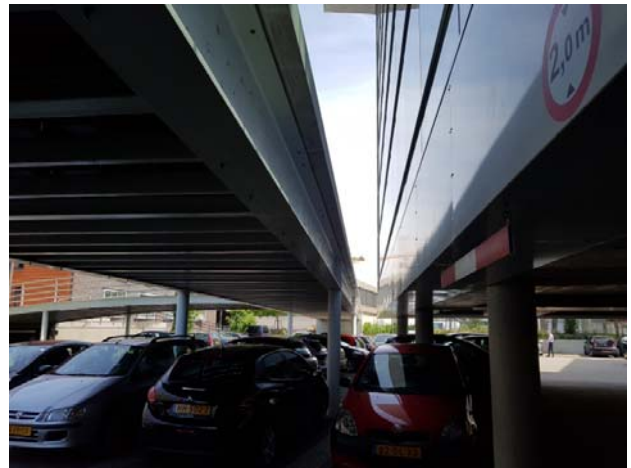
Timber skywalk (left) adjacent to building (right)
