**Hogeschool Inholland**  
**Hogeschool Inholland**  
**Den haag, Netherlands**

**Risk Control Report**  
**Property / Multi-Discipline**

**Location:** Hogeschool Inholland  
Theresiastr 6-8  
Den haag 2593 AN  
Netherlands

**Date On Site:** 12th June 2017  
**Consultant:** Sander Verboog

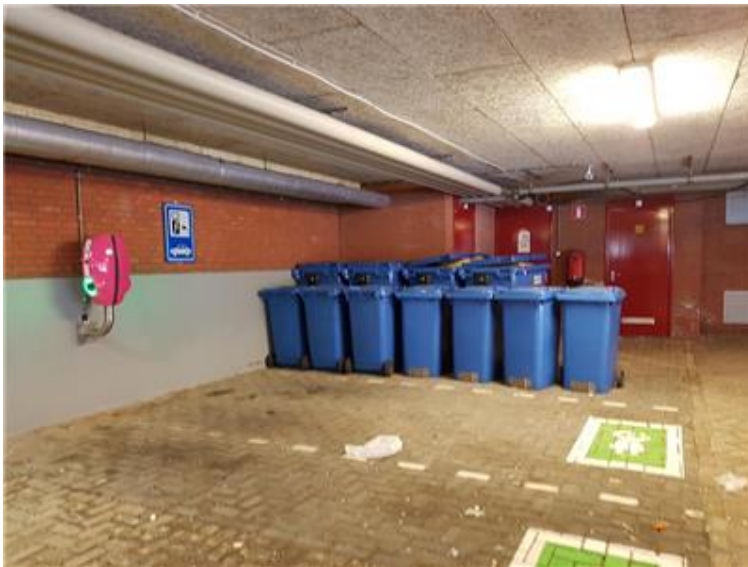
**2017-06:03 : Verbeter de afvalopslag. (Housekeeping and Loss Control Self-inspection)**

Een brand in de containeropslagplaats wordt niet gedetecteerd en kan zich daardoor voortplanten naar het bovenliggende gebouw.

Plaats alle mobiele plastic containers die op dit moment in de parkeergarage staan buiten het pand op ten minste 10 m van de buitengevel. Tijdens ons bezoek hebben wij gesproken over het plaatsen van de containers op de plaats van de fietsen of het plaatsen van extra ondergrondse containers.
