## 1. Executive Summary

The March 2019 survey of all 14 regional referral hospitals in Uganda conducted by representatives from MOH Uganda confirmed a clear need for intervention into the 6 core departments identified in the 2017 AMPC feasibility study report.

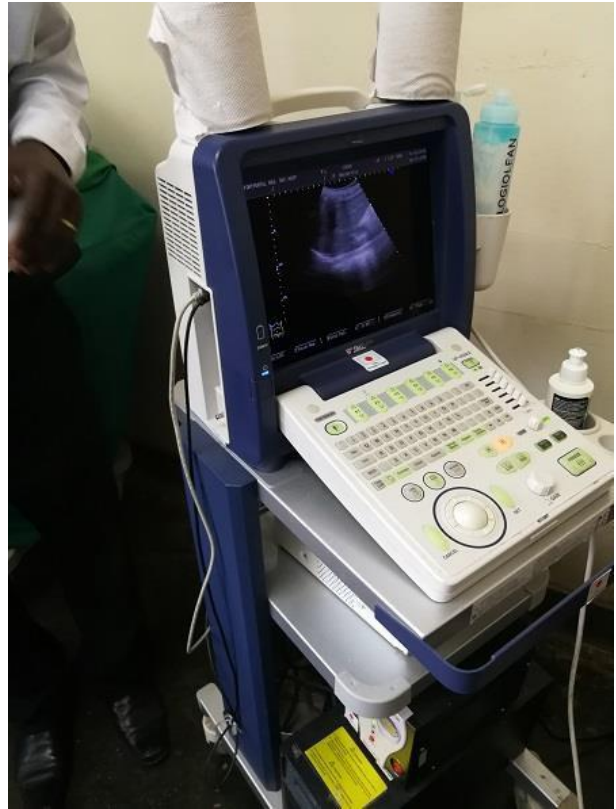
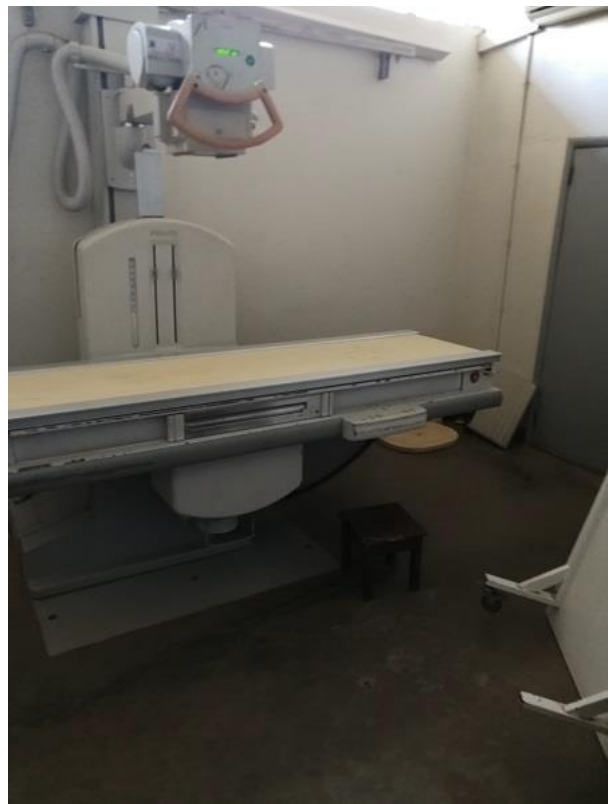
## Radiology:

The Radiology Department is located in a dilapidated, stand-alone structure and is in fairly close proximity to the theatre complex. The Radiology Building has an X-ray machine, which is still functional, but has no automatic film processing units or dryers available. Films are processed manually and hung to dry outside. Ultrasound services are provided from within this department. The building was found to have very limited space and would require expansion to accommodate new and additional equipment. There is adequate space adjacent to the building to accommodate the expansion of the building, however it is recommended that the entire structure be demolished and rebuilt.

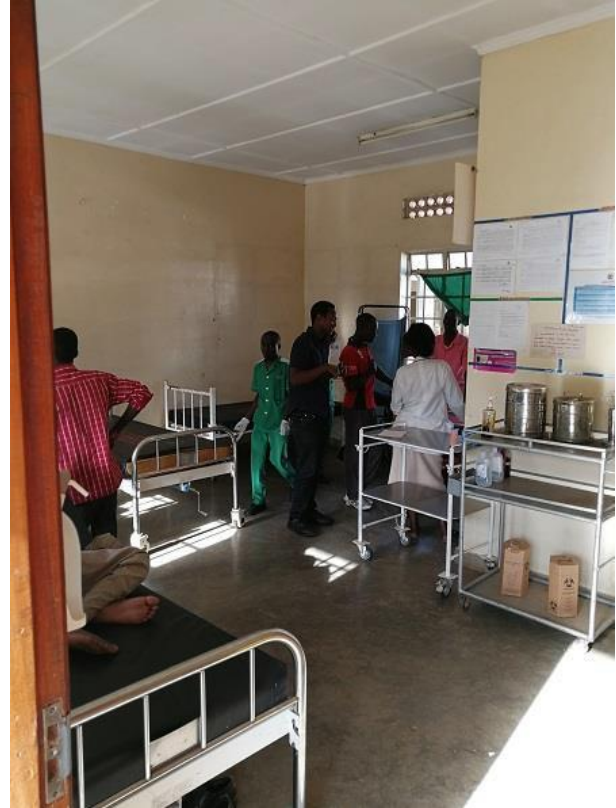
## Accident & Emergency:

The existing A&E unit comprises of 4 beds and a theatre. Due to the lack of staff, and the fact that this unit is only open between 9am and 5pm daily, the occupancies in this ward are very low. There are no afterhours A&E services provided by this department. The A&E is housed in the out-patient building, far from Radiology and the Theatre Complex. The necessary equipment within the A&E was found to be inadequate and/or not available.

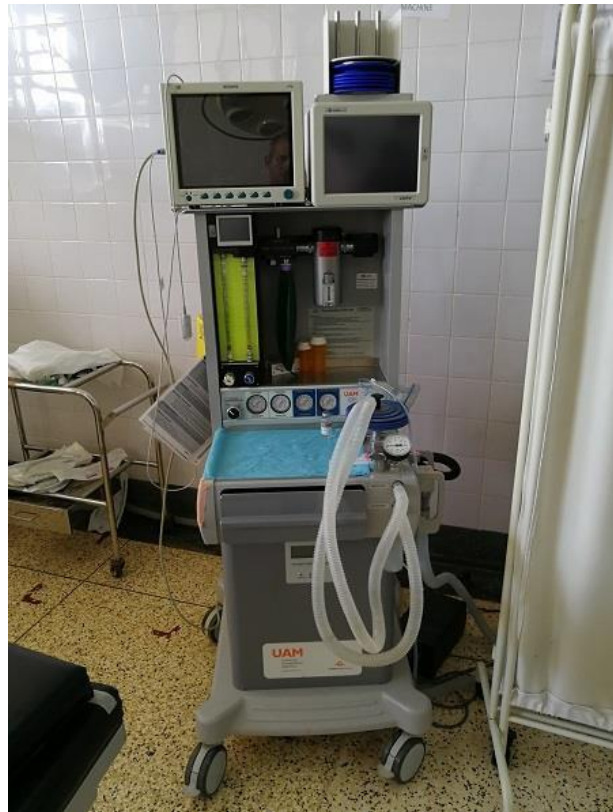
## Main Operating Theatres:

Two theatres are located in a stand-alone building in close proximity to A&E and Radiology. The structure of the building was found to be in a good condition, however the roof structure is dilapidated and the electrical services are not compliant nor safe.

Internally, the Theatre Complex was found to be well kept and functional for the procedures being undertaken, however the equipment being utilised has reached its end-of-life and/or is not functional. Recovery within the Theatre complex is non-functional as there is no equipment available for this function.

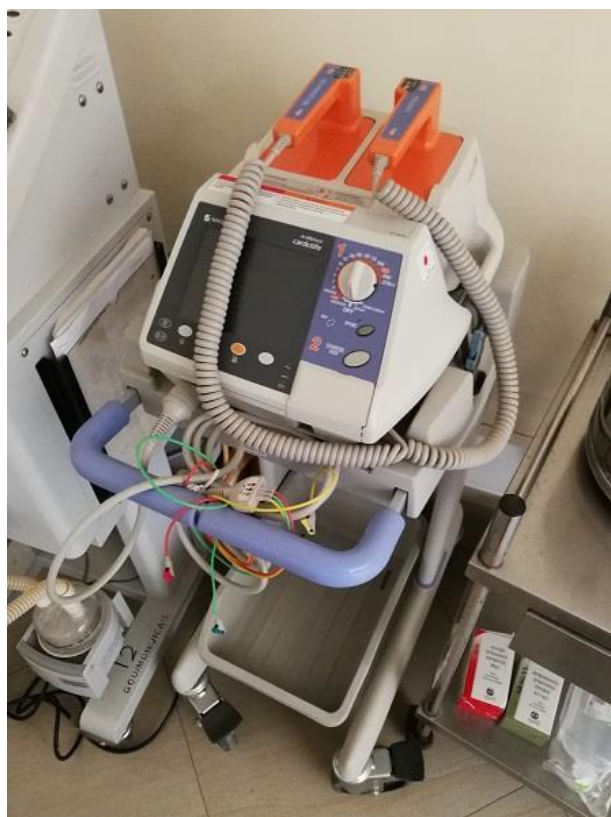
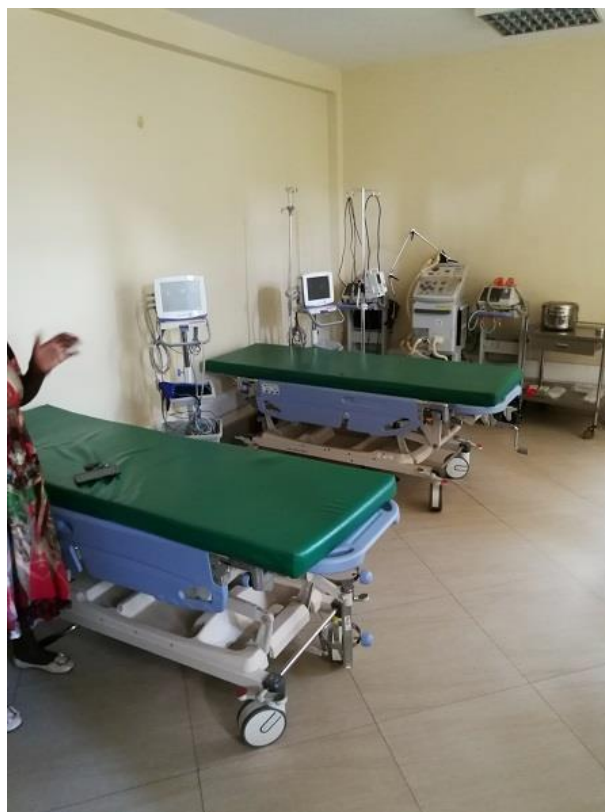
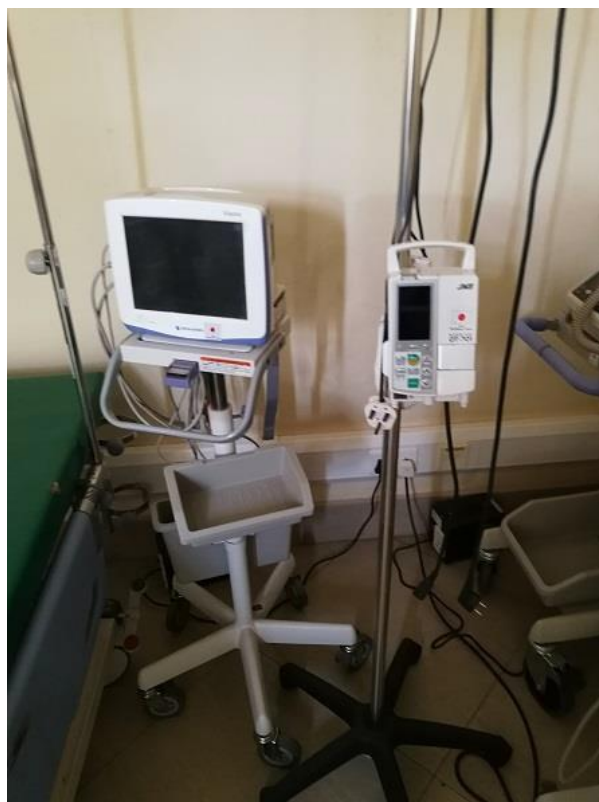
## ICU:

There is no ICU in the General hospital, however there is an ICU located in the Private Wing. The ICU is not currently being used by the hospital due to lack of nursing staff. The ICU was found to be in a good condition with adequate equipment, however this equipment and ward is rarely used.

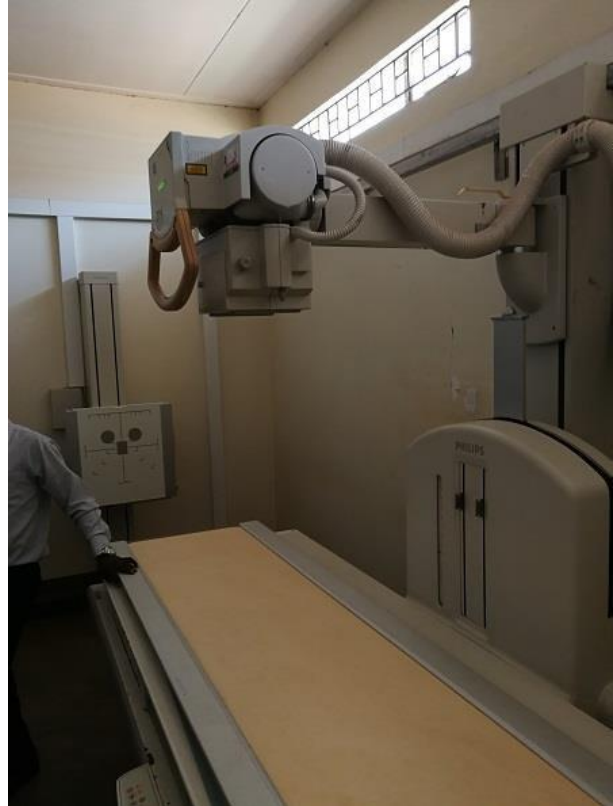
## Radiology:

The Radiology Department is in a dilapidated, stand-alone structure behind the newly constructed Administration Building. It is in close proximity to the new JICA building housing the theatre complex, A&E and ICU. The Radiology Building has an X-ray machine, which is still functional, but has no automatic film processing units or dryers available. Films are processed manually and hung to dry outside. Ultrasound services are provided from within this department. The building was found to have very limited space and would require expansion to accommodate new and additional equipment. Ideally the existing Radiology building should be demolished and a new structure built, as there is adequate space adjacent to the building to do so.

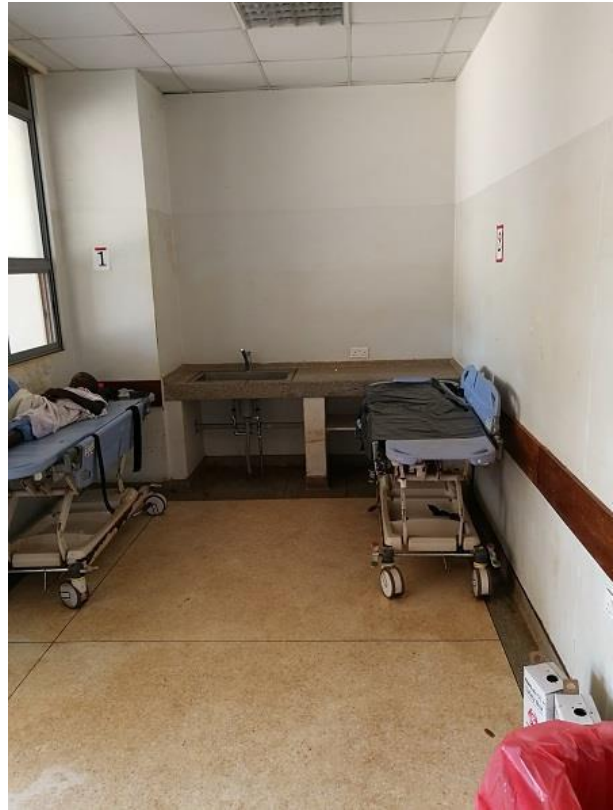
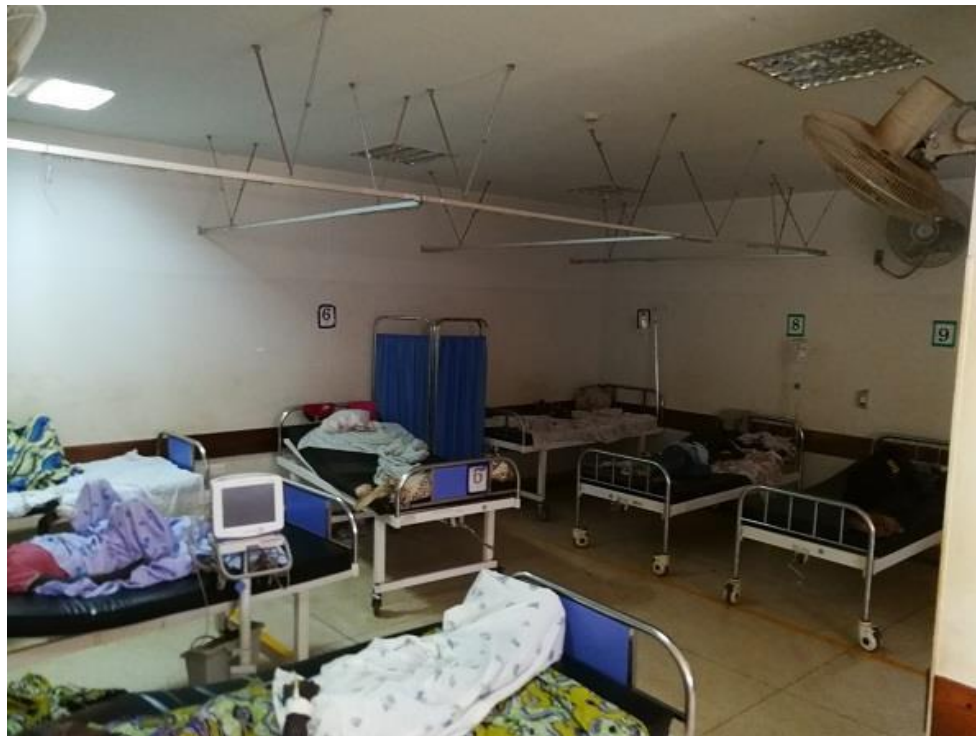
## Accident & Emergency:

This department was found to be ill-equipped and understaffed for the number of patients being attended to.

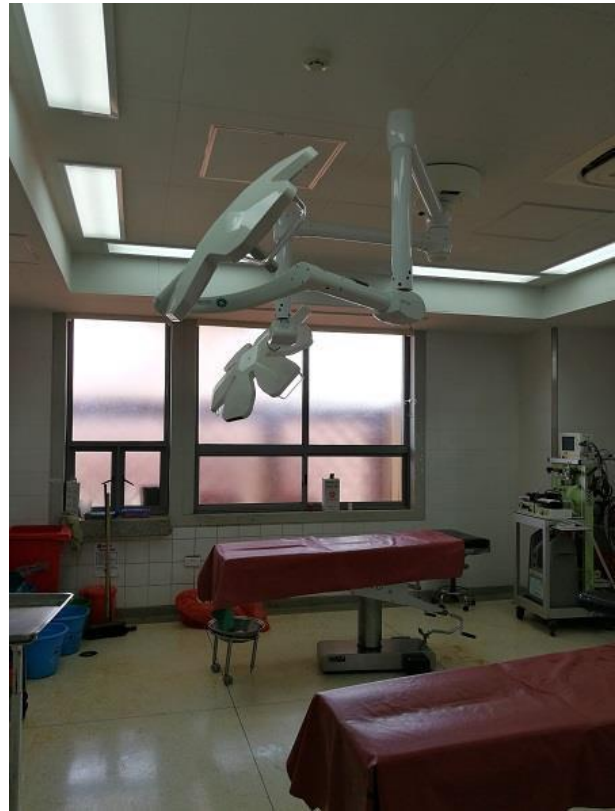
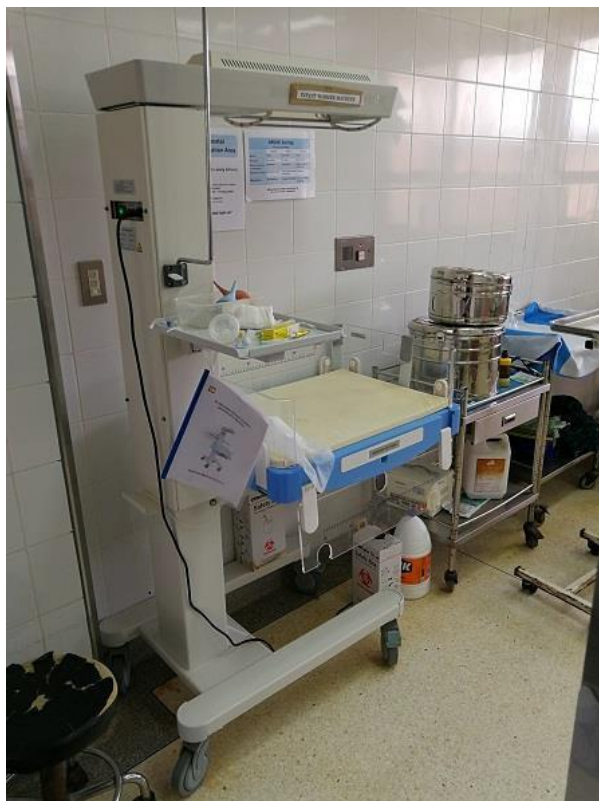
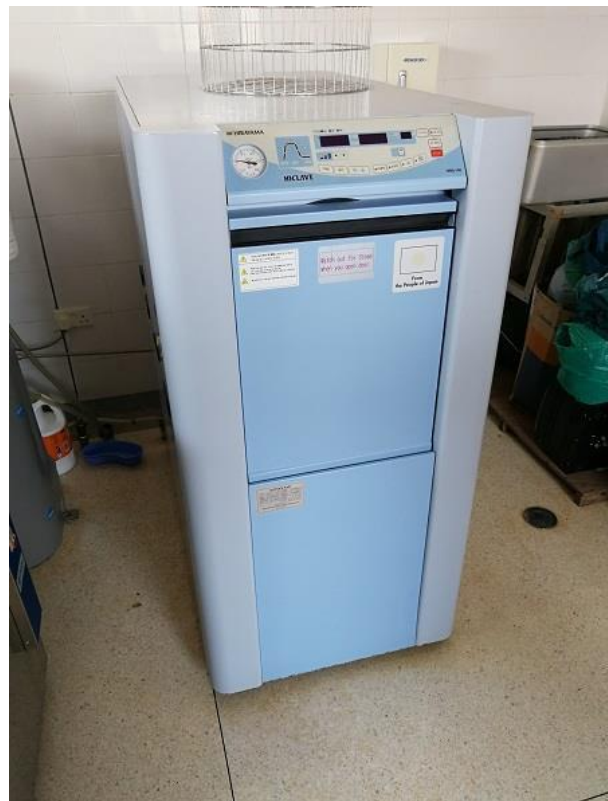
## Main Operating Theatres:

Three theatres are located on the ground floor of the newly built JICA building. The theatres were found to be in a good condition, however the equipment is reaching end-of-life and requires replacement. A CSSD is located directly adjacent to the theatre complex, however the autoclaves are not utilised due to insufficient electrical supply to the hospital.

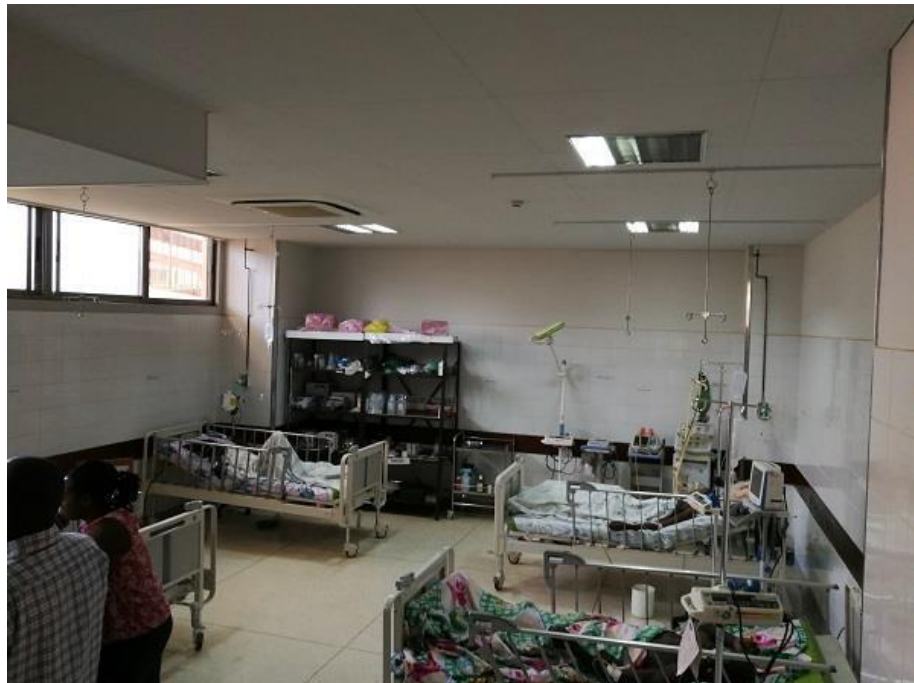
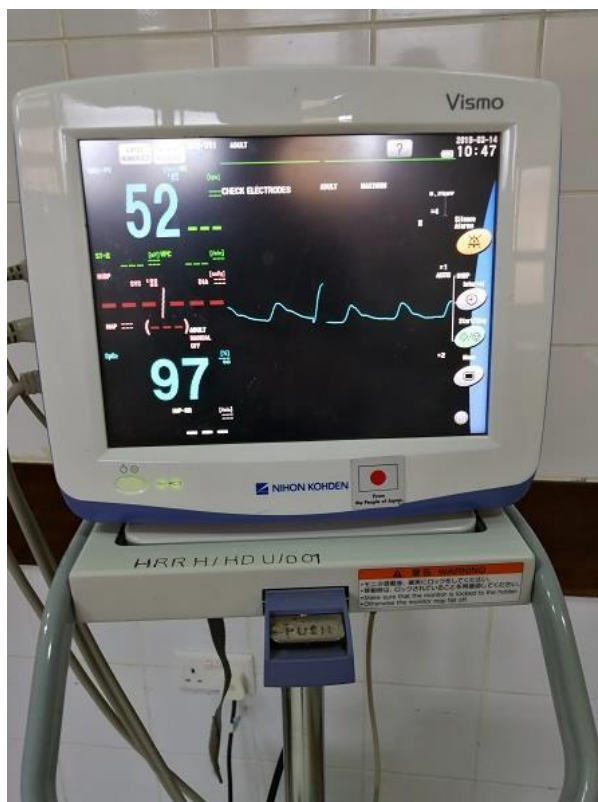
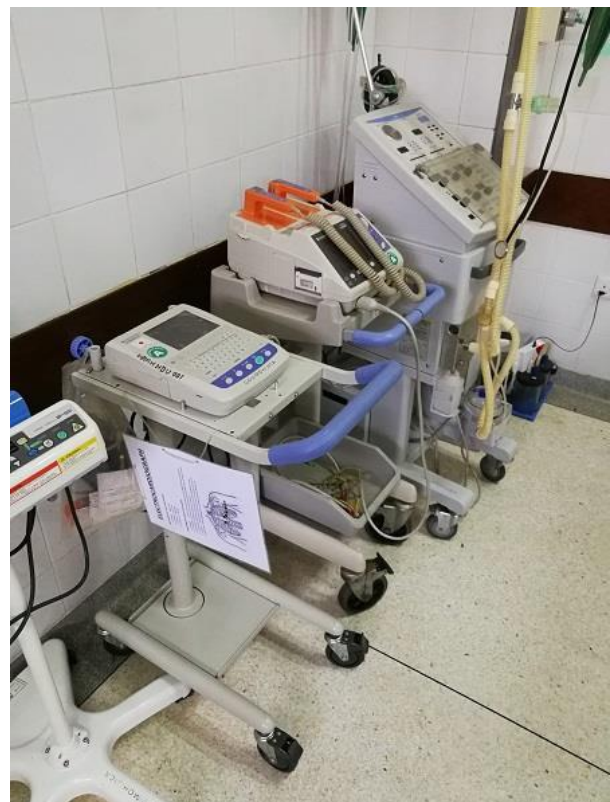
## ICU:

A 4 bed High Dependency Unit is located in the newly built JICA building. The unit was originally constructed as a Recovery Area to the Theatre Complex, however is currently used as an HDU. The unit was found to be in a good condition and fully occupied. There are, however, no qualified ICU nurses and very limited equipment, even for an HDU. Feedback from the unit manager confirmed the need for a dedicated ICU.

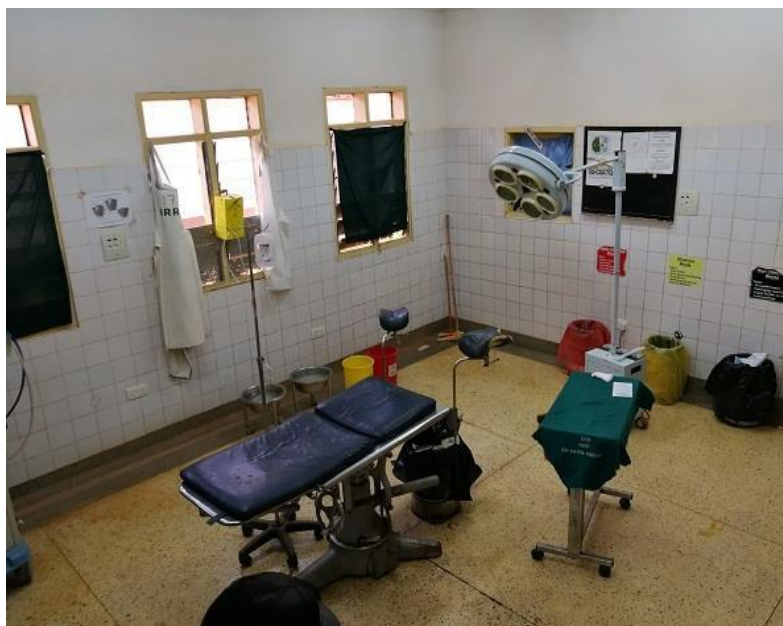
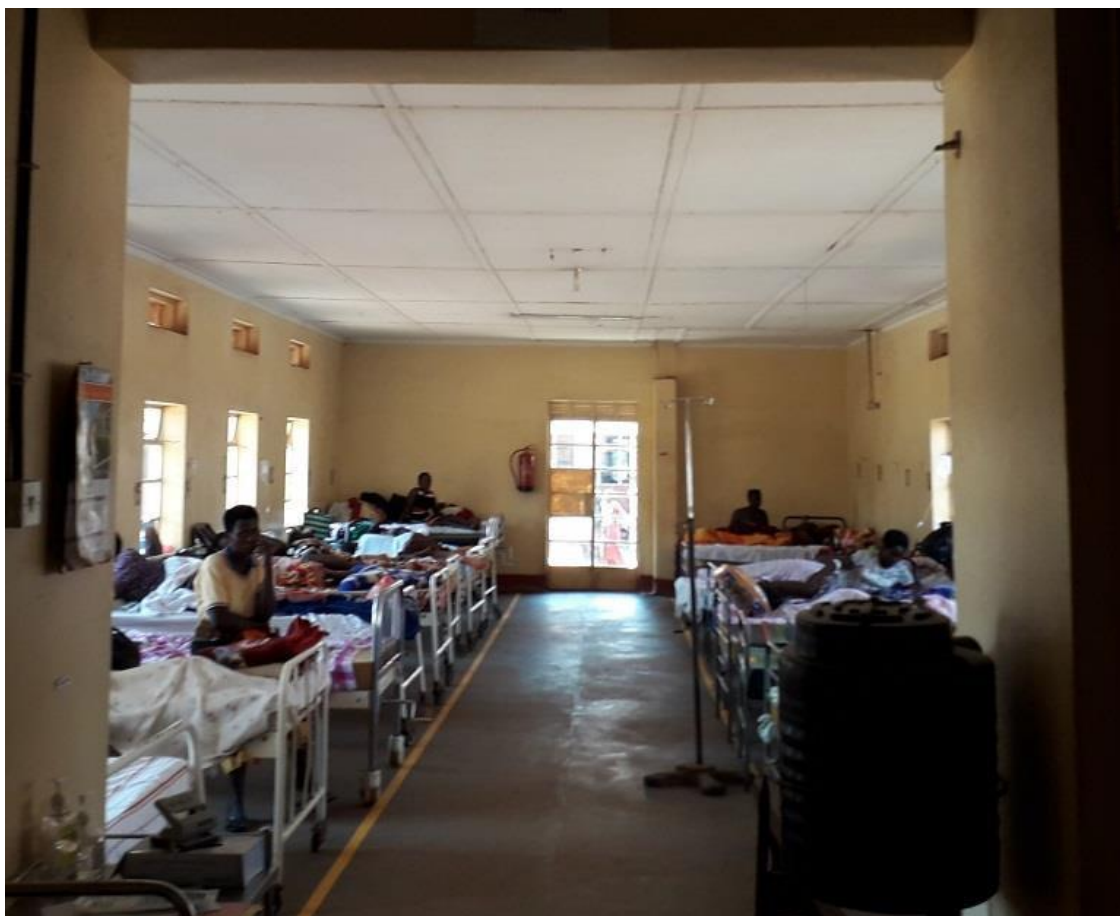
## Maternity:

A delapidated Maternity Wing is located directly adjacent to the newly built JICA building. Although in a severe state of disrepair the Ward was fully occupied at the time of the inspection. The Maternity ward consists of an Obstetrics theatre, a Delivery Ward and two 16-bed Wards. All equipment within the Maternity Ward was found to be at end-of-life and/or beyond repair. The high occupancy rate indicates a potential lack of capacity/competence at surrounding District Hospitals.

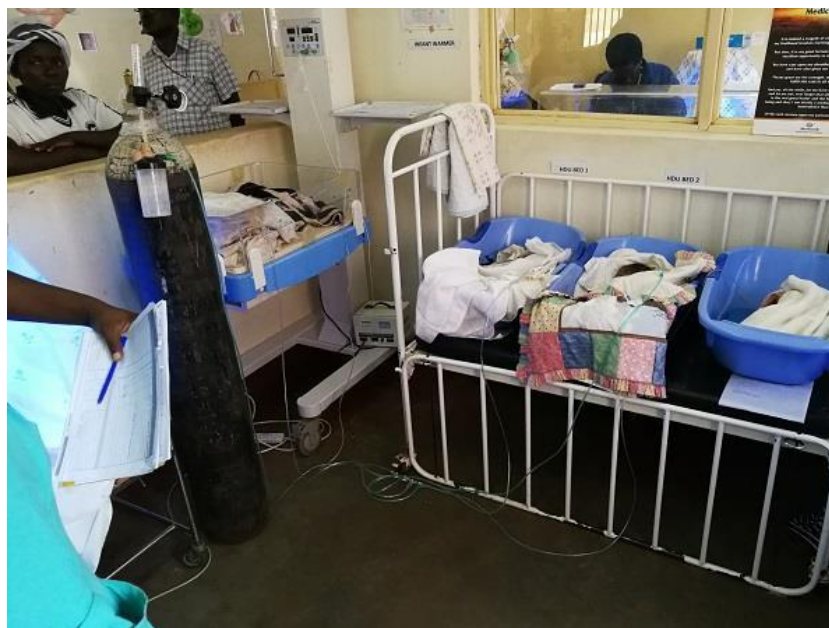
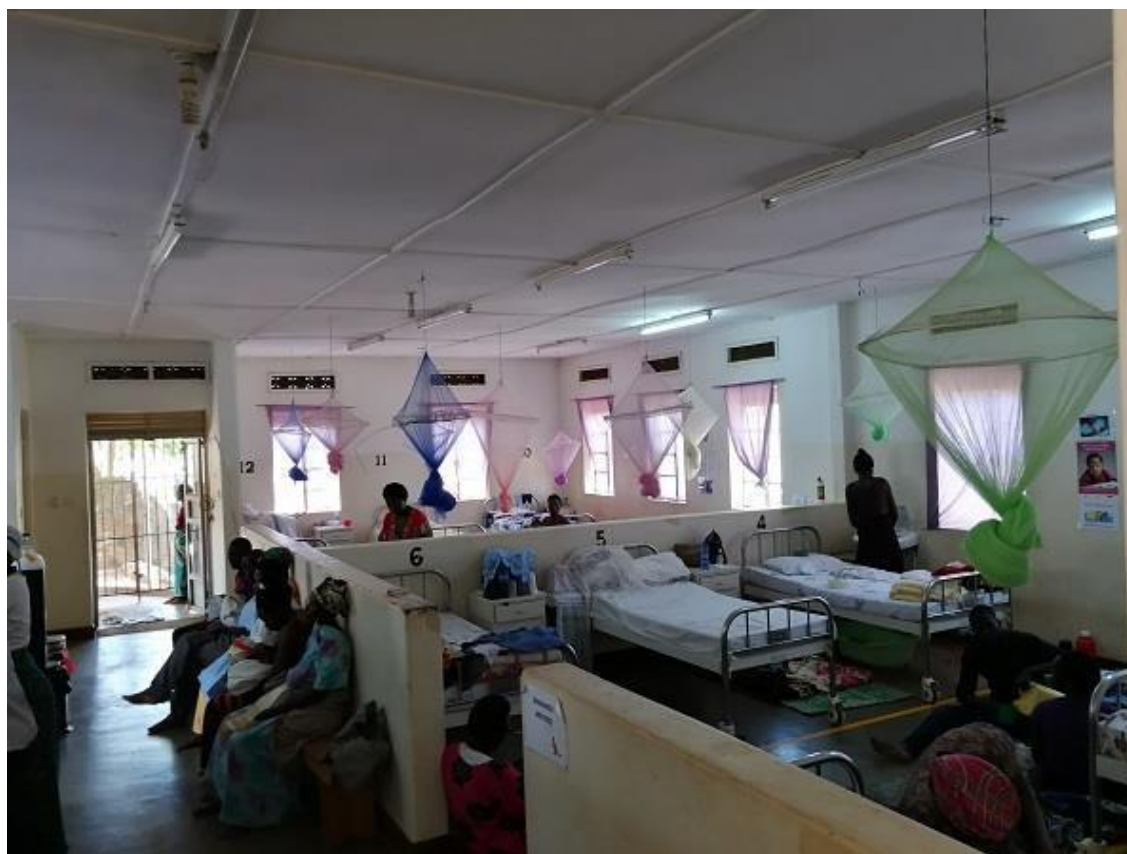
## NICU:

An NICU is located to the rear of the Maternity Ward and is also in a severely dilapidated state. The Ward was found to be over-occupied, with equipment either beyond repair and/or not available at all to facilitate the necessary care for babies.

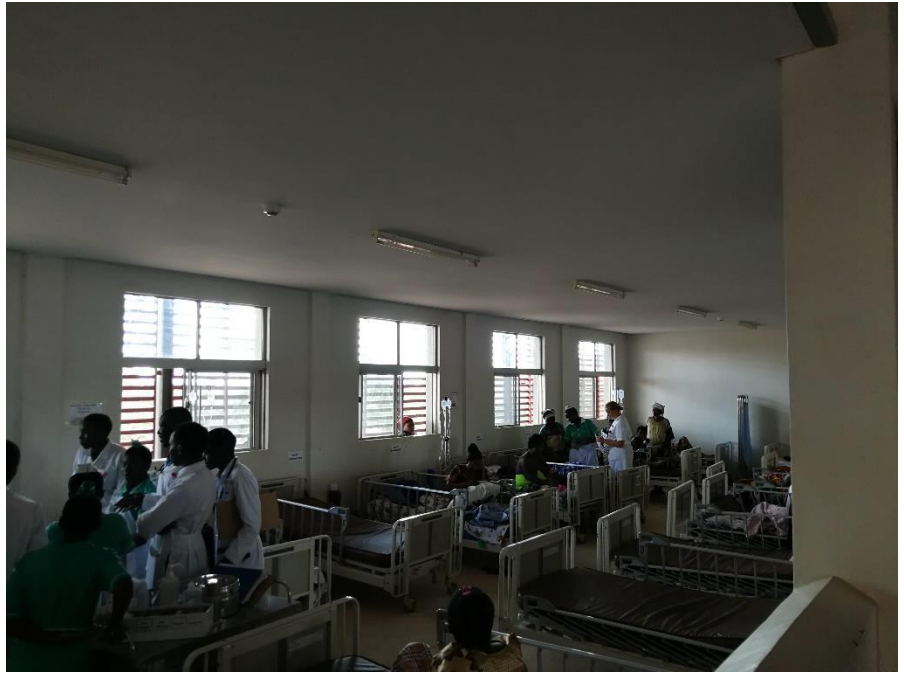
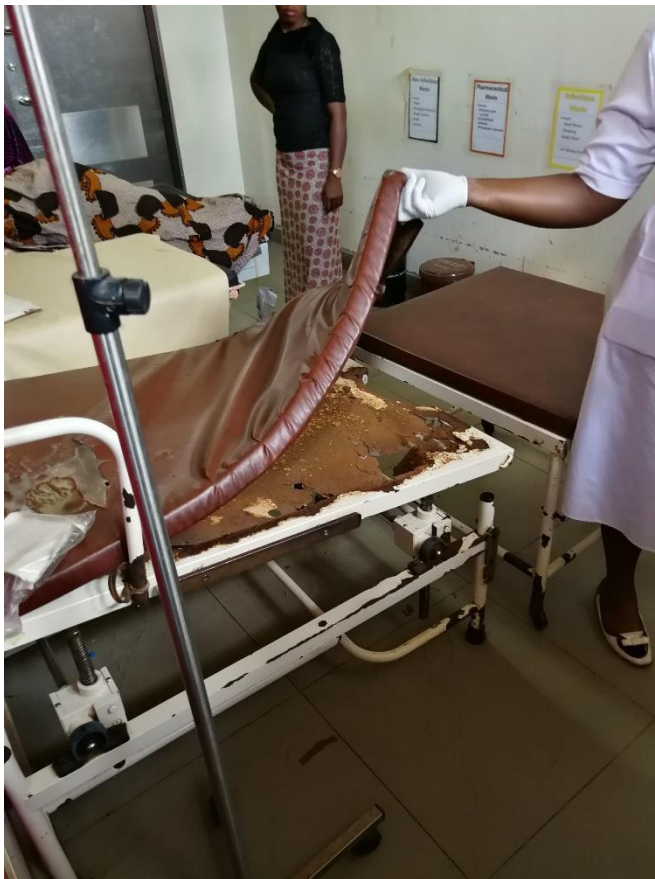
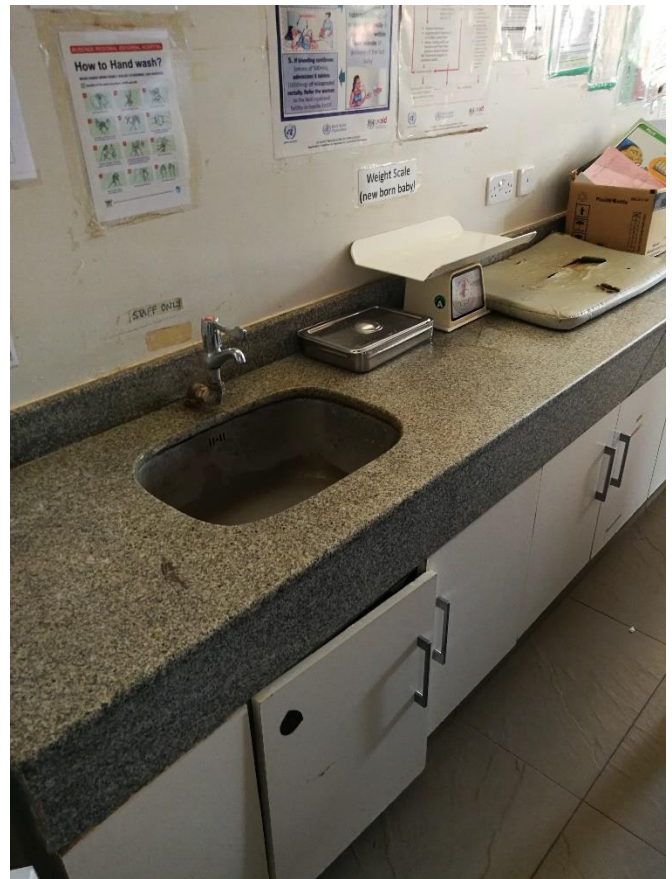
The hospital receives a high number of expectant mothers and runs a very busy delivery ward, but as can be seen from the photo below, the condition of the birthing beds is critical and they are not safe to be used anymore.
