# Risk Engineering Report

**TECHNISCHE UNIVERSITEIT EINDHOVEN**

**Date of Survey:** December 2, 2022

**Survey Type:** Site Summary Review

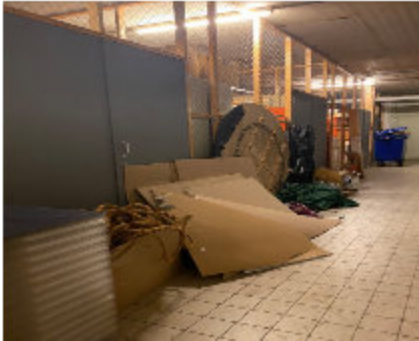
A fire involving the combustible materials may contribute to the smoke contamination of the equipment within the room.

During the visit we noticed that the basement areas of building Vertigo was being used for storage.

Basement area-1

Remove the combustible materials from the basement and technical areas.

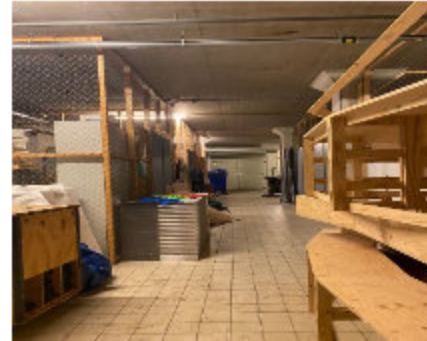
Basement area-2

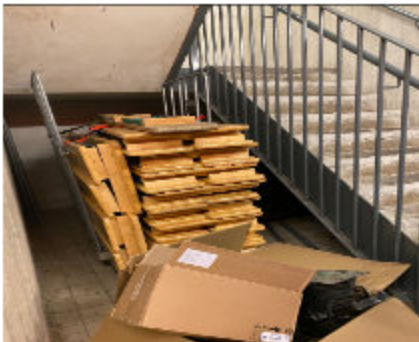
Staircase

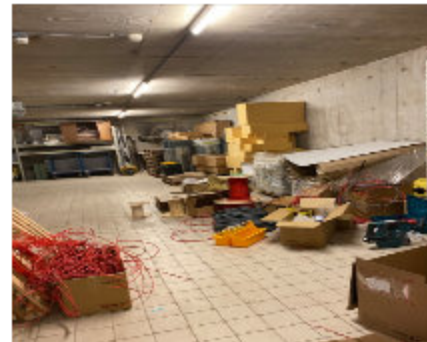
Technical rooms

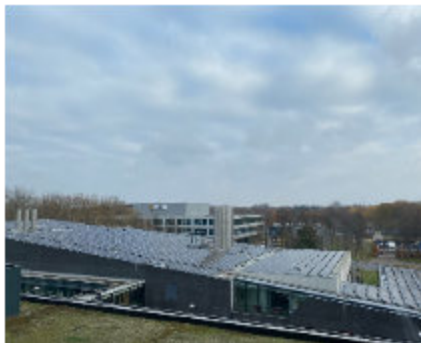
The roof of the Spectrum building has PV solar panels installed. The panels need to be inspected and certified based on the local standards.

The Scope-12 inspection for the PV solar panels installations in the Spectrum building needs to be completed to understand if there are any potential risk to the building from the installations.

PV solar panels :Spectrum

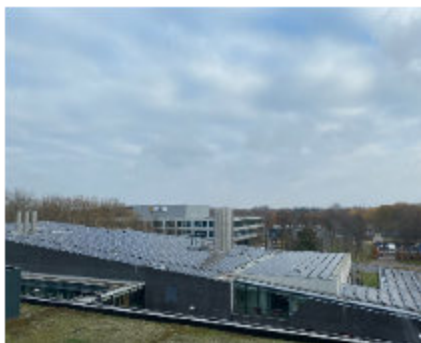
PV -Panles : Spectrum

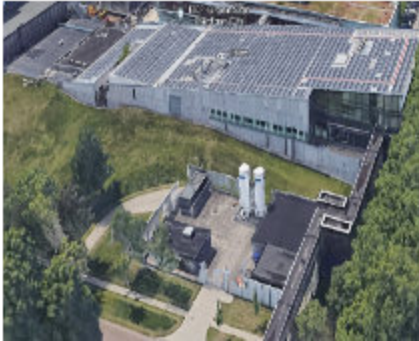
Flammable gas storage
