# Chubb Risk Control Program Property Underwriting Report

Prepared for  
Stichting NHL Stenden Hogeschool  
Rengerslaan 10  
8917 DD Leeuwarden  
Netherlands

Inspection Date: 17 June 2024

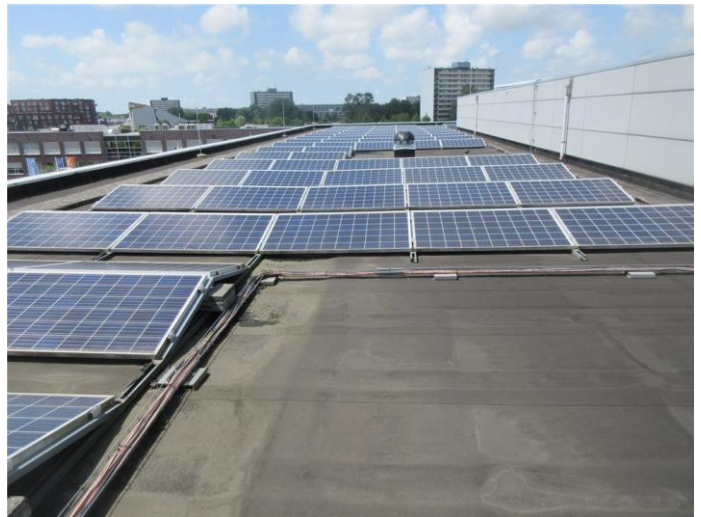
Solar PV panels are on the roofs, and inverters are in technical rooms. A Dutch Scope 12 inspection has not been performed yet. A recommendation has been issued.

Solar panels, mineral insulation roof

Tijdens de rondgang was het duidelijk dat er ingebruikname geen Scope 12 keuring is gedaan. Visueel constateerde we tijdens het bezoek dat connectoren los liggen op het dak. Daarom raden wij aan om een inbedrijfstellingsinspectie en eens per drie jaar een inspectie van het zonnepaneelsysteem uit te voeren volgens de richtlijnen Scope 12 (TD18). Een gespecialiseerde derde partij moet de inspecties uitvoeren en de geconstateerde gebreken moeten zo nodig worden verholpen.

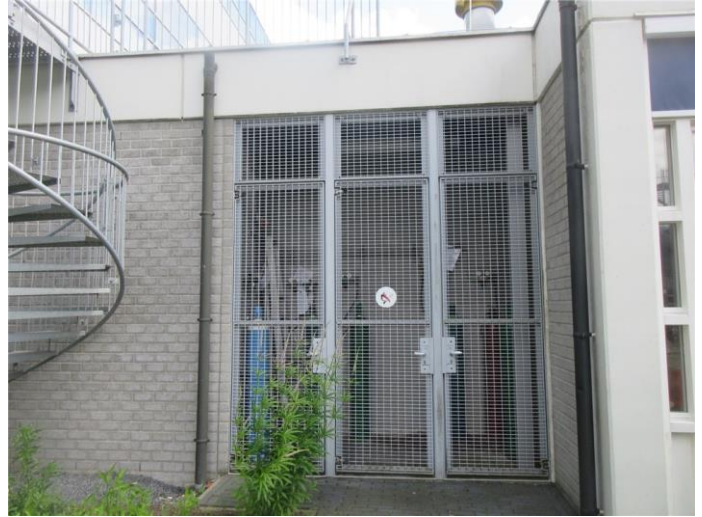
Storage of inert gases

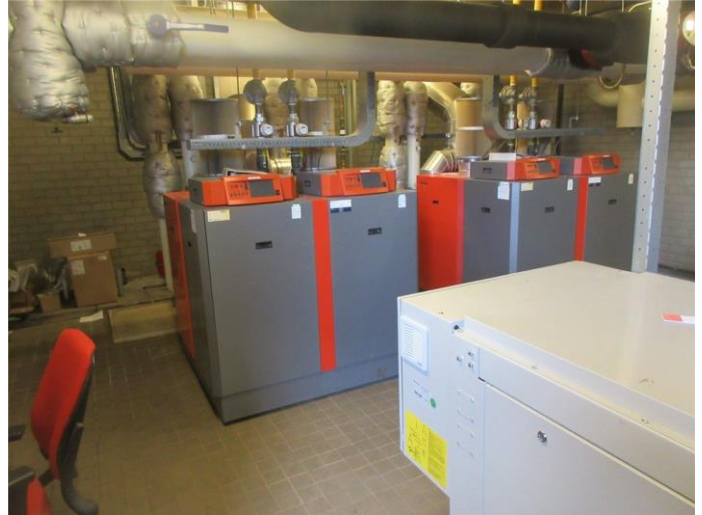
In general, good housekeeping in technical rooms
