# Chubb Risk Control Program

## Property Underwriting Report

Prepared for  
Stichting NHL Stenden Hogeschool  
Rengerslaan 8  
8917 DD Leeuwarden  
Netherlands

Inspection Date: 17 June 2024

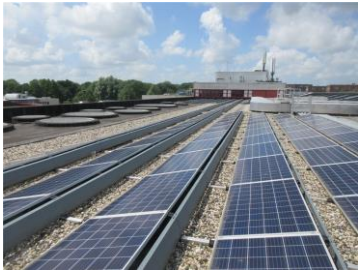
Solar panels

Tijdens de rondgang was het duidelijk dat er ingebruikname geen Scope 12 keuring is gedaan. Visueel constateerde we tijdens het bezoek dat connectoren los liggen op het dak. Daarom raden wij aan om een inbedrijfstellingsinspectie en eens per drie jaar een inspectie van het zonnepaneelsysteem uit te voeren volgens de richtlijnen Scope 12 (TD18). Een gespecialiseerde derde partij moet de inspecties uitvoeren en de geconstateerde gebreken moeten zo nodig worden verholpen.

Bovendien moet het PV-systeem na hevige wind- en sneeuwstormen worden geïnspecteerd om gebreken vast te stellen, zoals losse of verroeste bouten waarmee de modules zijn bevestigd, fysieke schade aan de PV-structuur, blootliggende bedrading, enz..

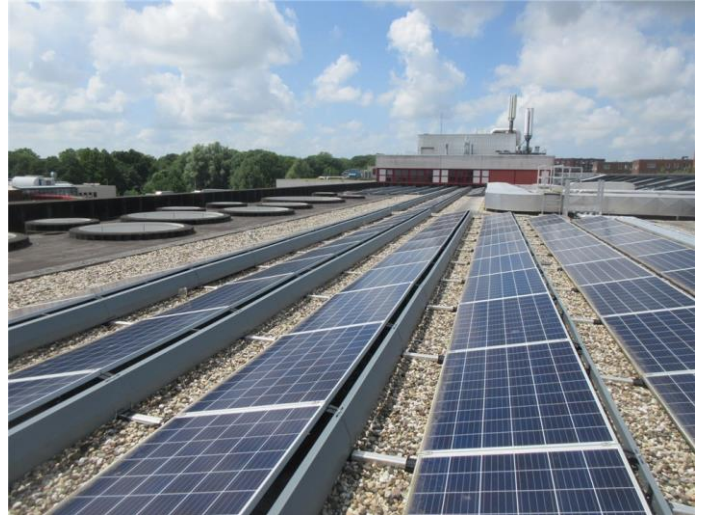
Solar PV panels are on the roofs, and inverters are in technical rooms. A Dutch Scope 12 inspection has not been performed yet. A recommendation has been issued.

Solar panels

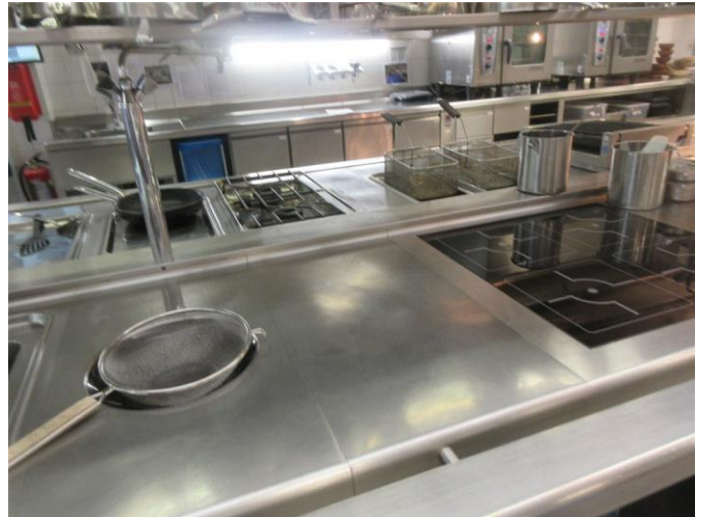
Tijdens de rondgang constateerde we dat er geen F-brandblussers aanwezig waren in de buurt van enkele frituurinstallaties. In geval van een calamiteit wil je snel een blusser kunnen gebruiken. Daarom adviseren we om een blusser te plaatsen in de buurt van de keuken met o.a. klasse F.

Deep fat fryers

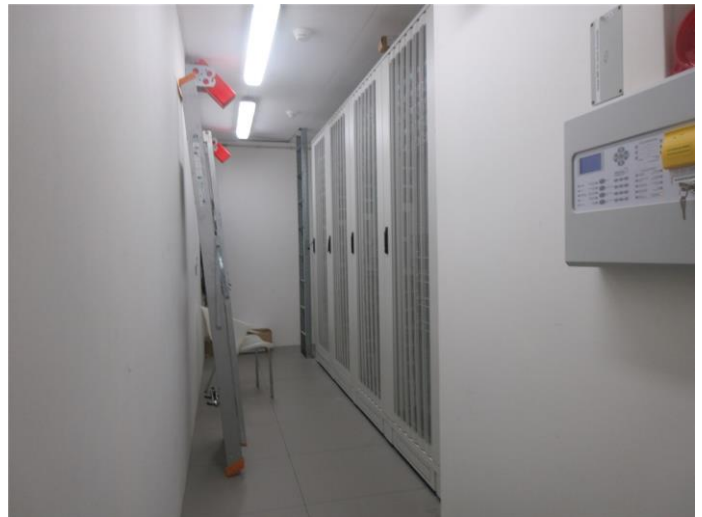
The MER is equipped with a fire-extinguishing gas installation.

MER room with object extinguisher

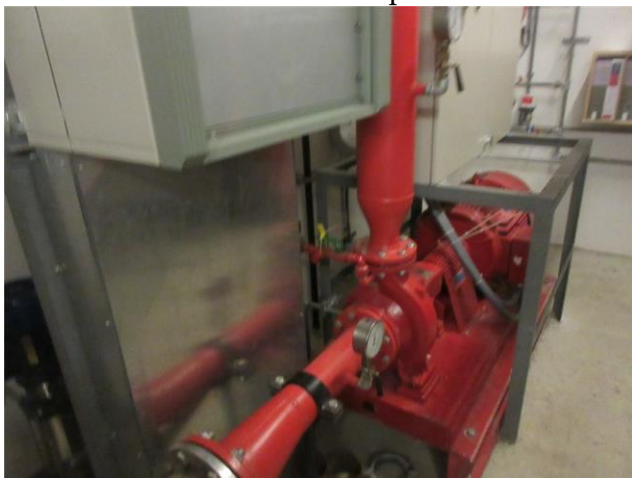
| The sprinkler system has 1 electric pump connected to the municipal water supply and supplies 120 m <sup>3</sup> /hr with a pressure of 6 bar. The installation is maintained by Engie. The pump is tested by Aqua+ once every 2 weeks. | | | |

Sprinkler pump
