# Risk Engineering Report

**Stichting BVE Zuid-Limburg**

**Site Name:** Schandelermolenvweg 21

**Survey Type:** Property All Risk - Initial

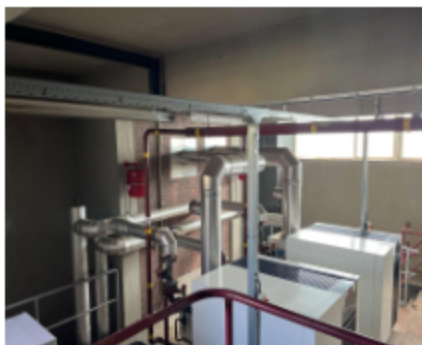
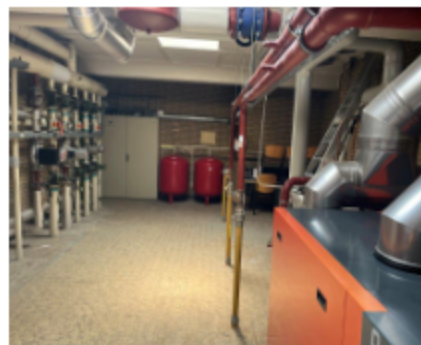
Gas fired boilers

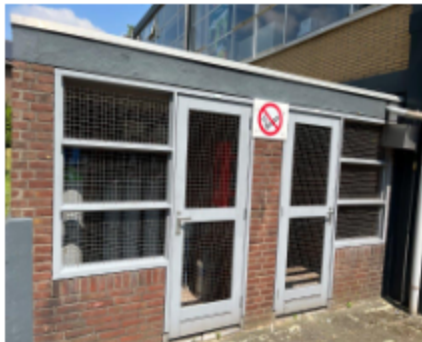
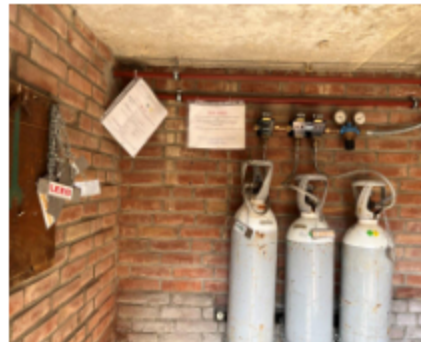
Outside, a dedicated storage cabinet cylinders with different gasses are stored. Cylinders are secured to the wall.

Cylinder storage
