# Risk Engineering Report

**Stichting BVE Zuid-Limburg**

**Site Name:** Valkenburgerweg 148

**Survey Type:** Property All Risk - Initial

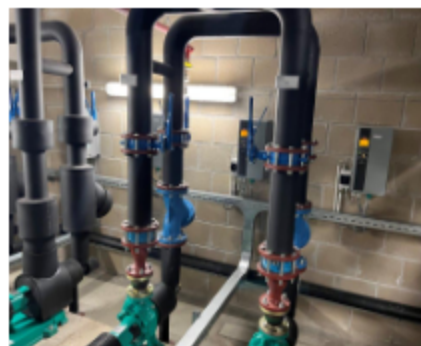
Heat pumps, connected by heatexchanger to 'Mine water system'

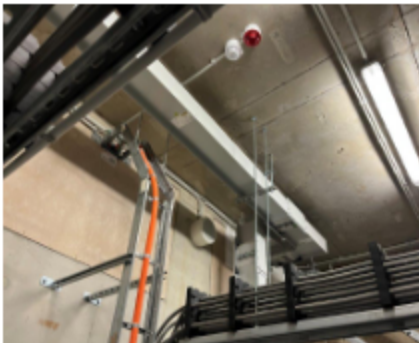
Electricity is supplied from the power grid via an underground connection to two indoor HV transformer placed in a fireproof room on ground level (expedition). These rooms has not been visited, the transformers are of an unknown type and owned by the power grid operator, whom inspects and maintains this transformer according to national guidelines. Fixed (including 16 solar water heaters on roof of building A) and equipment is owned by Vista. There is a internal policy document defining responsibilities and inspection. The various electrical utilities are inspected in accordance with the Scope 8 and 9.

High tension room

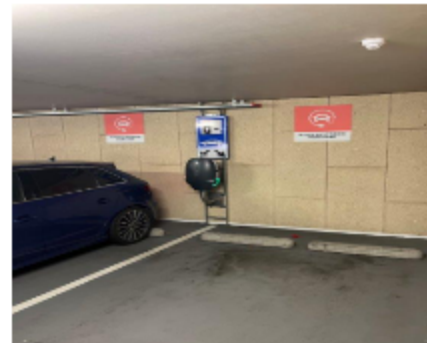
In the parking at the lowest level 6 charging positions are realized, during the site visit only two functional. There are no plans to activated all 6 positions as current the power supply is not sufficient. During the site visit it was discussed to move to charging positions to a location near the exit. And check if the power supply to chargers is cut of in case of a fire alarm.

charging position

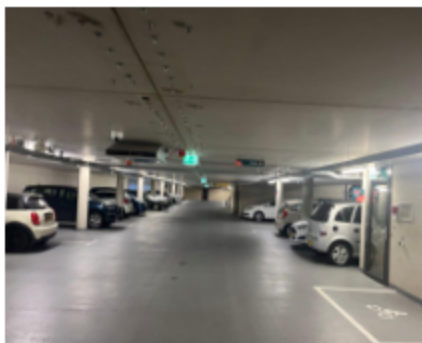
Parking

In a two story ground level/ basement (split level) approximately 25% of the building area is a parking garage for staff, with adjacent bicycle and scooter storage for students (separated with a 60-minute fire-resistant wall). The parking garage has a capacity of about 200 passenger cars. The garage is equipped with automatic fire detection based on thermal detection. Also CO and LPG detection at multiple locations in the parking. In the basement there is a smoke extraction system that - with aeration from the basement entrance and from an additional aeration shaft for the lower parking level - provides this garage with cross ventilation, in case of alarm by this (fire) detection, the ventilation is increased in order to thus remove as much smoke and heat as possible. The exhaust to the outside air of this forced smoke/heat ventilation goes to the roof of the most southeastern (taller) building, entirely through a "dedicated" fireproof shaft through this building. The parking garage is not equipped with sprinkler protection; a recommendation to install it has been made.

Extend the existing sprinkler system to protect the parking garage Extend the system in accordance with NFPA 13.

The parking garage is lacking sprinkler protection. Extending the existing sprinkler system will increase the likelihood that the sprinkler system will control a fire starts in the area.

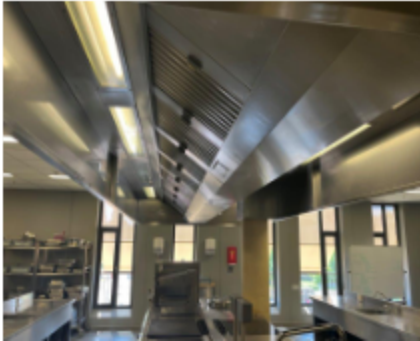
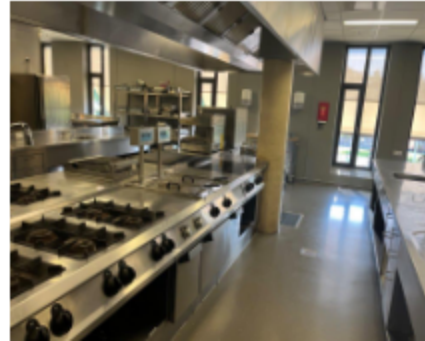
Kitchen

Almost all cooking, baking and frying equipment is concentrated in one building section, this equipment is partly gas-fired and partly electrically heated. All this equipment is in use (by students) only when a professional supervisor (teacher) is present, the frying equipment in these educational kitchens is in limited use. Also, in the general restaurant on the ground floor level, there are some cooking and frying equipment. There are no special extinguishing devices installed in the metal exhaust hoods above the cooking and deep-frying installations, particularly through the use of the metal lids of the deep-frying installations, extinguishing can be organized. The fire blankets present in the various kitchens are suitable for extinguishing fires in deep-frying facilities. The metal filters in the extractor hoods are cleaned regularly (mostly weekly and sometimes monthly if contamination remains limited), the interior of these extractor hoods and the associated extraction ducts are not cleaned (risk improvement noted). Emergency stops are provided in several locations to shut off the gas and electric supply. During the visit, it was recommended that new kitchens be immediately equipped with a kitchen fire suppression system when they are replaced. For imaging this information can be found on the Internet. But we as AIG are also happy to provide the desired information.

Thoroughly clean all exhaust ducts from the kitchen to the roof.

Grease residue can accumulate in kitchen exhaust ducts, among other things. In the event of a kitchen fire, rapid escalation is possible. Periodic thorough cleaning limits the fire load in an exhaust duct and prevents it from contributing to fire propagation.

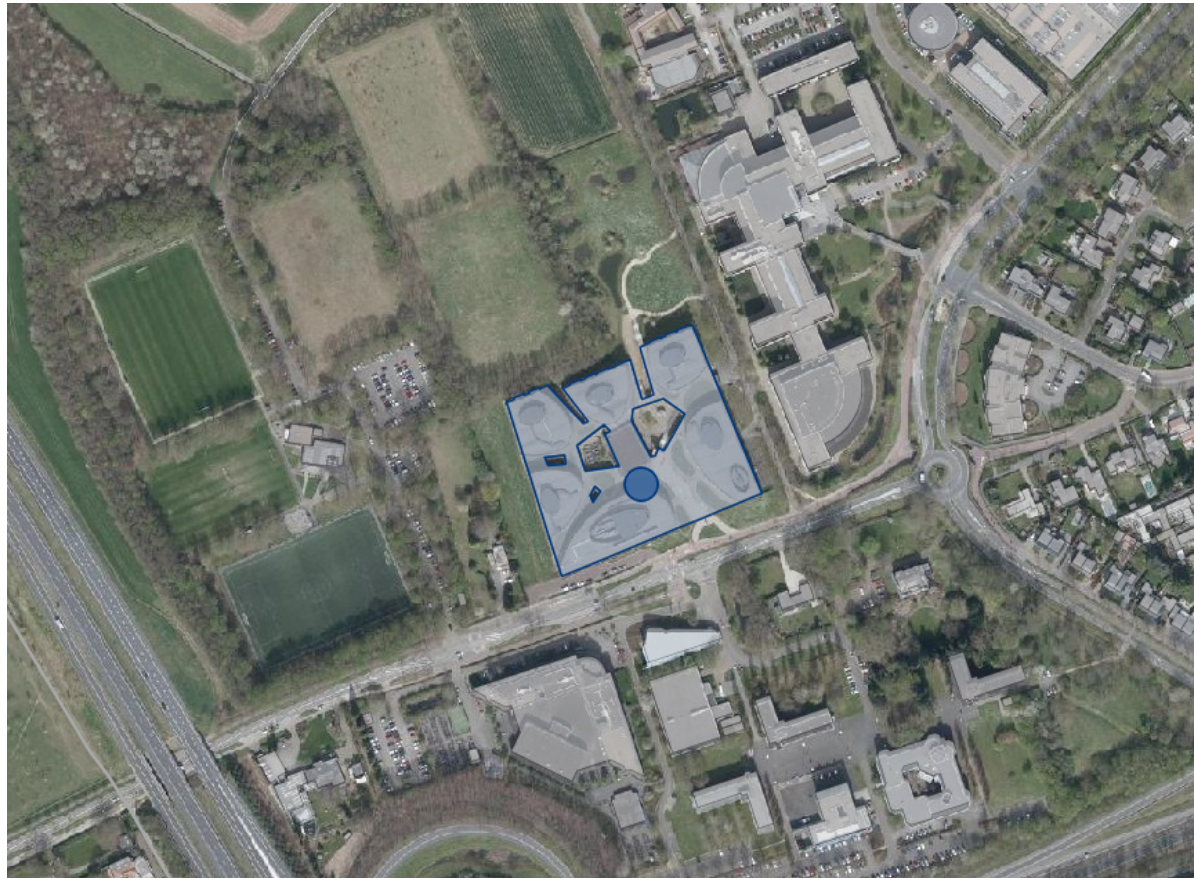
Fig: site with exposures

- North: trees and agricultural land.
- East: an university of applied sciences at 29 meter.
- South: the public road with across a comprehensive school and an Open University at > 50 meter.
- West: a house at 27 meter.
