# Risk Engineering Report

**Stichting BVE Zuid-Limburg**

**Site Name:** Arendstraat 12 (Valkstraat 10)

**Survey Type:** Property All Risk - Initial

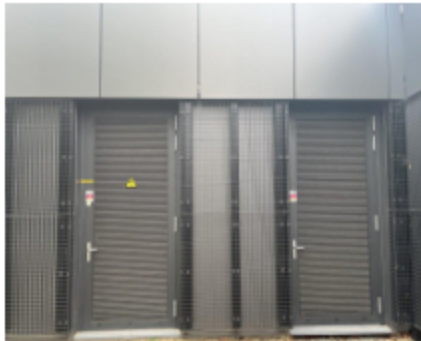
Transformer

Electricity is supplied from the power grid. Each building has a transformer (rental), type and capacity unknown. Transformers are checked and maintained by the utility company.

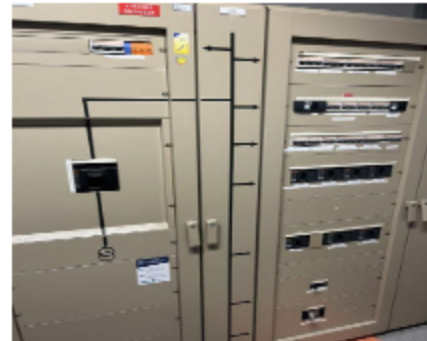
Main switch room

The electrical installations appear visually in a good state of repair. Penetrations for electrical cables were found to be adequately fire stopped, including inside vertical utility shafts. An external company inspects and maintains the electrical installations in accordance with the local NEN 3140 standard (incl. thermographic checks).

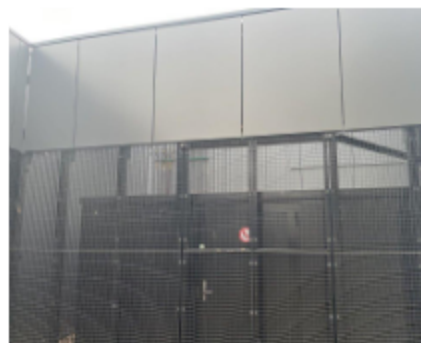
Practical classroom - Gas cylinder storage

In the chemistry (labs with fume cupboards) and in the mechanical engineering class room small quantities of flammable / combustible liquids & gases can be present. And the end of the day/ class materials are removed or placed in steel closed chemical cabinets. Outside there are in a dedicated cabinet against the outer wall for storage of gasses, according Dutch PGS legislation.

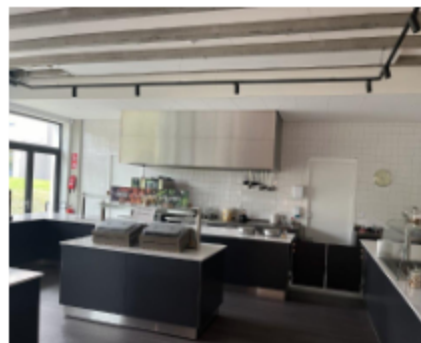
Kitchen

There is one professional kitchen on the ground floor. It contains electrical and gas fired kitchen equipment like an oven (electrical) and deep fat fryers (gas). The professional equipment in the kitchen is well maintained and is always operated under supervision of professionals. High temperature limit switches are reportedly available. There are no special extinguishing devices installed in the metal exhaust hoods above the cooking and deep-frying installations, particularly through the use of the metal lids of the deep-frying installations, extinguishing can be organized. Periodic inspection and cleaning of the exhaust ducts is subcontracted to a professional company. The kitchen is not provided with a local extinguishing system (recommended only as best practice).

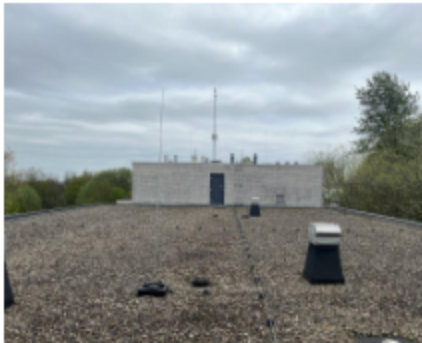
Roof Building B

On the steel deck roof, polystyrene is used as insulation material. In a fire, some of the material liquefies. By sealing openings, it can be prevented that a second (or more) fire source(s) in the complex is created by the dripping of liquid or burning polystyrene. This increases the likelihood of effective fire department deployment in the event of a roof fire.

Seal the exhaust penetrations in the technical room of building B with non combustible materials like for example mineral wool.

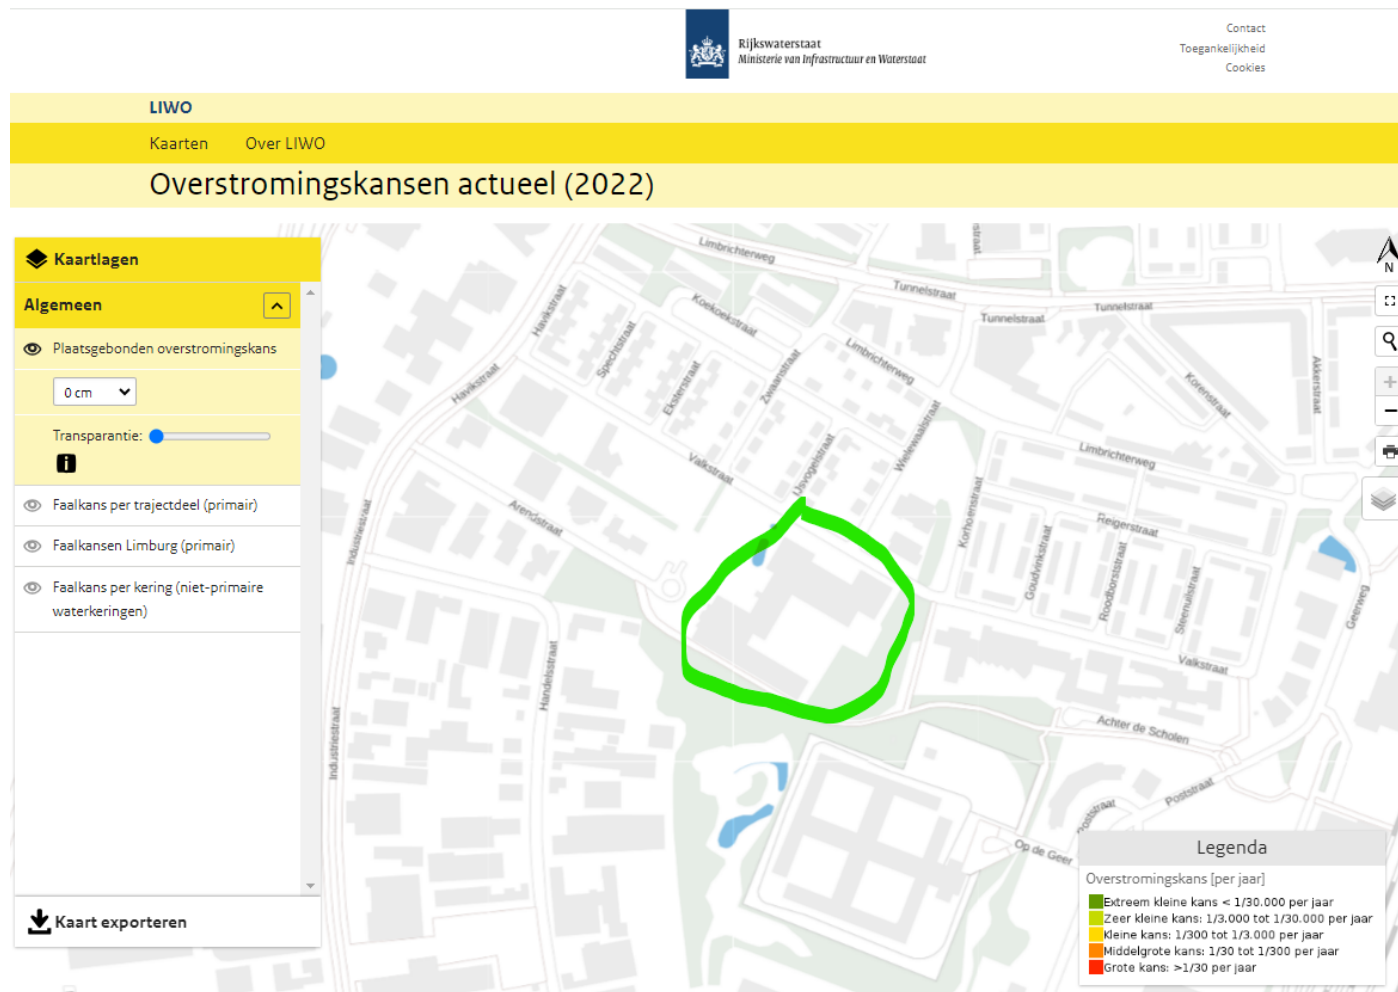
No flood exposure according Dutch government site Rijkswaterstaat:
