# Risk Engineering Report

**Stichting BVE Zuid-Limburg**

**Site Name:** Sibemaweg 20

**Survey Type:** Property All Risk - Initial

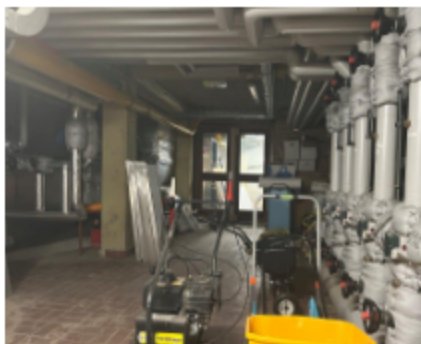
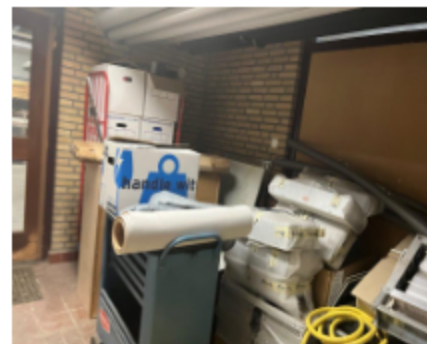
A fire involving the combustible materials may contribute to the smoke contamination of the equipment within the room.

Storage in TR

Remove the combustible materials from the technical rooms.

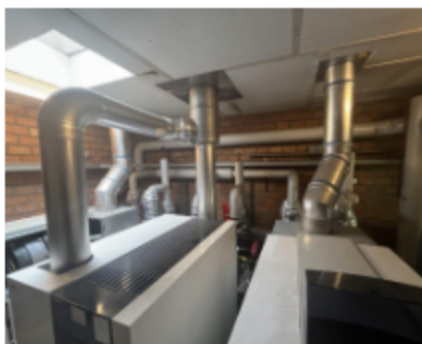
Gas fired boilers

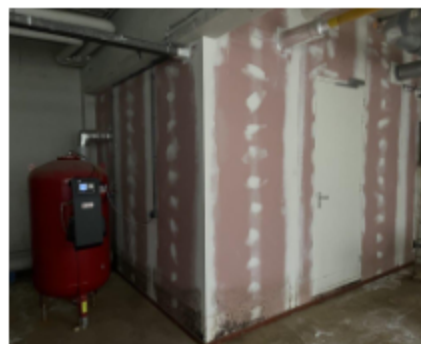
Compartment gas fire heating

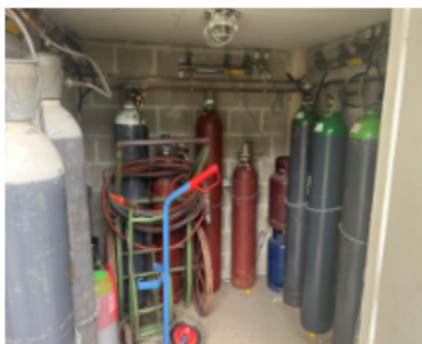
Storage of flammable liquids in steel enclosed fireproof cabinets. In a room, accessible from the outside, a dedicated storage cabinet cylinders with different gasses are stored. Cylinders are secured to the wall.

Gascilinders

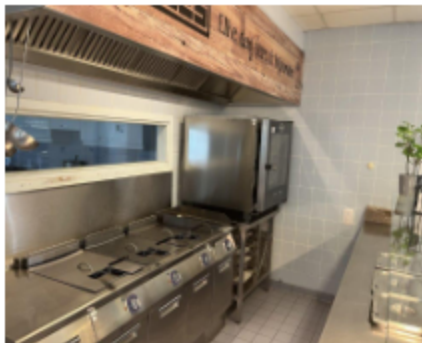
A commercial kitchen is present with standard equipment, including ovens and deep fat fryer. The deep fat fryer is not fitted with an automatic extinguishing system. Standard safety measures in place. Maintenance and cleaning conducted by a specialized contractor.

Kitchen

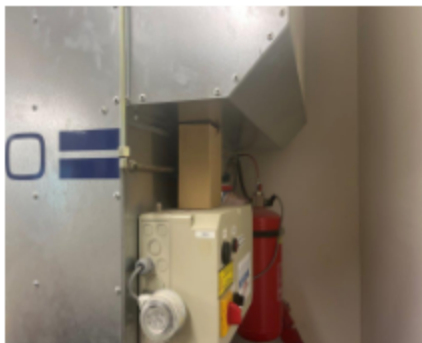
Dust extraction system - stand alone extinguishing

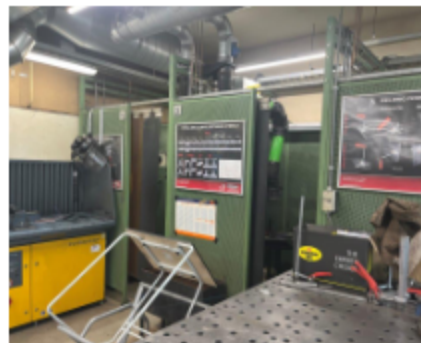
Practical classroom - welding

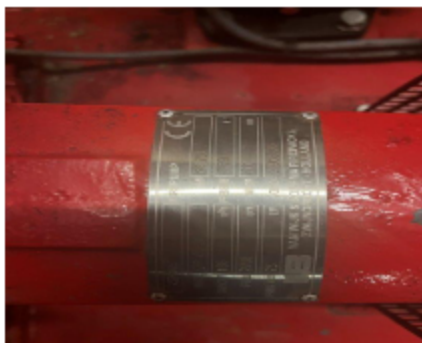
Sprinkler pump - type

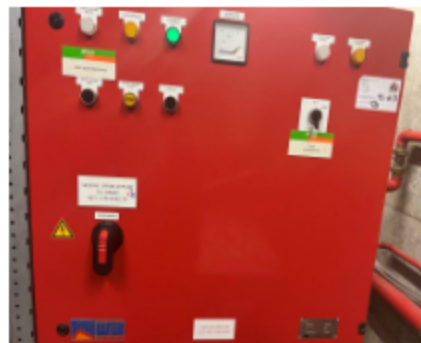
Sprinkler pump - cabinet

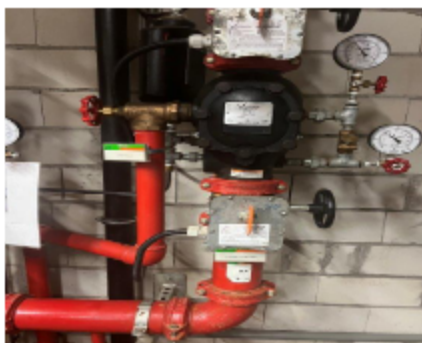
Alarmvalve
