Risk Engineering

Risk Assessment and Risk Improvement

Property - Fire
Date of Assessment: 24 May 2023
Date of Issue: 15 Jun 2023
Confidential

Hogeschool Rotterdam
Hogeschool Rotterdam Academie
Academieplein 9

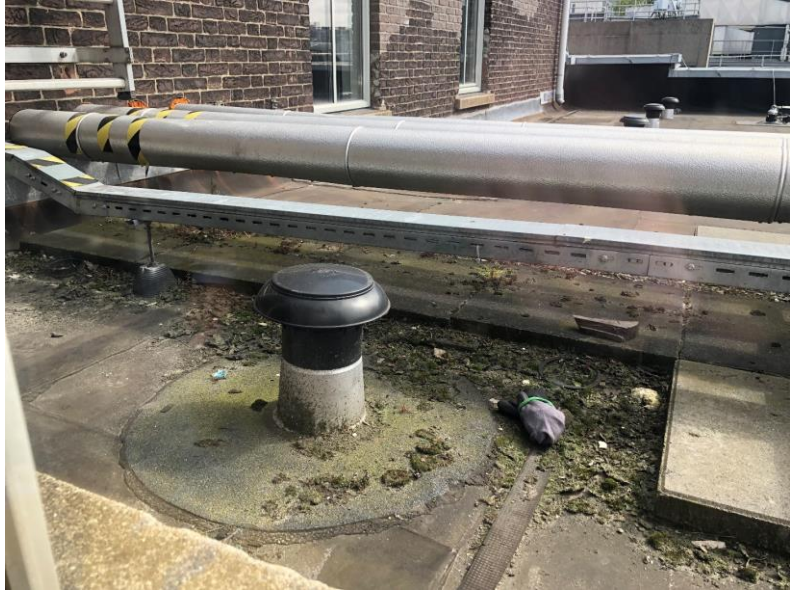
RIA	Periodiek schoonmaken van de daken			Important
RIA ID 00003	Completion Status	Not yet actioned		
	Onsite Date	24 May 2023	Target Implementation Date	
Description	<p>Observatie: Tijdens het bezoek aan het dak lag er veel aangroei wat voor belemmering van de hemelwater afvoeren kan zorgen.</p> <p>Risico: Bij onvoldoende afwatering kan water zich verzamelen en lekkages veroorzaken</p>

langs dakranden of erger een dak kan instorten. Actie: Implementeer een periodieke inspectie en schoonmaak ronde langs de verschillende dakvlakken waarbij aangroei en afval wordt verwijderd.

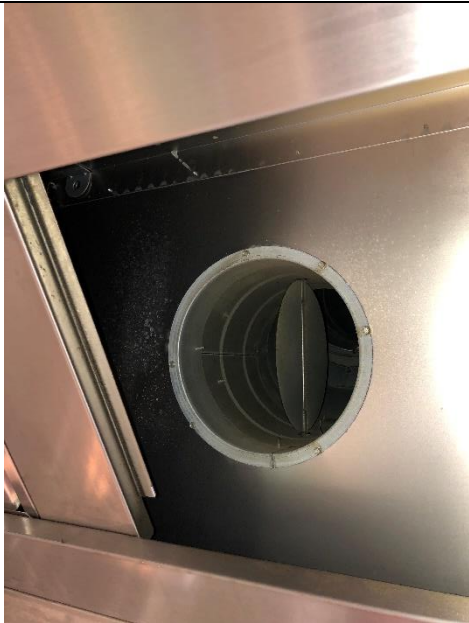
Schoon afzuigkanaal keuken

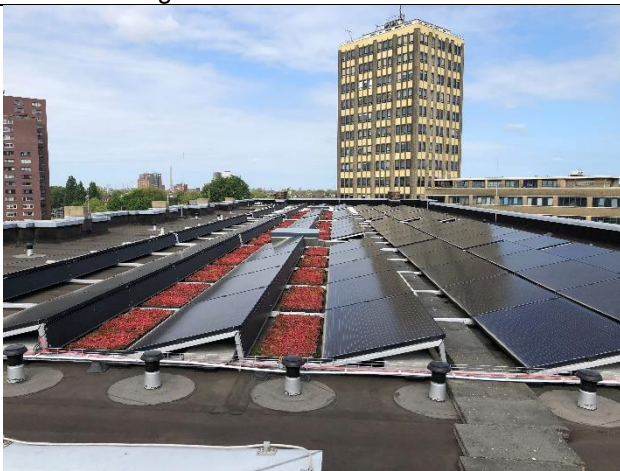
Zonnepanelen op het dak van gebouwdeel A

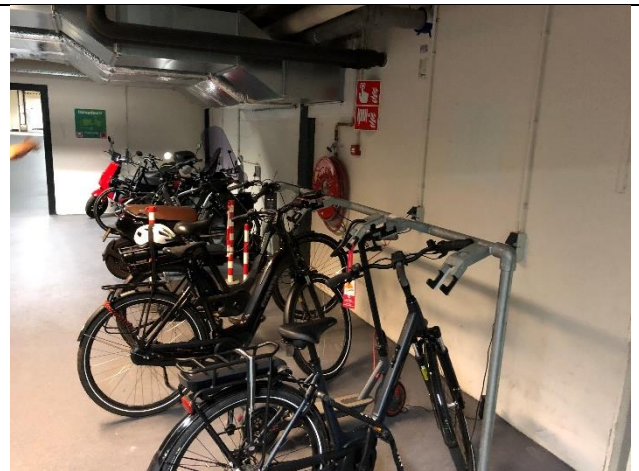
Fietsenstalling zijde elektrische fietsen met oplaadmogelijkheid

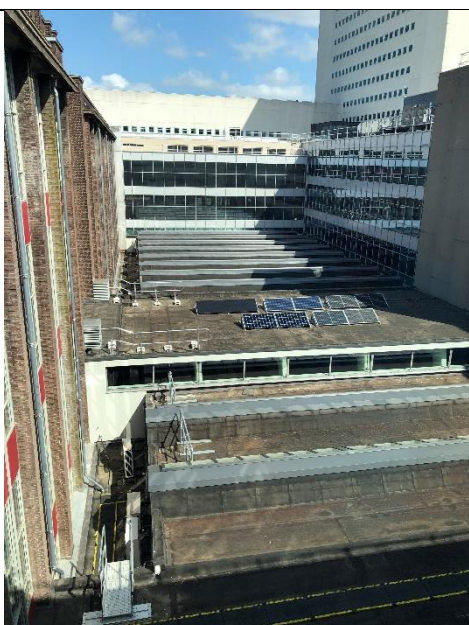
Indruk dak bouwdeel B

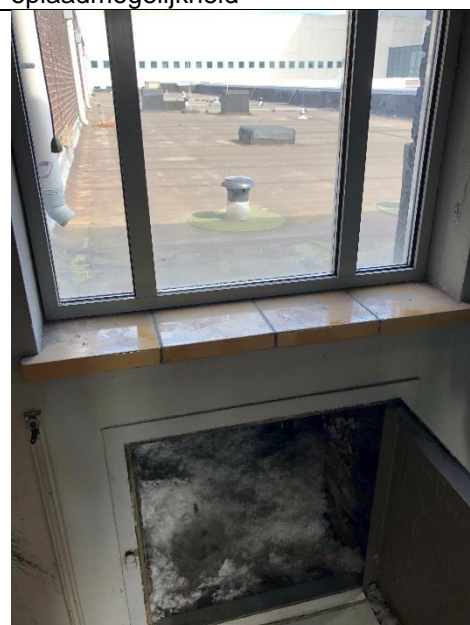
Cellulose isolatie onder houten dak

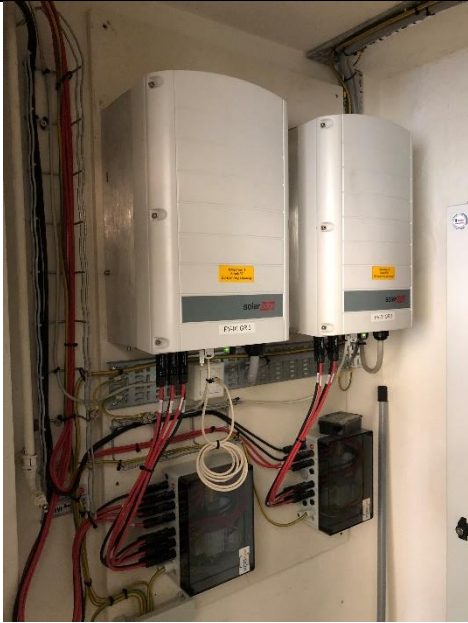
De twee omvormers van de zonnepanelen

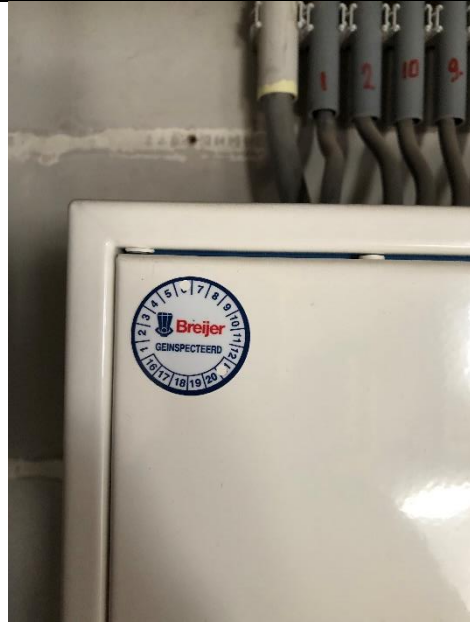
Sticker juni 2021 Keuring elektra

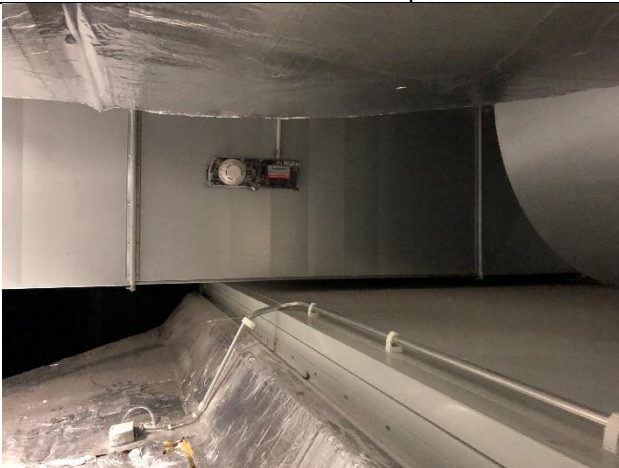
Hvac installatie voorzien van automatische rookmelder.

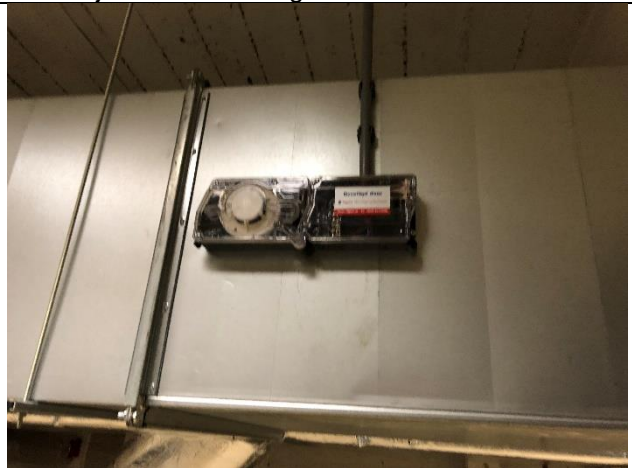
Hvac installatie voorzien van automatische rookmelder.

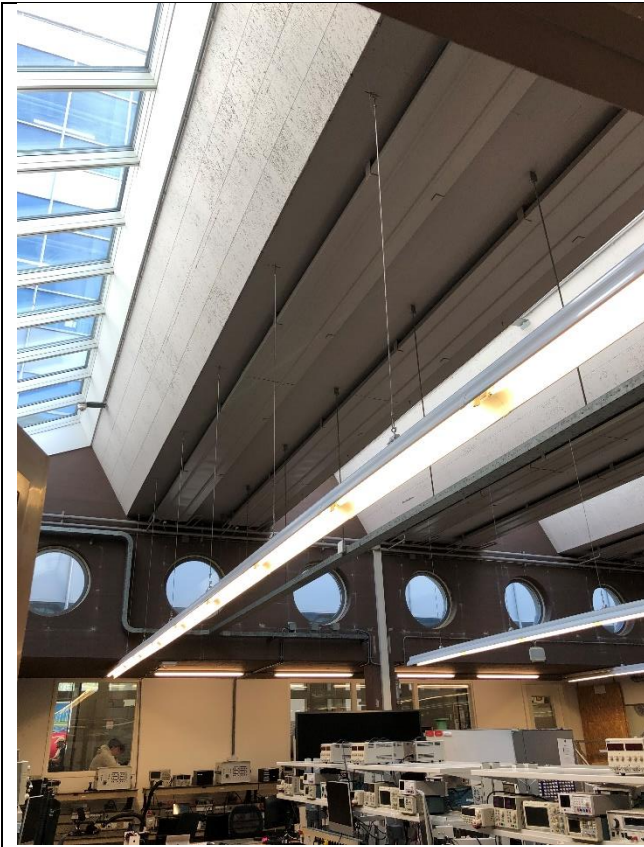
Technische opleiding gebouwdeel C

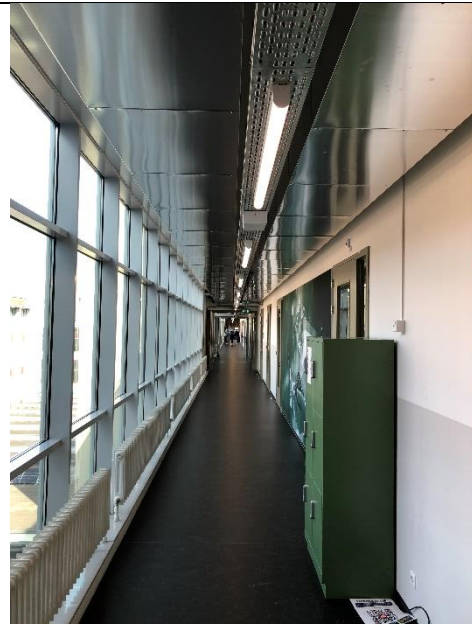
Gang gebouwdeel D met lokalen voorzien van laboratorium zuurkasten
