# Risk Engineering

Risk Assessment and Risk Improvement

Property - Fire  
Date of Assessment: 6 May 2024  
Date of Issue: 21 May 2024  
Confidential

**Hogeschool Rotterdam**  
Kralingse Zoom  
Kralingse Zoom 91

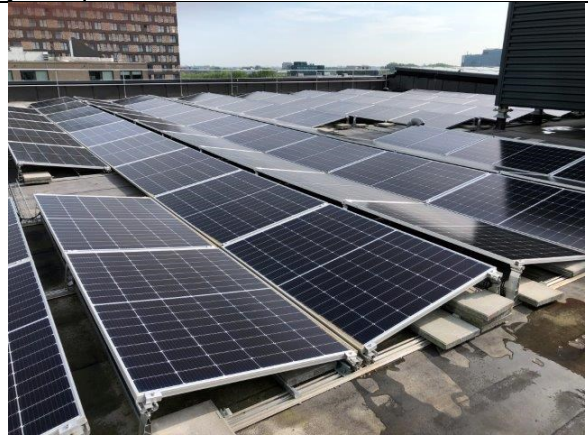
- Zonnepanelen op het dak van bouwdeel C, de isolatie is onbekend;
- Geen duidelijkheid omtrent keuring van de elektrische installatie en de zonnepanelen, omdat de gevraagde documentatie niet ontvangen is;

Zonnepanelen op gebouwdeel C.

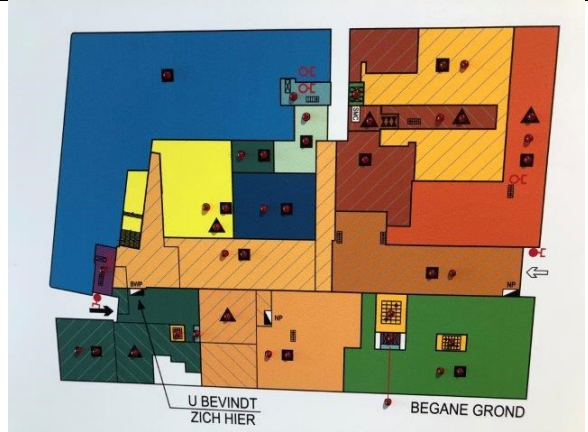
- Hoewel een sprinklerinstallatie en een brandmeldinstallatie aanwezig zijn, is de projectering gemixt: op vrijwel alle verdiepingen zijn deels beide beveiligingen, soms geen beveiliging en soms alleen sprinkler of brandmelding. Een duidelijke lijn in de projectering kon niet gevonden worden en daarmee kan er geen duidelijk schadescenario gemaakt worden;

Er kon geen duidelijke opbouw in de positionering van de brandmeld- en sprinklerinstallatie vastgesteld worden. Er zijn delen waar geen beveiliging is, er zijn delen waar alleen brandmelders of sprinklers geplaatst zijn en er zijn delen waar zowel brandmeld- als sprinkler aanwezig is. Deze situatie kan per verdieping verschillend zijn, zonder duidelijke compartimentering of wijziging in activiteit.

Impressie van de gebouwen op begane grond niveau. De gearceerde delen zijn voorzien van brandmelding, de dubbel gearceerde van sprinkler. Delen die niet gearceerd zijn, zijn niet beveiligd. Dit is per verdieping verschillend.

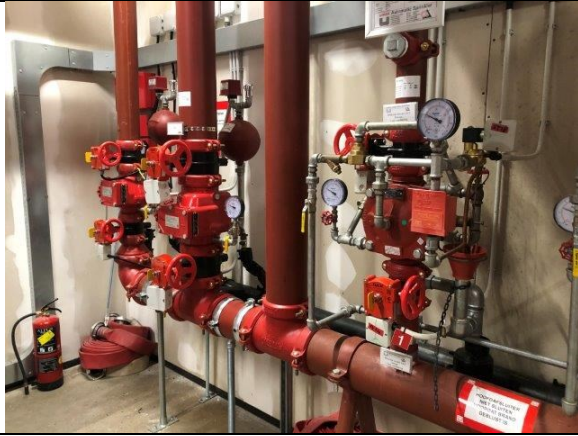
Impressie van de sprinkler pomp ruimte.

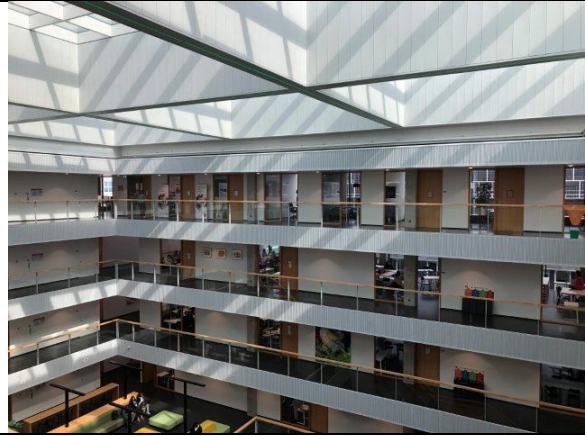
In het atrium van gebouwdeel D is een rook-warmte-afvoer installatie aanwezig. Deze opent automatisch op brandalarm. Het is onduidelijk of dit de effectieve werking van de sprinklerinstallatie beïnvloed.

Atrium in gebouwdeel D, voorzien van een RWA-installatie.
