# Risk Engineering

Risk Assessment and Risk Improvement

Property - Fire  
Date of Assessment: 24 May 2023  
Date of Issue: 15 Jun 2023  
Confidential

**Hogeschool Rotterdam**  
Hogeschool Rotterdam Museum  
Museumpark 40

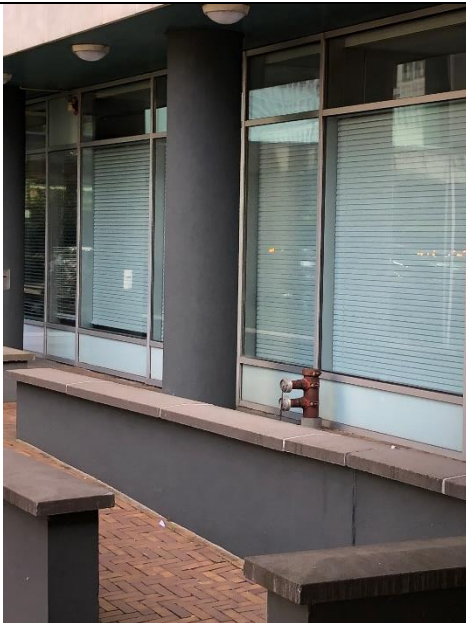
Hydrant voorzijde langs hoogbouw

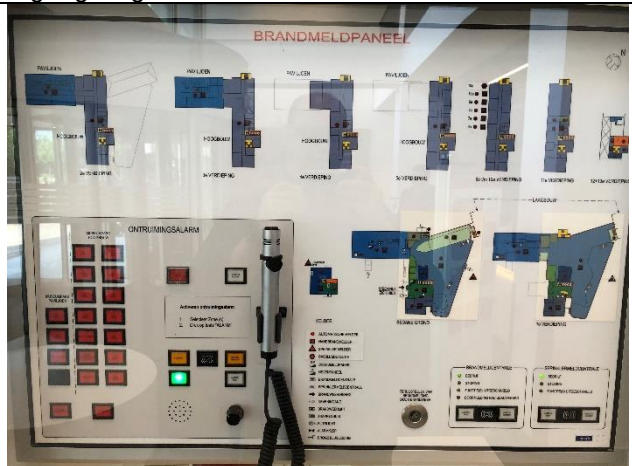
Brandmeldpaneel

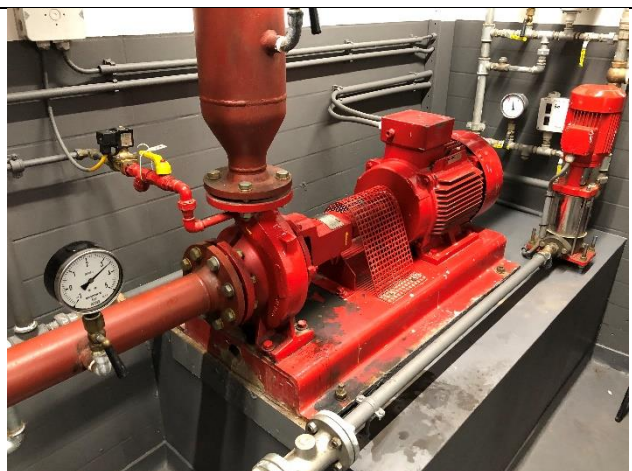
Sprinklerpomp

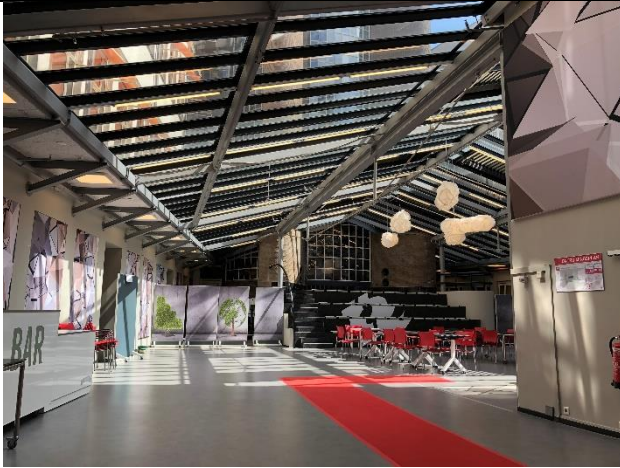
Inkijk laagbouw atrium voorzien van sprinklers

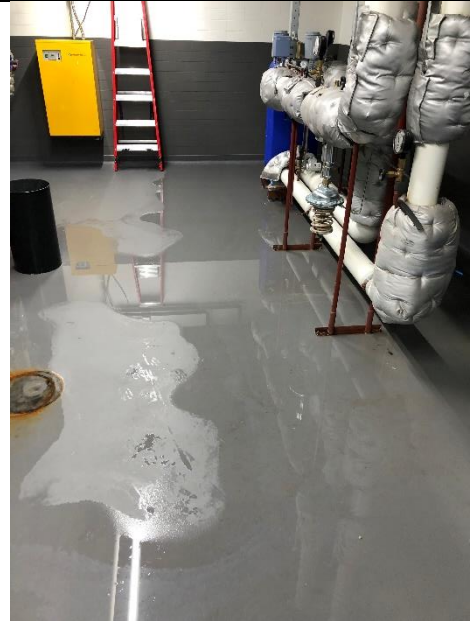
| Year | Month | Amount Zurich share | Description |
|---|---|---|---|
| 2023 | 05 | | Tijdens het bezoek bleek er een lekkage in de kelder afkomstig van de bovengelegen toiletgroep. Verdere details ontbreken. |

Waterlekkage kelder tijdens survey
