# ACE Risk Control Program

## AAA Report

Prepared for  
UNIVERSITEIT UTRECHT  
Yalelaan 104-114 / Munsterlaan 1, Utrecht

Inspection Date: 06/10/2015

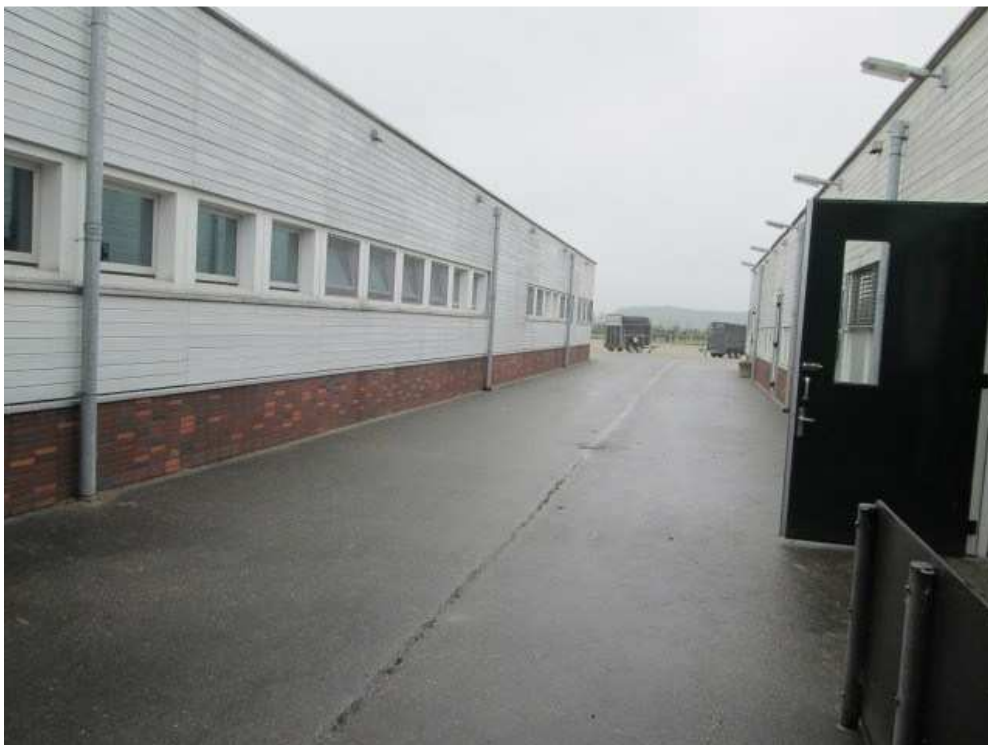
The building has a partly steel and partly concrete load bearing construction. Most of the roofs are made of concrete and partly of steel with mineral wool insulation. The exterior walls are a mixture of masonry provided at the outside with PUR insulation covered with tiles and partly with wood covered. Therefore is the construction rated as combustible (inferior). The building is widely spread and provided with several 30 and some 60 minutes fire retardant partitions. Fire detection is installed to close the fire retardant doors. Automatic sprinklers are installed in most parts, however not in some high value rooms such as the six surgery rooms (for pets) and the MRI-room. The MRI is comparable with one for humans and probably represents a value of about € 1 mio. Additional sprinkler protection is recommended under the roof for the storage of straw and hay (see photo), and some outside stables. Additional fire detection is recommended for the low tension room (no detection and no fire suppression system).

Some of the exterior walls with wood.

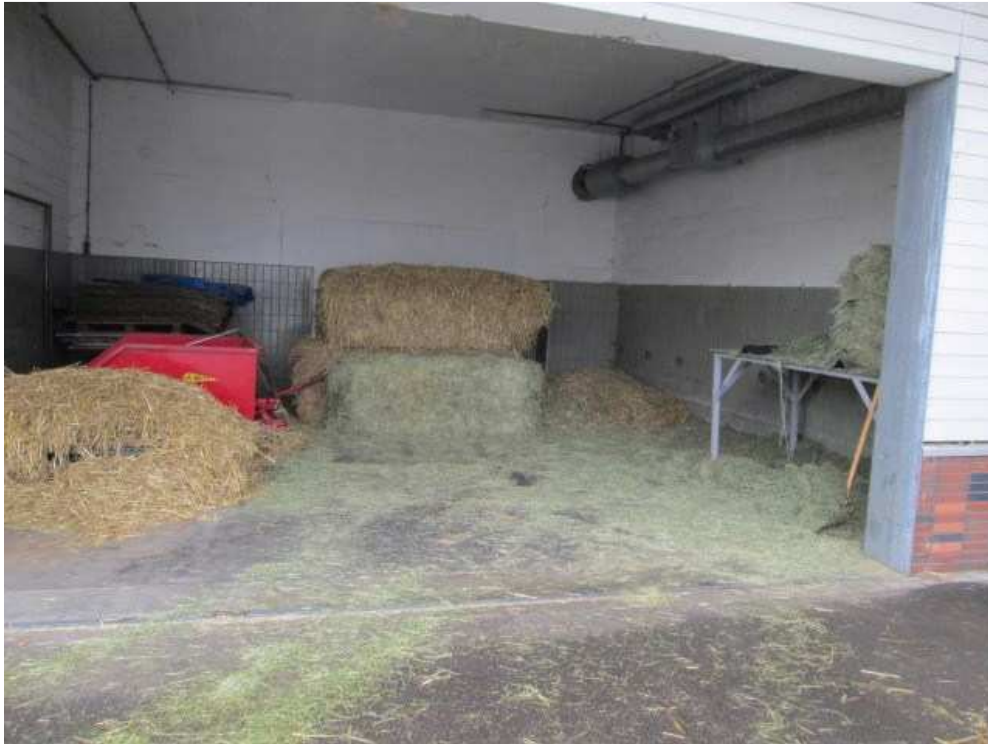
| sprinkler beveiliging | | | |
|---|---|---|--|
| <p>Een groot gedeelte van het gebouw is voorzien van automatische sprinklers. Echter buiten de paardenstallen is een overkapping in gebruik voor de opslag van hooi, stro en bevinden zich ook enkele buiten stallen. Deze ruimte is niet voorzien van automatische sprinklers. Een brand van deze materialen wordt niet gedetecteerd en tijdens de avond, nacht en weekends kan een brand lange tijd branden voordat deze opgemerkt wordt en daarbij de deels brandbare gevel ontsteken. Een dergelijke brand zal niet door de automatische sprinkler in het gebouw beheerst gaan worden waardoor nog steeds een (zeer) grote schade kan ontstaan. Aanbevolen wordt de ruimte te voorzien van automatische sprinklers (droog of antivries -systeem om bevroering te voorkomen).</p> | | | |

| PROTECTION & HAZARDS | | |
|---|---|---|
| <b>Special Hazards</b> | Storage of hay, straw and animal food. The storage is in relative small quantities and bulk storage is located at sufficient distance from the buildings. At one location is the storage of hay in a non sprinklered part. it is recommended to install dry or anti-freeze sprinklers under this roof. | AA |

Some hay storage (not sprinkler protected)

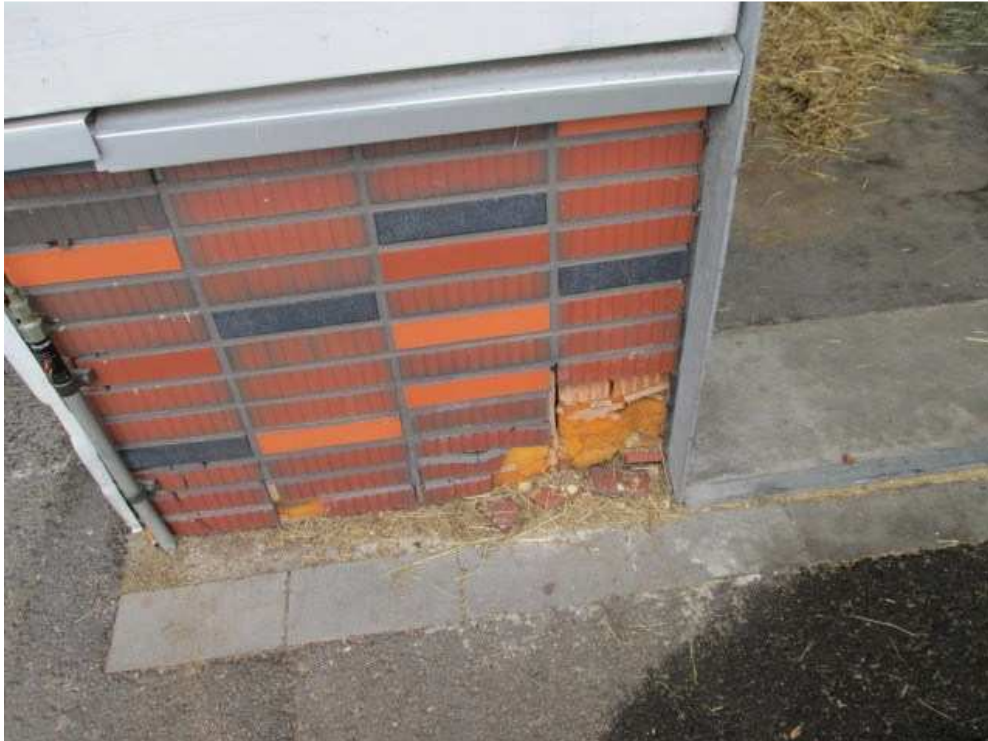
The exterior walls insulated with polyurethane and covered with tiles.
