COPE Report      David de Wied Building (Universiteit Utrecht)  
Adress:            Universiteitsweg 99, Utrecht

Wout Jan Weide            date of visit 11/04/2024  
Mr Marco Thien (Facility Manager UU)  
Mr Ruud van Zanten (Fire protection engineer UU)  
Mrs Astrid Drenth (Aon Risk Consulting)  
Mr Wout Jan Weide (Chubb Risk Engineer, writer of this report)

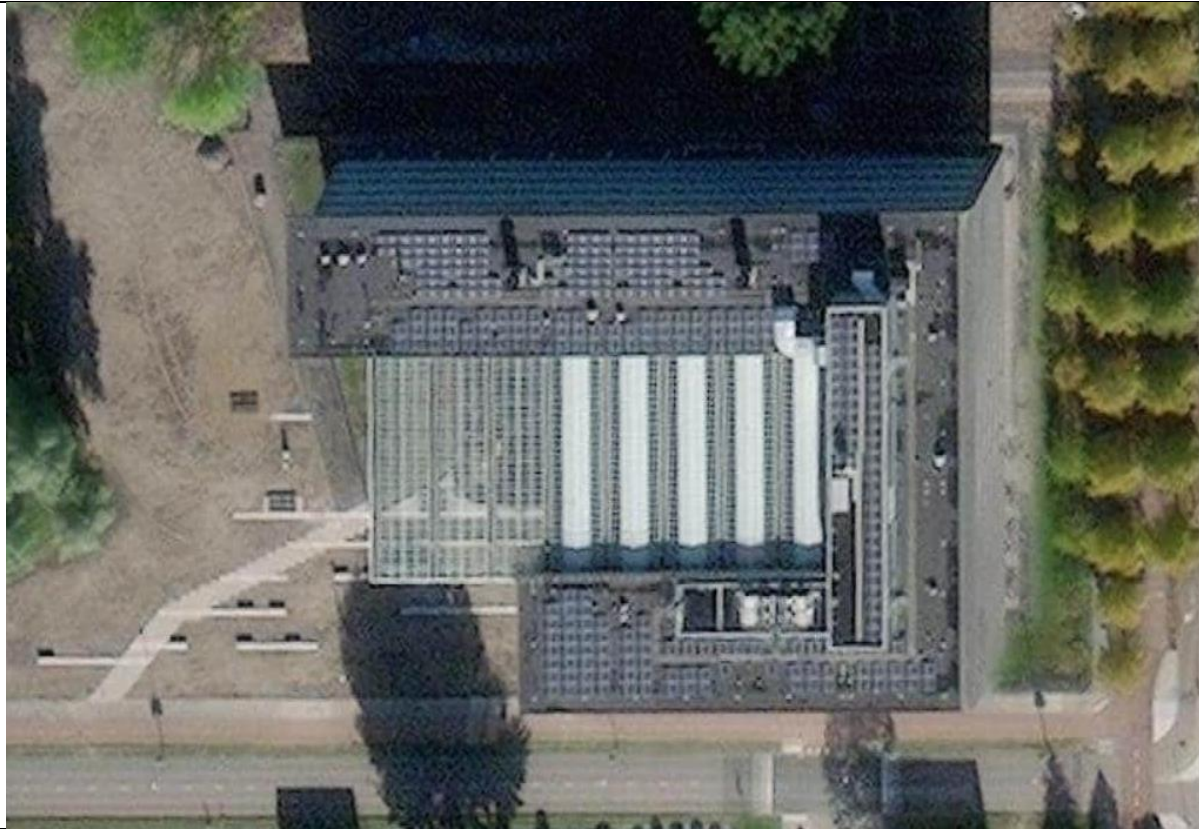
Overview of the David de Wied building.

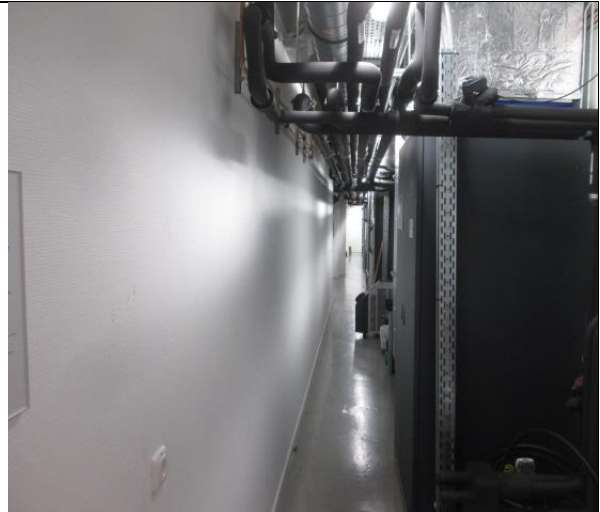
The utility room behind the various (smaller) electro microscope rooms.

De Gang achter de low-end elektronen microscopen bevat water koelingssystemen maar geen vloeistof detectie. Om een lekkage snel op te sporen zodat adequaat actie ondernomen kan worden wordt aanbevolen in ruimte 0.37B vloeistof detectie toe te passen en vloeistoffen in lekbakken op te slaan.

De Low-end elektronen microscopen staan alle in aparte ruimten opgesteld. Voor de koeling zijn gaten in de wand naar ruimte 0.37B geboord. Bij een onverhoopte brand kan rook en roet zich via deze openingen verspreiden en voor een grote rook- en roetschade zorgen. Aanbevolen wordt de gaten door een gespecialiseerd bedrijf af te laten dichten.

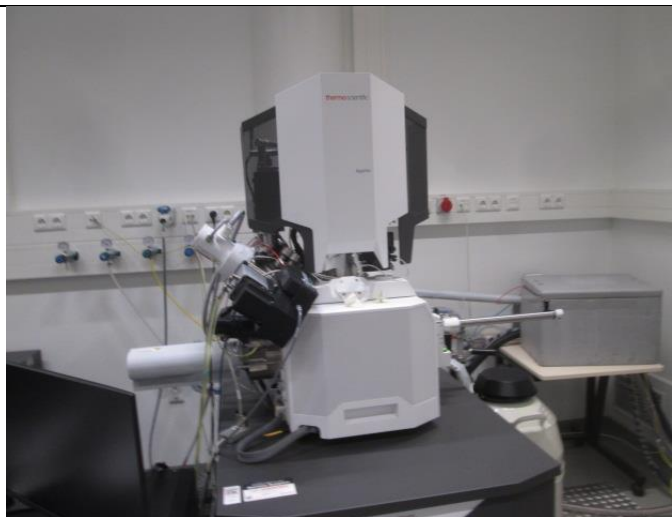
A smaller electron microscope

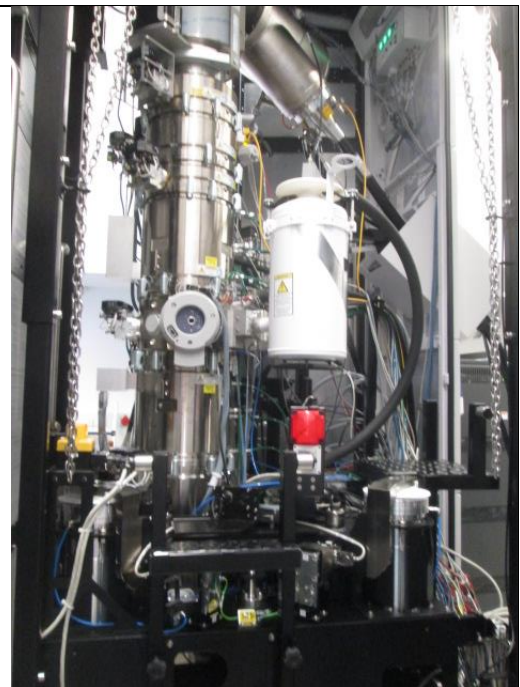
The larger microscope

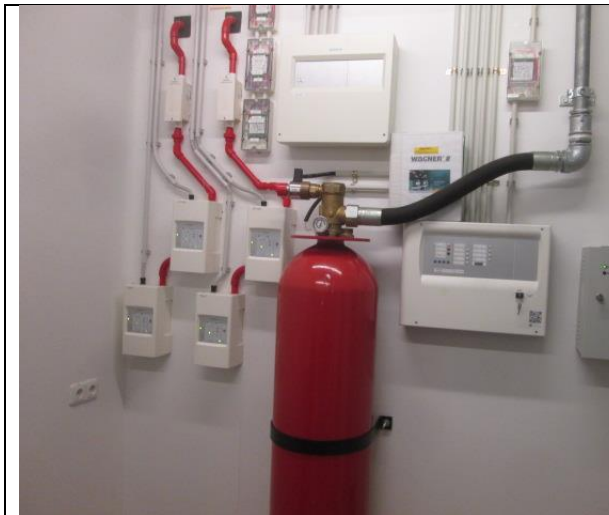
Double aspiration fire detection and extinguishing

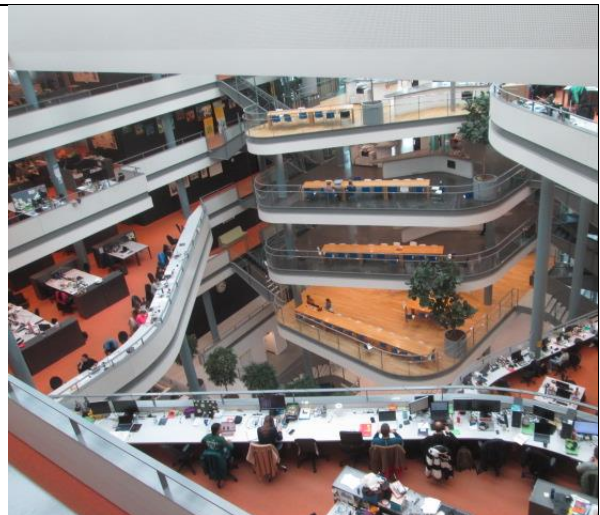
The atrium and various floors

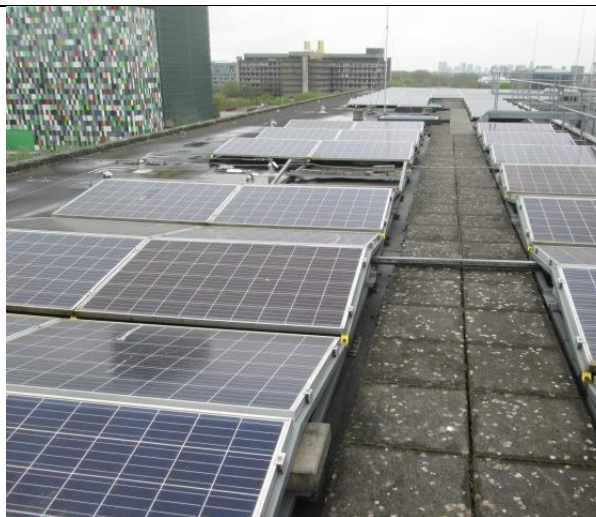
PV-panels on top of the roof (see rec.).

De PV-panelen op het dak zijn behoorlijk vuil en bevatten veel vogelpoepen. Een verstoring van licht en schaduw kan voor piekspanningen in een cel zorgen waardoor de cel op termijn kapot kan gaan. Op enkele plaatsen lijkt de cel al verkleurd, wat betekent dat er veranderingen optreden. Aanbevolen wordt de panelen te reinigen en deze minimaal eens per maand te controleren op verontreinigingen en schoon te laten maken indien nodig.

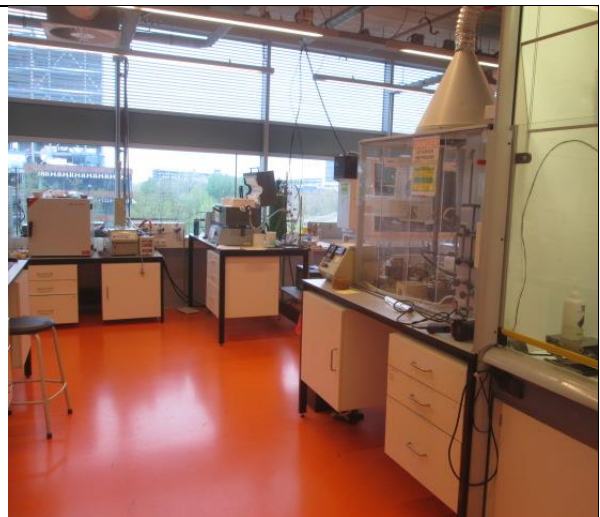
One of the laboratories at the North side

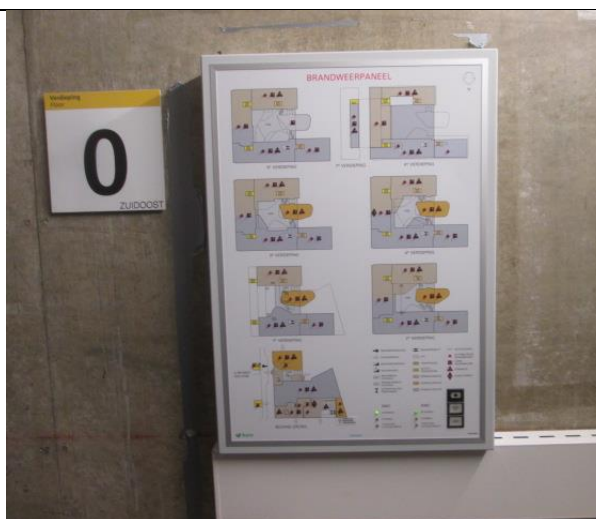
Sprinkler panel

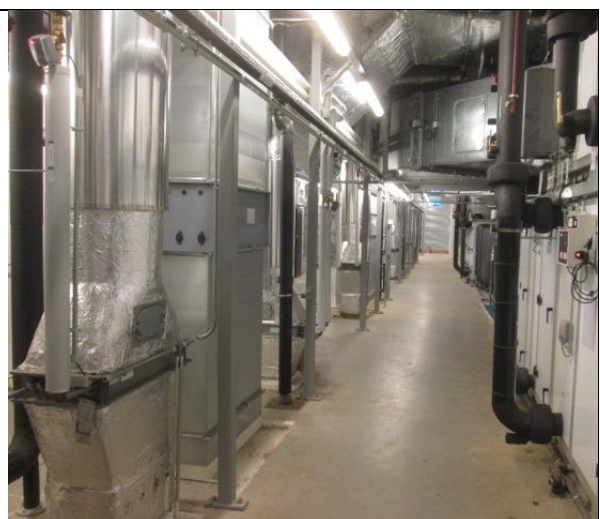
Utility rooms free of combustibles.
