# 70COPE Report Ornstein Laboratorium

Adress: Princetonplein 1, Utrecht

The University of Utrecht was visited April 11th, 2024 for a survey to get an impression of the exposures and controls. The building has In general in use as laboratory (60 %) and offices (40%).

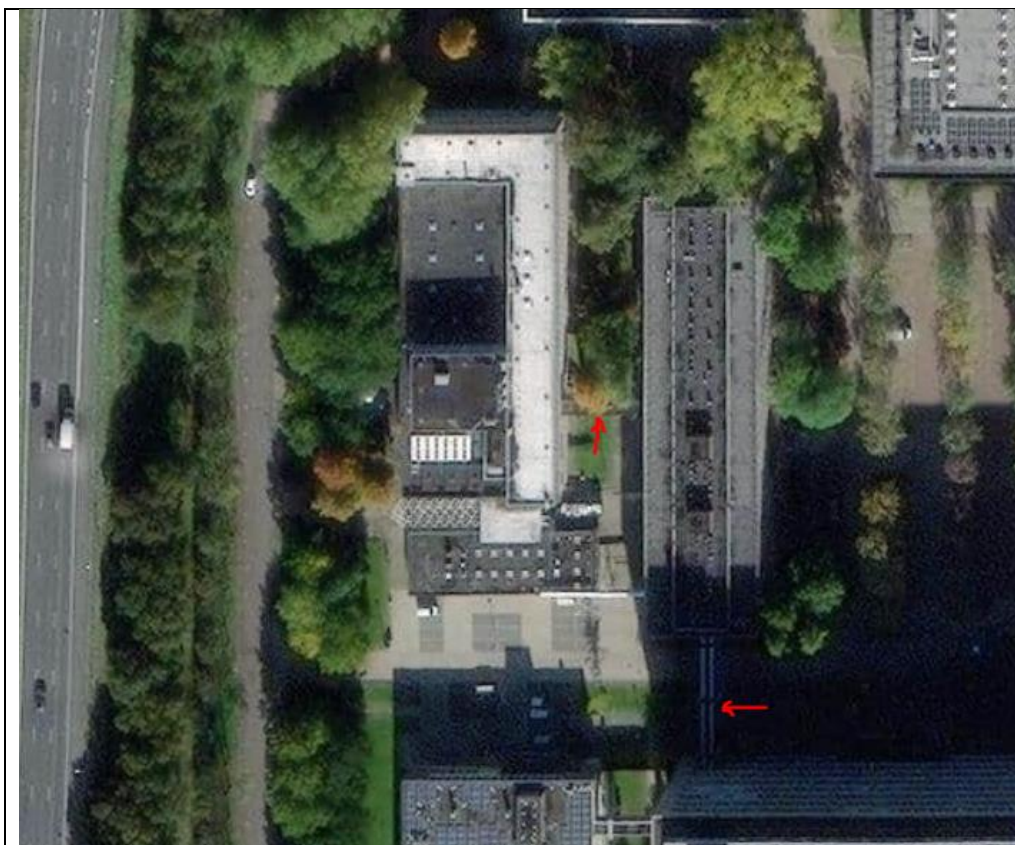
Next door buildings: The Ornstein Laboratorium is interconnected with the Buys Ballot building at 30 meters distance via a corridor with an unknown construction that is 60 minutes fire retardant separated at the Buys Ballot side. The above mentioned ESRON building is located at 19 meters and interconnected by a single floor overhead corridor that is provided with a single fire retardant partition at the Ornstein side (see rec for improvement during the renovation of ESRON).

Overview of the Ornstein Laboratory (middle right building: The two arrows indicated the single floor bridges to adjacent buildings (below Buys Ballot, left another laboratory (ESRON) building that will be renovated soon)

- The next door building (ESRON) is going to be renovated. During this renovation the risk of fire is increased. The connecting bridge (single layer) corridor should be 60 minutes fire retardant separated at the ESRON side to prevent fire spread (see rec.).

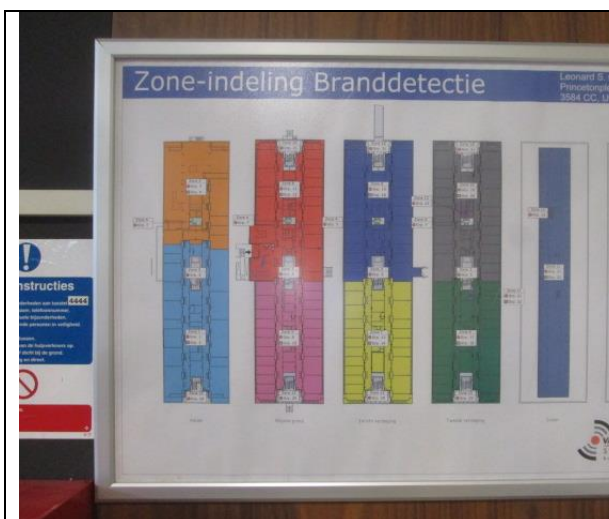
Overview of the various floors (fire detection)

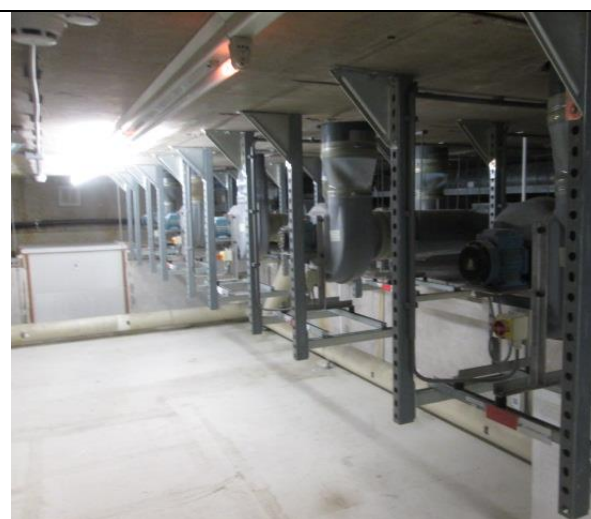
Ventilation systems of the fume hoods

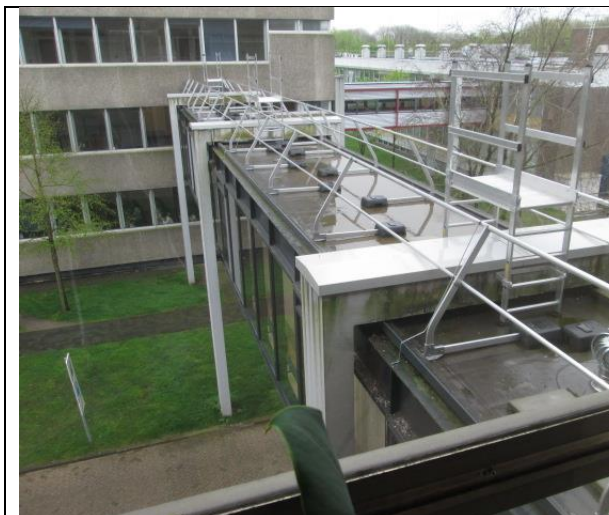
Connection bridge to Buys Ballot bld

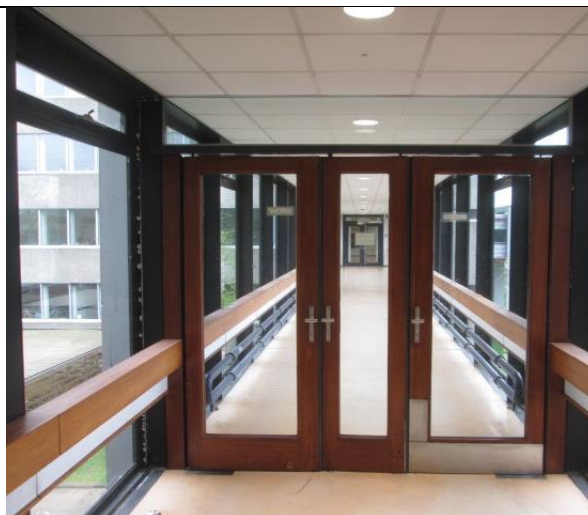
Connection bridge to Buys Ballot bld

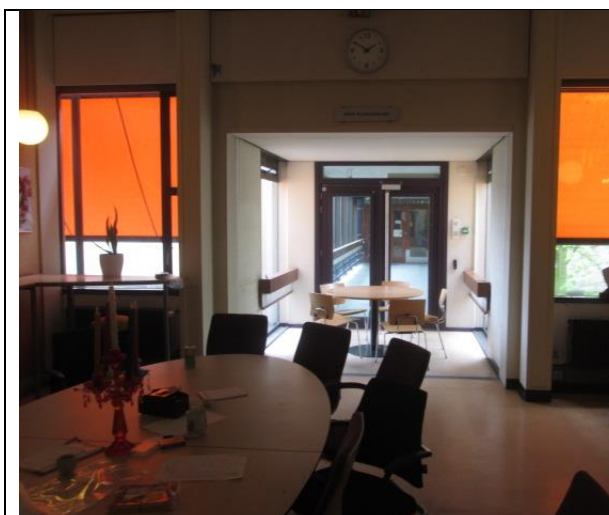
Connection bridge to ESRON bld

Het ESRON gebouw gaat binnenkort gerenoveerd/verbouwd worden. Tijdens deze periode is het risico van brand duidelijk verhoogd. Om het Ornstein Laboratorium te beschermen dient de verbindingsgang aan de zijde van het ESRON gebouw 60 minuten brandwerende afgescheiden te worden. Bovendien is het raadzaam ook in de toekomst de verbindingsgang tussen beide gebouwen aan beide zijden te voorzien van 60 minuten brandwerende scheidingen.

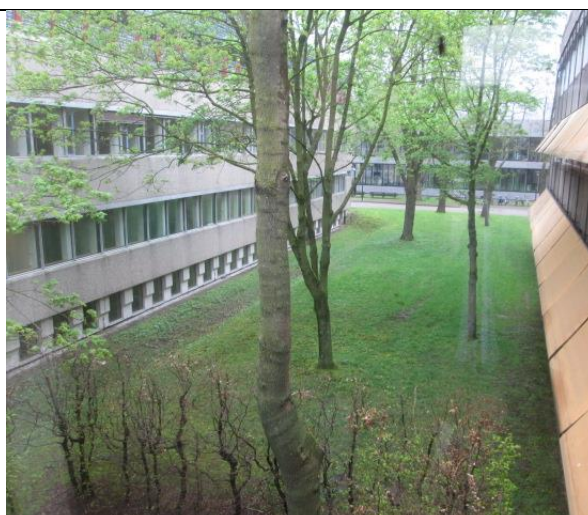
Esrn bld left, Ornstein right

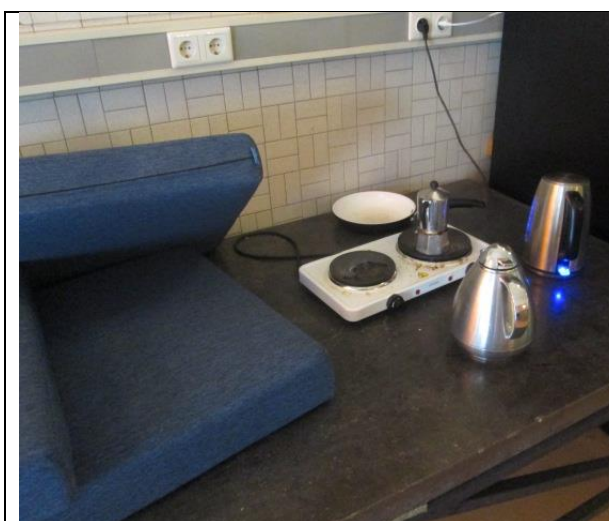
- Cooking device: in a meeting room is a cooking device (electrical heated) installed close to foam plastic cushions. This represents an unacceptable risk and the cooking device and/or cushions need to be removed (see rec and photo).

Cooking device next to combustible cushions

**Overall an acceptable risk but the cooking device has to be removed.**

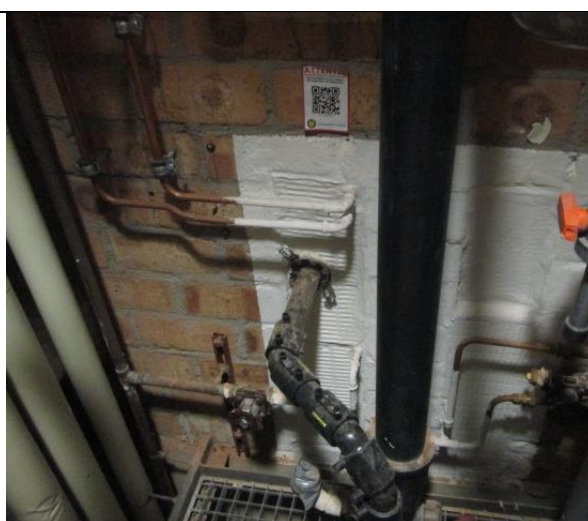
- The electrical installation. The electrical installation is checked in accordance with the local standards NEN 3140 including infrared scanning. The cable penetrations are properly sealed off by a specialized contractor.

Cable and pipe penetrations adequately sealed

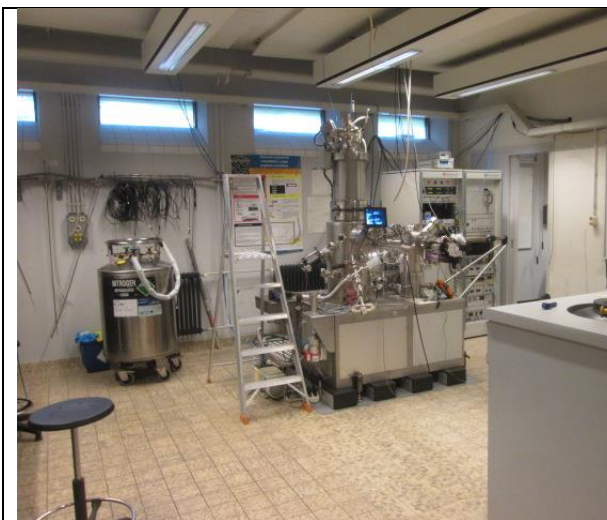
One of the laboratories in the basement

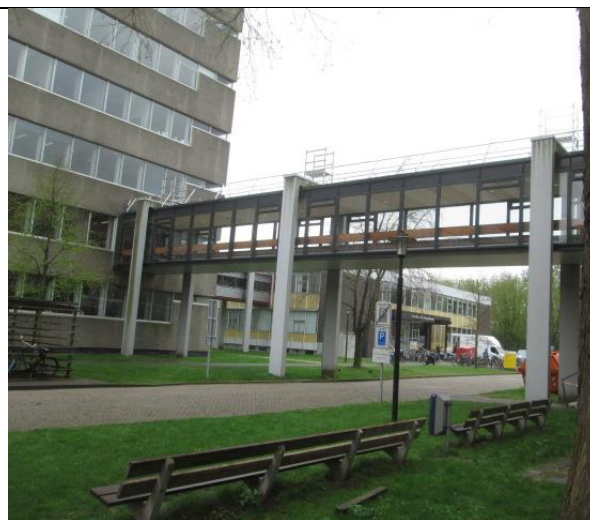
Connection bridge to Buys Ballot bld

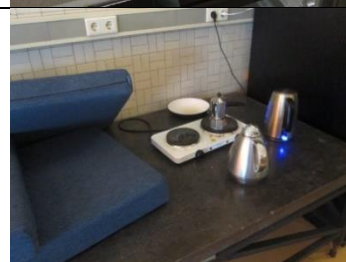
Kooktoestel. Op de eerste verdieping is een elektrisch kooktoestel aangetroffen naast kussens. De kussens van schuimkunststof kunnen ontstoken worden waardoor een zeer moeilijk te beheersen brand ontstaat. Het kooktoestel mag alleen in een keuken gebruikt worden vrij van brandbare materialen.

Aanbevolen wordt bovengenoemde punten direct op te lossen en vervolgens een zelfinspectieprocedure in te voeren of te intensiveren.
