# Chubb Risk Control Program

## AAA Property Risk Report

Prepared for  
UNIVERSITEIT UTRECHT  
Kruytgebouw  
Padualaan 8  
Utrecht,  
Netherlands

Inspection Date: 11 April 2024

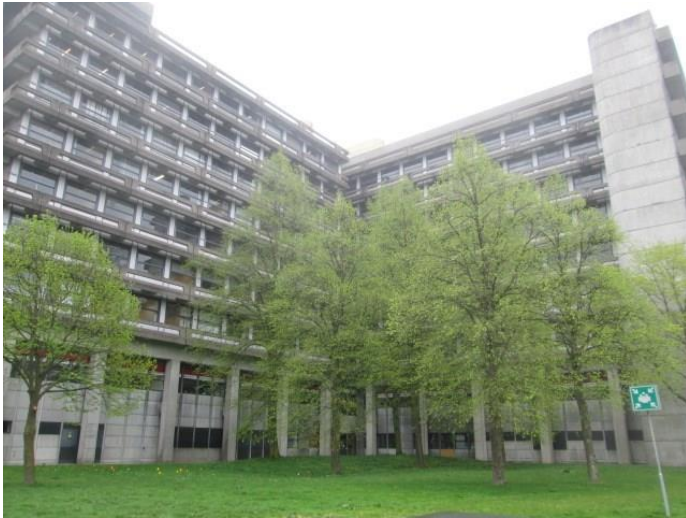
The exterior of the building

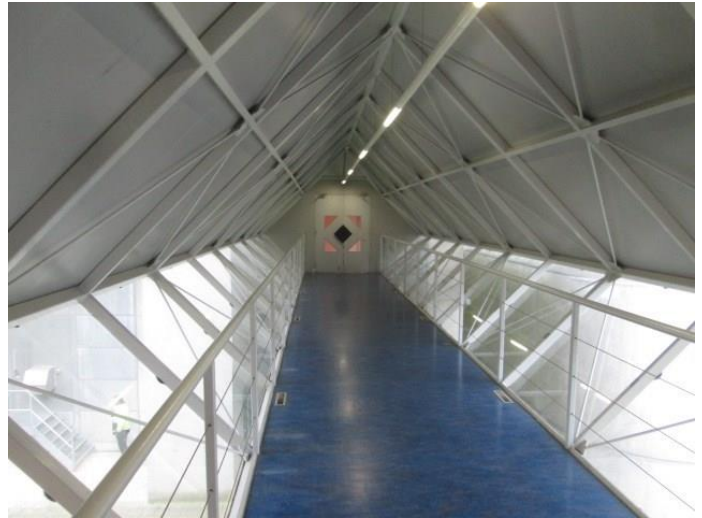
| Kruytgebouw is connected to the Groen building via an single layer non-combustible, 18 meter long, overhead corridor that is 60 minutes fire retardant separated at the side of the Groen building. Groen is separated to the Bloemenbergerbuilding via another 60 minutes partition. | |

Corridor to Bloembergen and Groen building

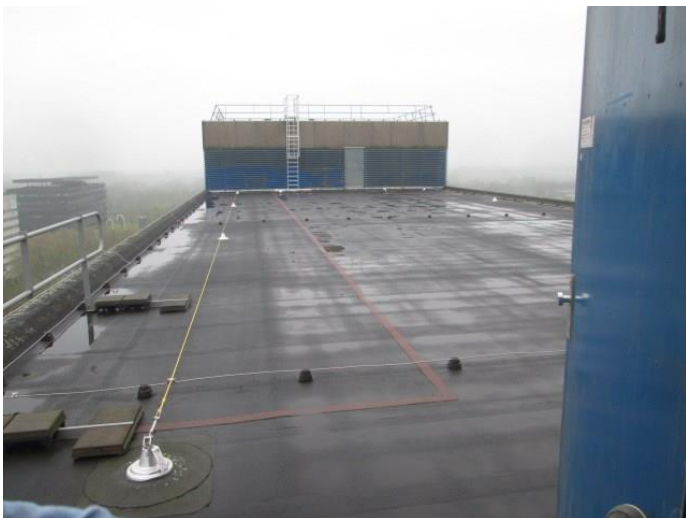
In 2013 there was a storm damage. A part was blown from the roof and landed lower on another part of the building. Details are not known. The building is going to be left at the end of 2026 to move to a new building. Here after the construction will be demolished. Although the maintenance might be reduced in the coming years, the total roof was provided with a new roof felt in 2014 that is visually still in perfect condition.

The roof of the building (in good condition)

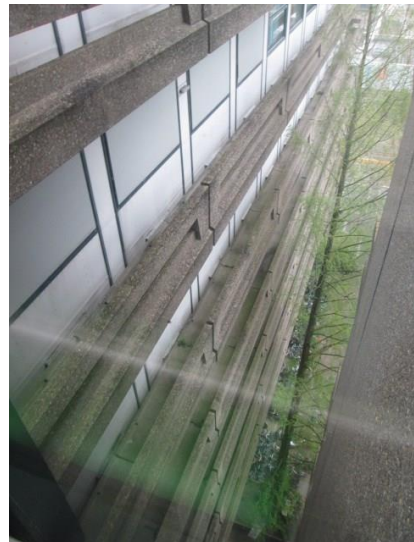
| Fire Construction Description: | The building has a heavy concrete construction with concrete floors and concrete roof. The facades consists of asbestos panels insulated with cork. The building contains a lot of asbestos (also for ventilation ducts). |
| Comments / Unusual Features: | <p>The RPF clarification (exterior walls are made of asbestos panels insulated with cork. This is comparable to EIFS (better fire rating, but higher contamination risk and therefore classified as EIFS). The all other RPF is given for the fact that the top floors are locked because of the present asbestos. At these floors ventilators are running constantly for the ventilation of fume hoods. As the area's are classified as restricted area's the systems are not being serviced anymore. Only in case of a fire alarm the fire brigade will enter the area's, but mechanics are not allowed now. This problem is escalated directly and indicated as unacceptable. It is expected that within a few weeks cleaning operations by a specialized contractor will start, asbestos will be cleaned and encapsulated and then servicing is possible again.</p> <p>Initially there were plans to close the building in 2008, then in 2010, 2017, 2021 and now the final plan is to close it in 2026. Alternative locations to house the laboratories are now being prepared. So 2026 seems to be realistic. On the other hand these figures indicate a lot about the state of maintenance the outdated building. Meanwhile the building became a monument. It is expected that a total refurbishment will start in 2027 (or later).</p> |

The facade wall containing asbestos panels

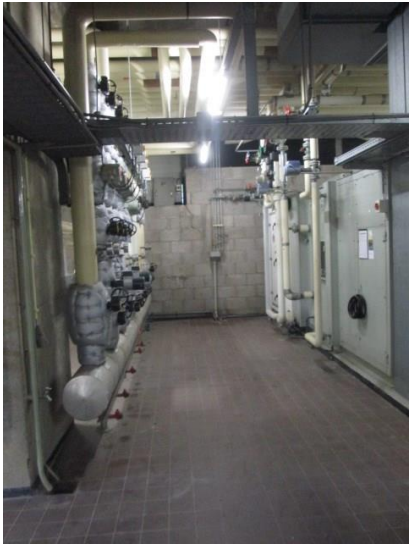
Utility room at ground floor level

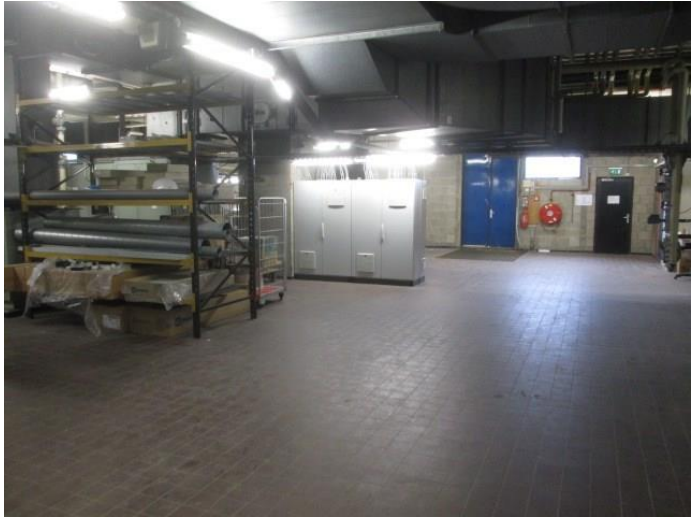
Utility room at ground floor level

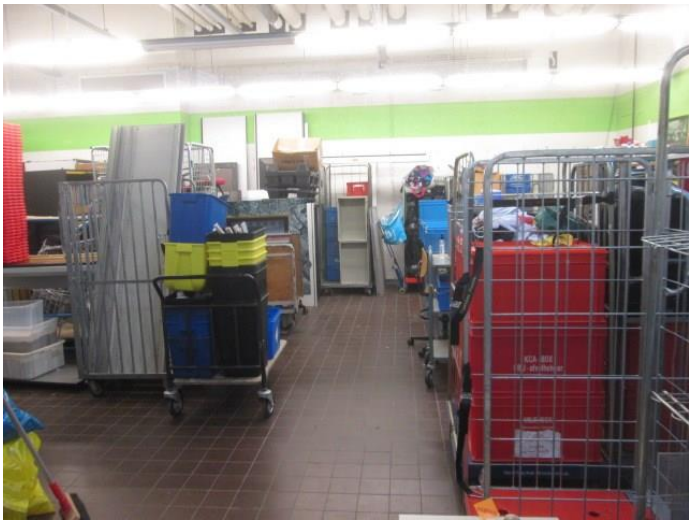
The housekeeping in the expedition area needs extra attention. The fire load in this part is too high and waste (like wood etc.) should be removed more often.

The self-inspection can be intensified, for example the expedition area. On the other hand self-inspections are being done in the vacant West wing.

Expedition area at grade floor level (see rec.)

Wij adviseren om veiligheidsrondes meer structuur te geven door deze regelmatig in te plannen en checklists te gebruiken, waarop per type gevaar, afdeling of proces/machine de mogelijke gevaren worden beoordeeld. Eventuele tekortkomingen kunnen dan eenvoudig hierop worden aangegeven, inclusief de te nemen actie, verantwoordelijke persoon, met een aparte indicatie van de status van uitvoering. Blijvende tekortkomingen dienen aan de directie te worden gerapporteerd.

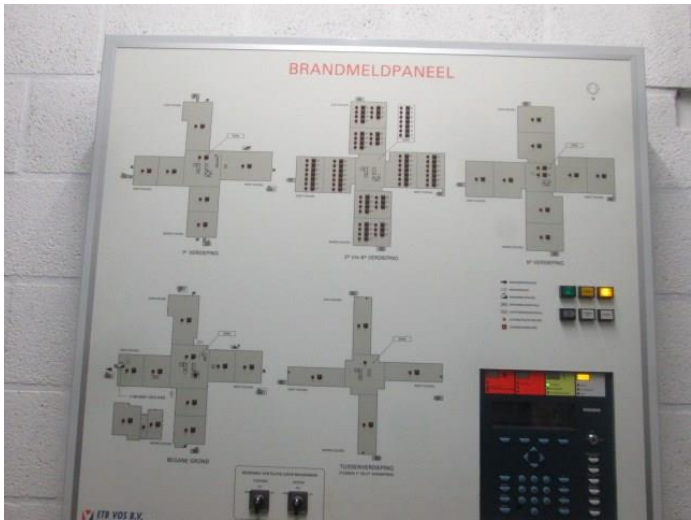
| The site is equipped with a selective detection limited to the laboratories and corridors in accordance with NEN 2535. The system is quite old but certified by a notified. body. The fire detection controls the magnetic door holders and releases the doors in case of an alarm. | | |

Fire detection panel
