## COPE Report

Androclus building Veterinary faculty

Yalelaan 1, Utrecht

date of visit 22/04/2024

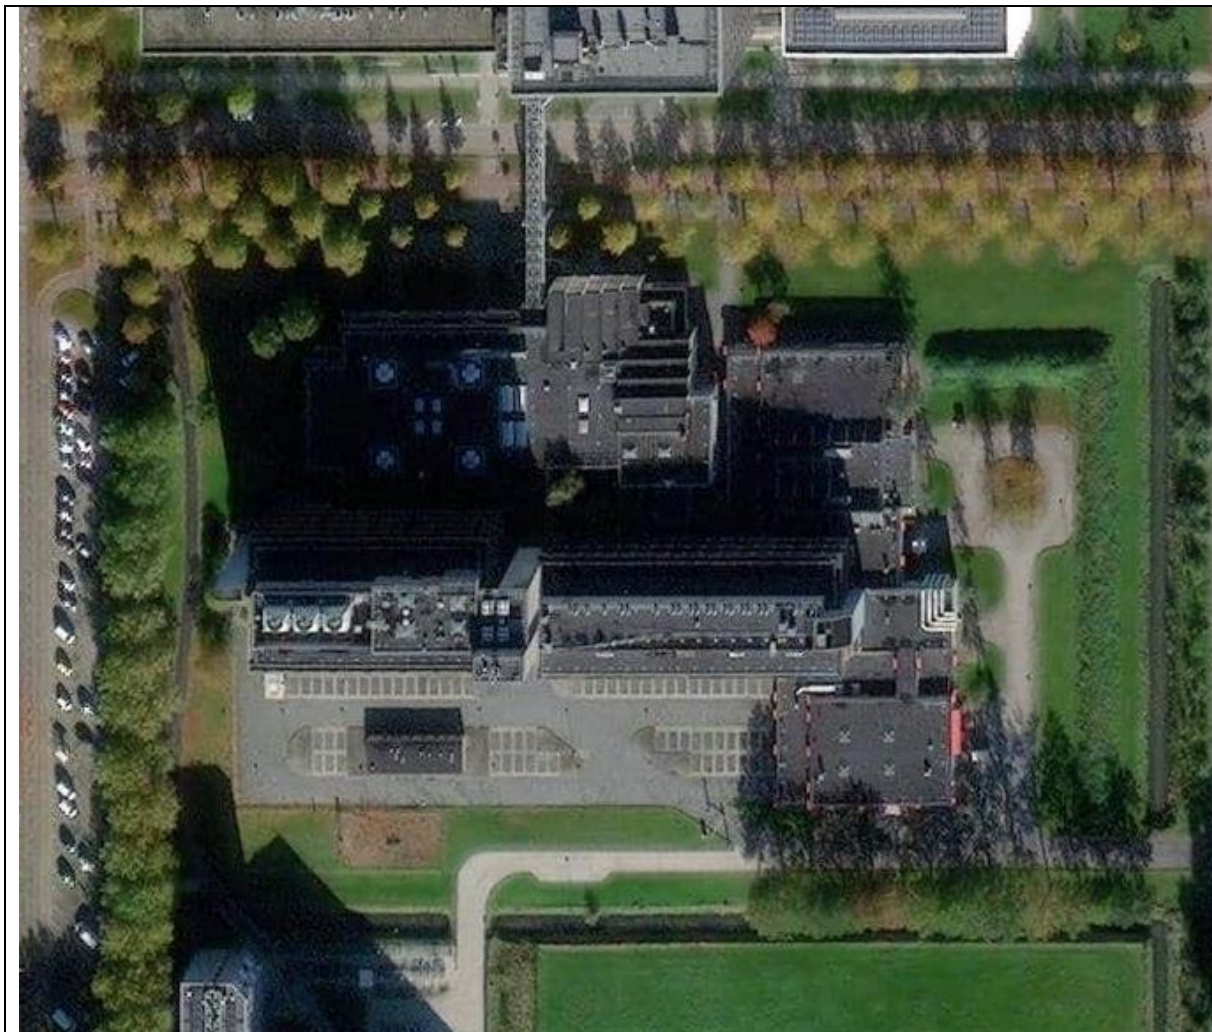
Overview of the buildings. In the middle: Androclus. At the top of the photo Nieuw Gildestein (interconnected by a single floor combustible overhead corridor).

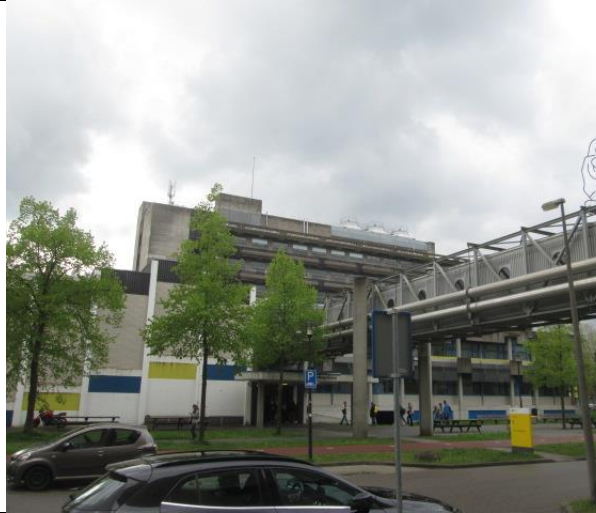
The bridge to Androclus building

Next door buildings: At the opposite side of the road is the Nieuw Gildestein building at 60 meters distance. There is a bridge (single floor) between these buildings, most probably with a combustible construction. The corridor is at both sides provided with a 30 minutes fire retardant partition. The cable penetrations of the Androclusbuilding need to be sealed off (see rec.).

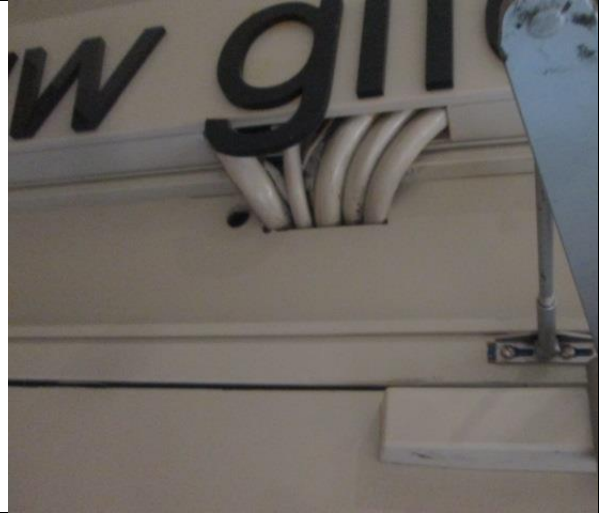
Cable penetrations to the bridge need to be sealed by a specialized contractor.

De verbindingsbrug naar Nieuw Gildestein is aan beide zijden voorzien van lichte brandwerende scheidingen. De kabeldoorvoeren boven de deuren zijn echter niet brandwerend afgedicht waardoor rook. Roet maar ook brand zich makkelijk kan verspreiden. Aanbevolen wordt de kabeldoorvoeren 30 minuten brandwerend af te laten dichten door een gespecialiseerd bedrijf.
