**COPE Report**      **Nieuw Gildestein/ GDL** (Gemeenschappelijk Dieren Laboratorium)  
**Adress:**            **Bolognelaan 50, Utrecht**  
**Report of**            Wout Jan Weide            date of visit 22/04/2024  
**Participants:**        Mr Benno Vedderts (Facility Manager UU)  
                              Mr Ruud van Zanten (Fire protection engineer UU)  
                              Mrs Marian Verhagen (Facility Management Diergeneeskunde UU)  
                              Mrs Astrid Drenth (Aon Risk Consulting)  
                              Mr Mahran Altawil (Chubb)  
                              Mr Wout Jan Weide (Chubb Risk Engineer, writer of this report)

**Introduction:**

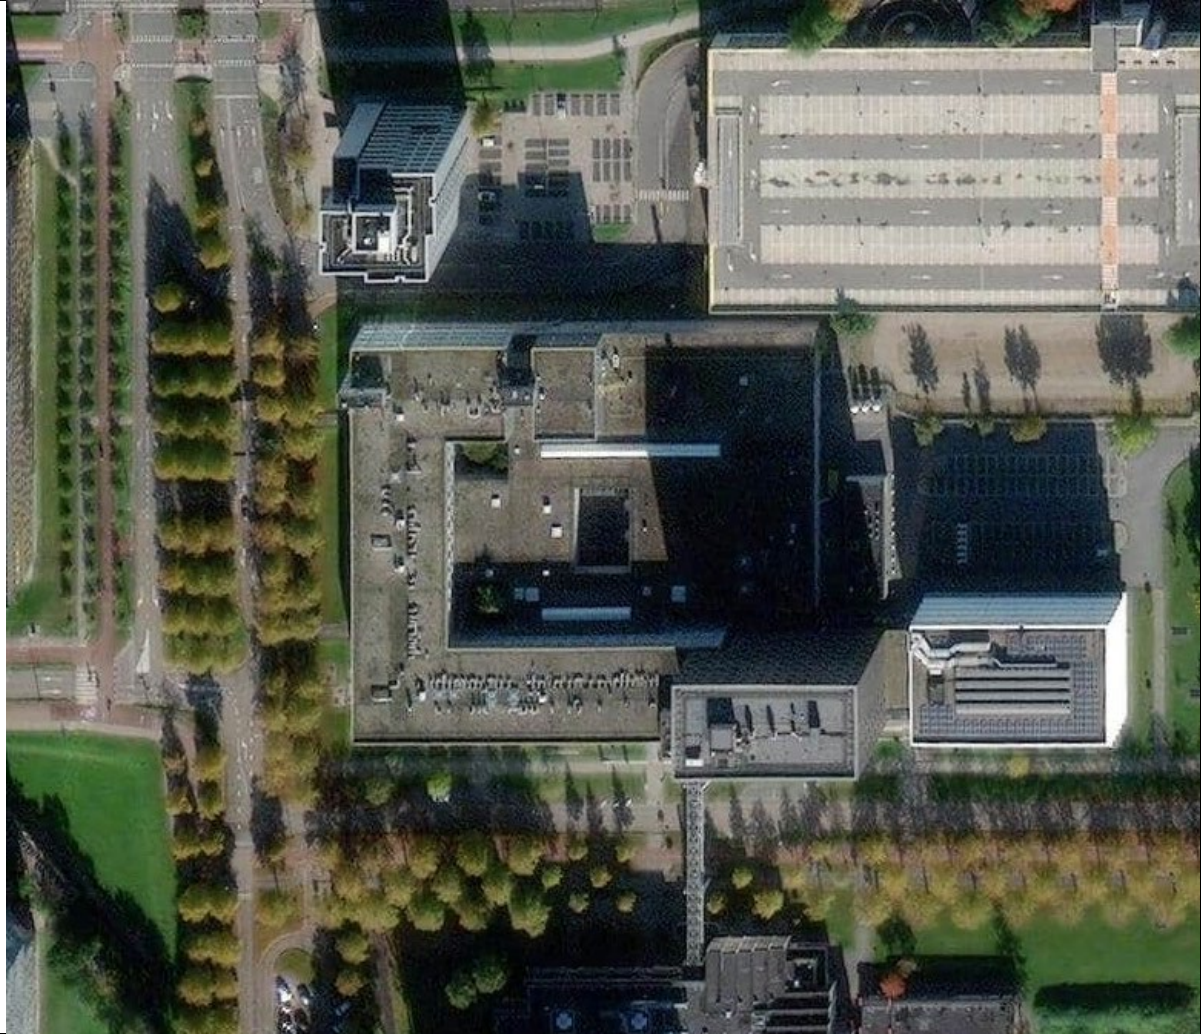
Overview of the buildings. In the middle: Nieuw Gildestein / GDL, right top a parking garage of the academic hospital at 6 meters distance, the high rise attached to Nieuw Gildestein is the Alexander Numanbuilding and right LSI. At the bottom, connected by the bridge is the Androclus building.

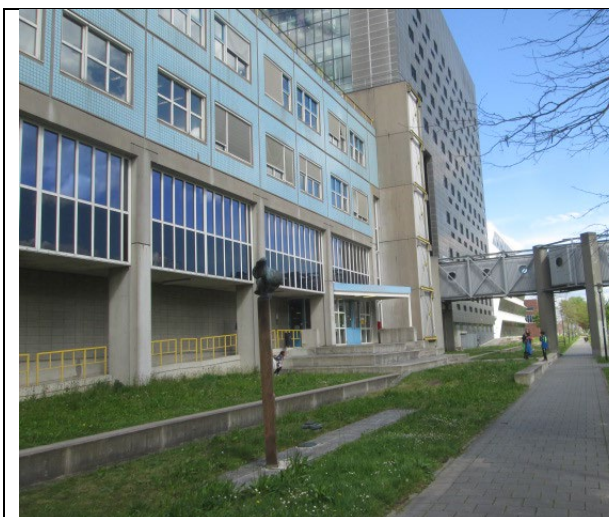
Left Nieuw Gildestein and at the rear Alexander Numan and LSI buildings including the bridge to Androclus)

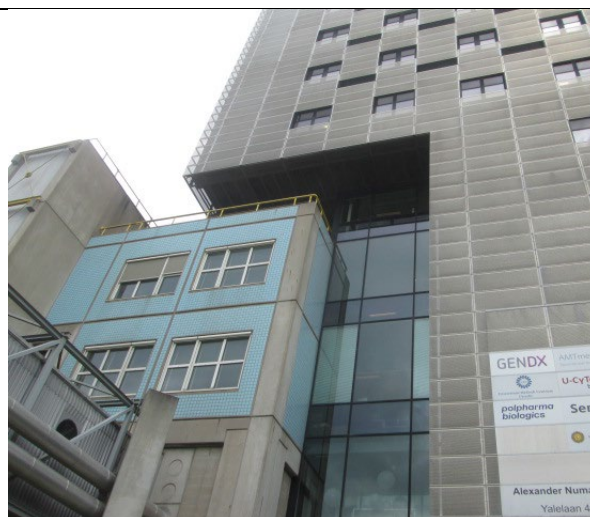
Alexander Numan building is partly constructed over Nieuw Gildestein

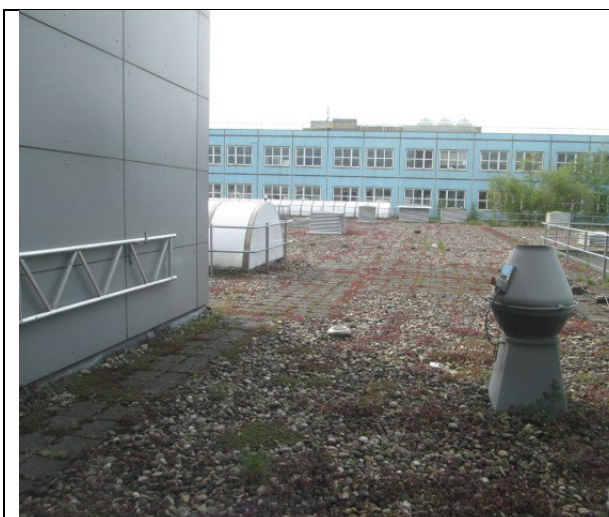
Water damage: The coffee machines are connected to the tap water system without a water lock (see rec.). The roof is in fair conditions and should normally be replaced / provided with a new roof felt. As there are plans to leave the building in about 6 years no large investments are being done anymore. Repairs are done where necessary. At present the roof has no leakages but the risk for a water damage is increased.

The older roof

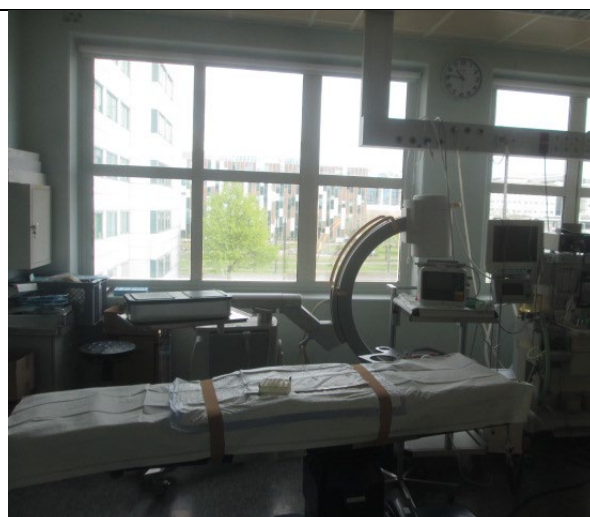
One of the surgery suites including C-bow (X-ray)

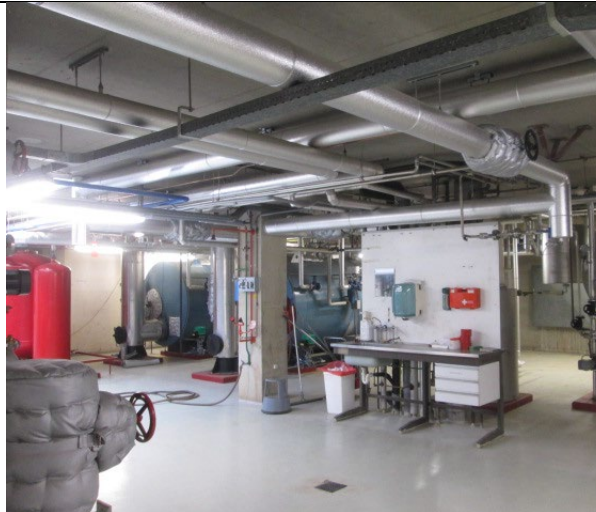
Utility rooms are free of storage

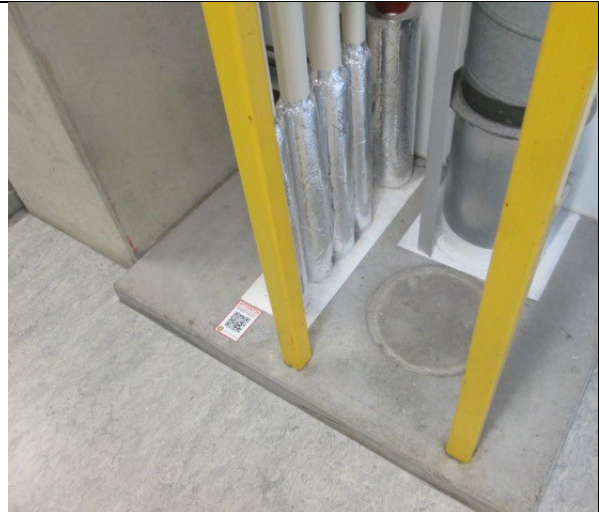
Pipe and cable penetrations through the floor adequate sealed and located at an elevated floor (good for water damage controls)

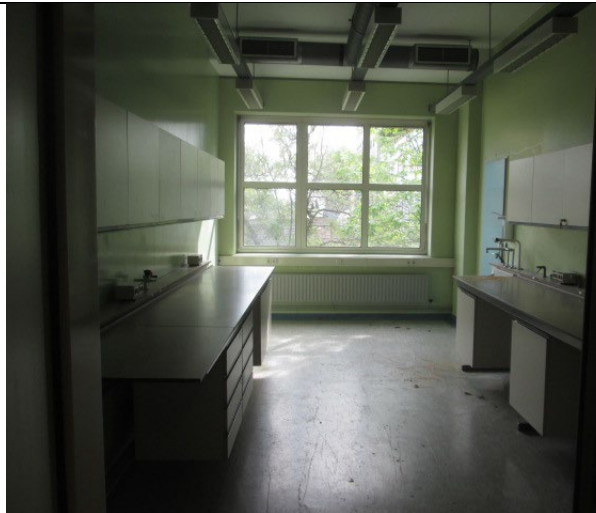
One of the vacant rooms

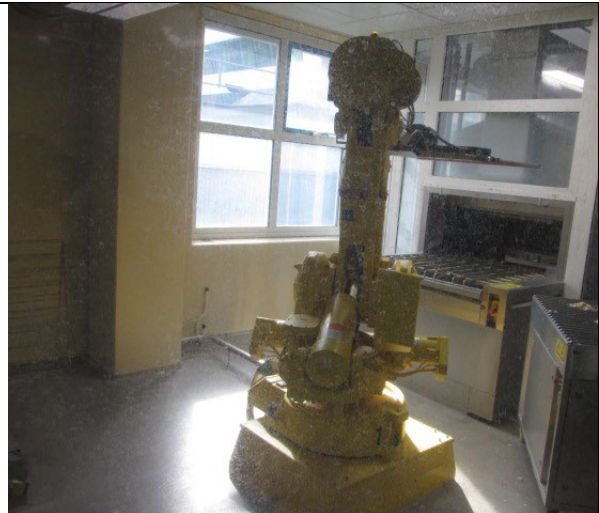
Cage washing robot

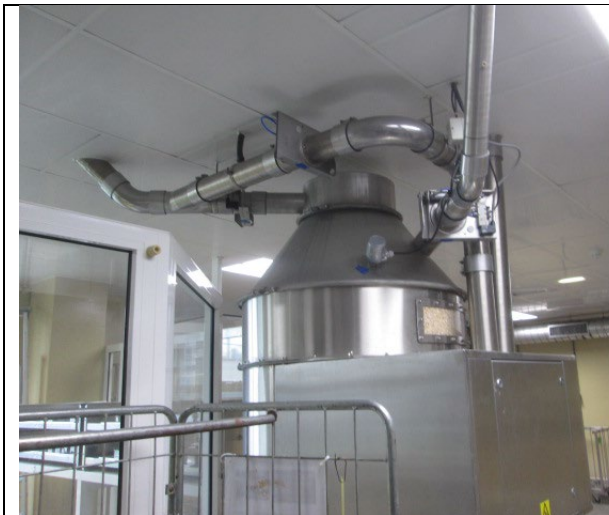
Wood chip system. Free of dust and therefore not classified as explosion hazard

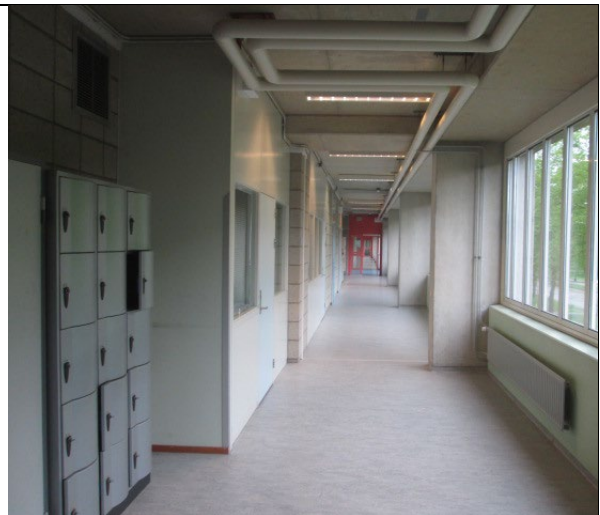
One of the corridors (nearly free of combustibles)
