# NL Utrecht Androclusbuilding Risk Summary Report 2021 Aon

**Location:** Yalelaan 1  
UTRECHT  
.  
Netherlands  
**Location code:** UU 1322  
**Created by:** Peter Uri

**Survey date:** 2021-06-15  
**Report date:** 2021-07-20

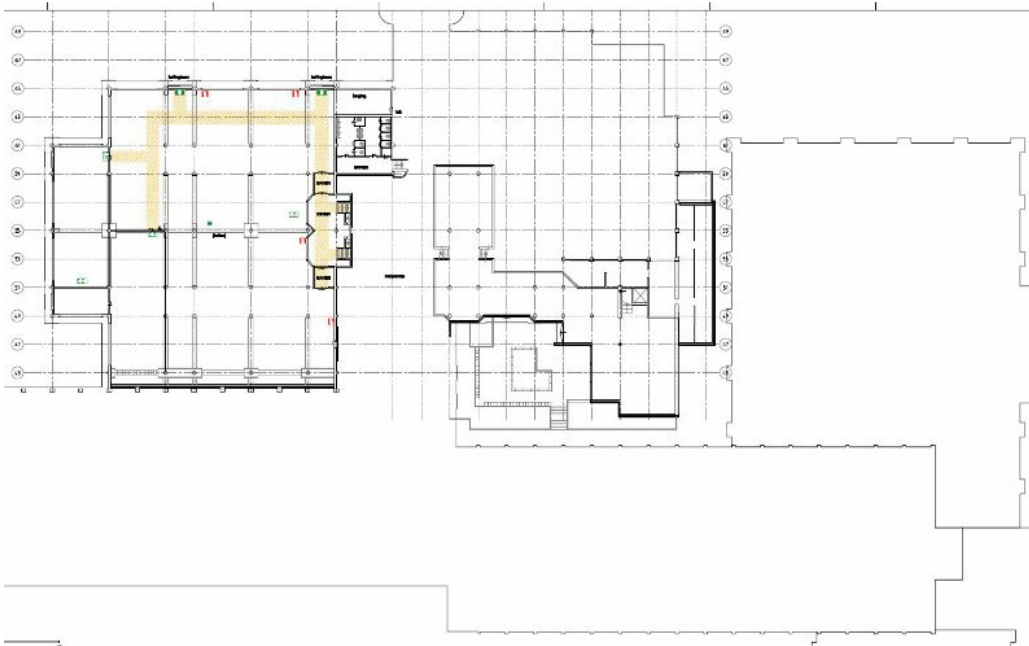
Basement

**Red lines** are 60-minute fire resistant walls/doors

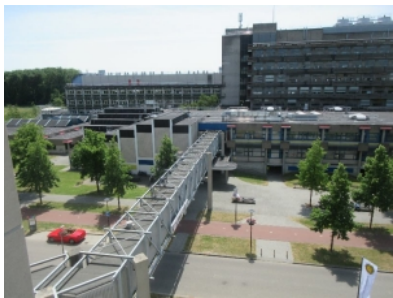
| The Androclus building. In front the overhead corridor to the building Nieuw Gildestein | The rear of the high rise part | Separate storage hazardous materials (Distance approx 25 meter) |

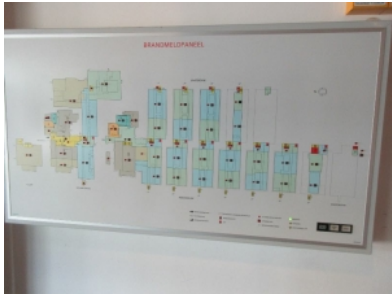
| Small exhibition hall with learning spaces | Fire alarm panel | An example of a laboratory |

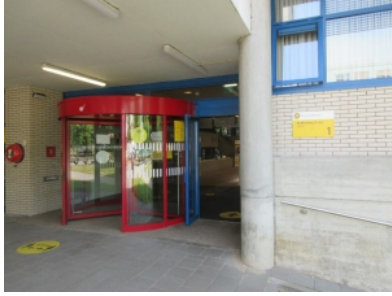
| 6-02 | <b>Extinguishing water</b><br>The public water supply consist of underground hydrants fed by the municipal water supply. There are also some ditches nearby that could also be used for firefighting. Sufficient water supply can be expected. In the stairs are dry raisers installed. | Peter Uri |

| Dry riser | Main entrance | Main entrance |

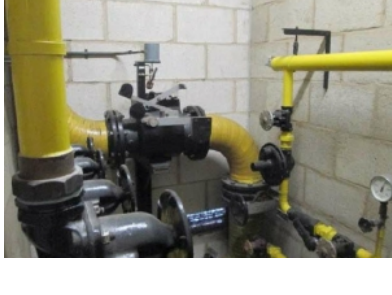
| 3-01 | <b>Practice rooms: gasses</b><br>Most of the laboratory rooms have natural gas supply for research purposes. The gas supply distribution room is provided with gas detection in combination with an automatic closing mechanism of the gas supply. There is no gas detection in the laboratories, however this is controlled by means of good procedures and instructions. | Peter Uri |

| The technical room in the basement | Gas supply | Gas detection at the gas supply closing the supply if necessary |

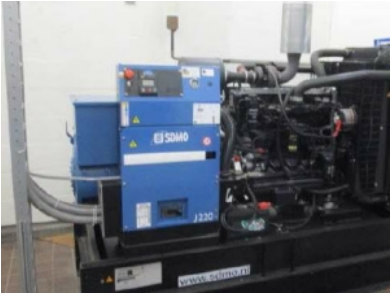
| Emergency Diesel Generator | Water treatment in the top floor | Cooling towers on top of the roof |
