## 1. Introduction

The survey (22-06-2021) has been accompanied by the following person from the UU organization:  
Marco Thien - Facility.

General information about David de Wiedgebouw location:

The so-called "David de Wiedgebouw" houses research laboratories for the Faculty of Science, Department of Pharmaceutical Sciences, Department of Chemistry of the University of Utrecht. The David de Wied building is the high-end facility where UU research parties come together: the Electron Microscopy Center (EM) as a facility for the faculties of Science, Geosciences, Veterinary Medicine and the UMCU.

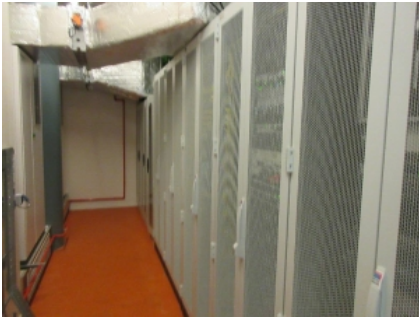
The synthesis laboratory and the server room on the 4th floor are both equipped with an extinguishing gas system.

| Server room with aspiration detection and gas extinguishing system | Glass roof | Glass roof and at the right a technical room |

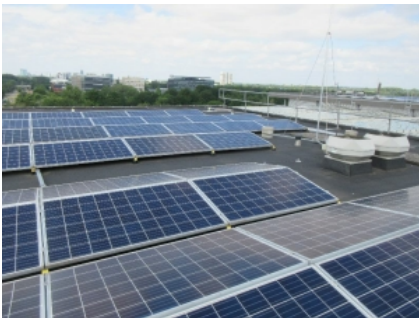
| 4-06 | <b>Solar panels</b><br>The building has a PV installations. Recently a Scope 12 inspection has been conducted. During the survey the report was not available. | Peter Uri |

| PV installation | Cabinet for flammable liquids | Sprinkler pumps |

On the roof of the David de Wied building, a PV installation is available. Reportedly this installation has had a recent inspection. The Dutch Scope 12 report was not available during the survey. Also, further specs about this installation are not known. Therefore, it is advised to share the Dutch Scope 12 report. If possible deficiencies emerge from the inspection, we recommend that they be resolved as soon as possible but no later than 4 months after the inspection.

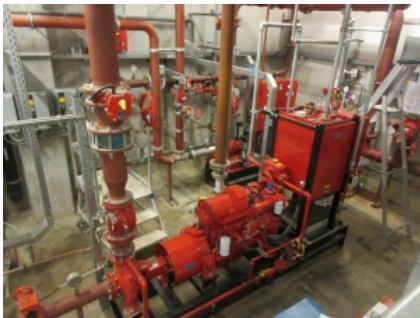
There is an automatic sprinkler system. The automatic sprinkler is not certified anymore due to the extension project. And because of the Covid pandemic the re-inspection of the sprinkler system is delayed. There are two independent pumps (diesel and electric). There are plans to provide their own water tank. The system was normally certified and audited adequately before the pandemic. The automatic sprinkler minimum design is 5 litres/min/m<sup>2</sup> over 260 m<sup>2</sup>, Class NIII.

The automatic sprinkler system is inspected and maintained according to the standard. Reportedly, during the last inspection, it was not possible to inspect the full installation due to an extension project (Cryo-elektron Microscopie). The project is now ready. Therefore, we recommend that the sprinkler installation be inspected again in the short term in order to obtain a certificate.

If there are deviations, it is highly recommended to resolve these points of attention for the effective functioning of the sprinkler system.
