# NL Utrecht Landbouwhuisdieren - Bruingebouw Risk Summary Report 2021 Aon

| <b>Location:</b> | Yalelaan 5-7-9<br>UTRECHT<br>Netherlands |
| <b>Survey date:</b> | 2021-06-15 |
| <b>Report date:</b> | 2021-07-15 |

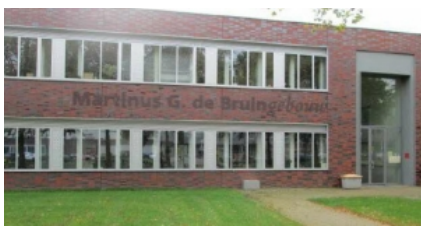
| Front of the building | Indoor parking for UU cars | UU cars |

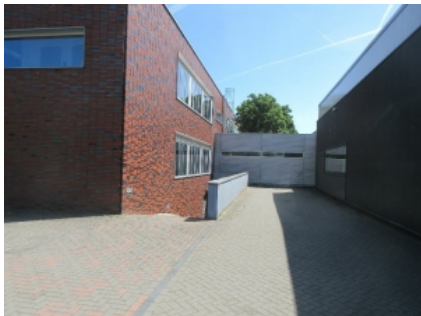
| Side of the front building with entrance to basement | Basement bicycle parking | Office area |

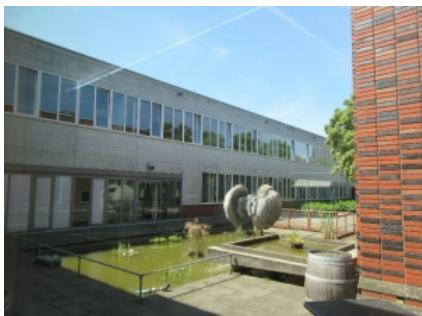
| Evacuation plan | Inner court of the front part | Emergency generator |

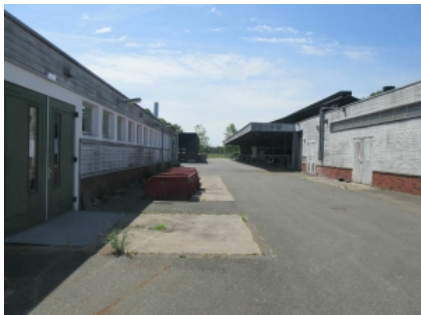
| Inner court at the rear of the building | Some open stables at the rear | Rear of the building |
