# NL Utrecht Nieuw Gildesteengebouw Risk Summary Report 2021 Aon

| <b>Location:</b> | Bolognalaan 50<br>UTRECHT |
| <b>Survey date:</b> | 2021-06-15 |
| <b>Report date:</b> | 2021-07-19 |

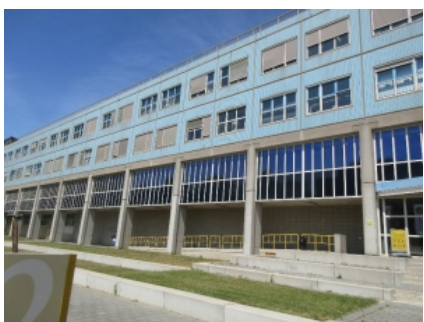
| Nieuw Gildenstein building | Nieuw Gildenstein building | Main entrance |

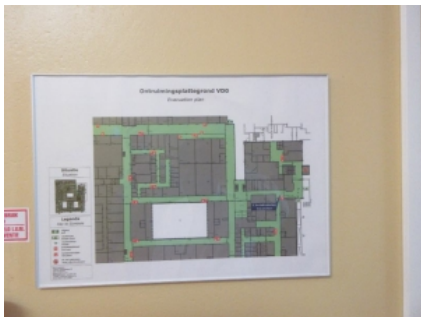
| Reception | Corridor | Evacuation plan |

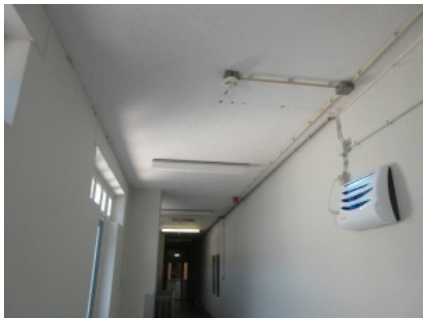
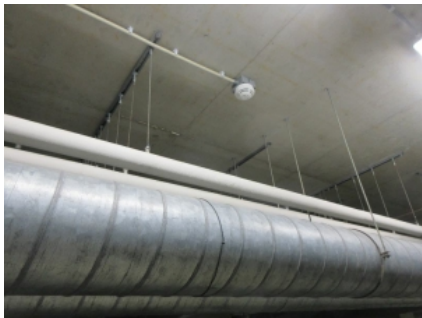
| 6-05 | <b>Automatic fire detection</b><br>The automatic fire detection system was extended in 2017—almost all floors (including technical equipment areas) are fully covered. However, reportedly, on the ground floor, detection is available but not at the stables, as the insured wants to prevent noise over there to keep the animals in a quiet environment. | Peter Uri |

| Fire detection | Fire detection | Technical area |

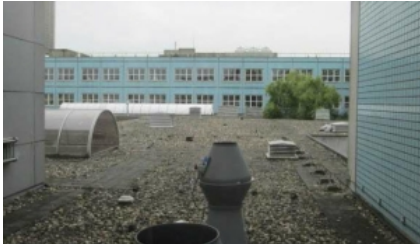
The building has a heavy concrete load bearing construction with concrete floors and concrete walls. The roof consist of concrete slabs covered with a roof felt and on top a foam plastic insulation and gravel.

| Corridor | Corridor | The roof of the lower part and at the rear the South side of the building |

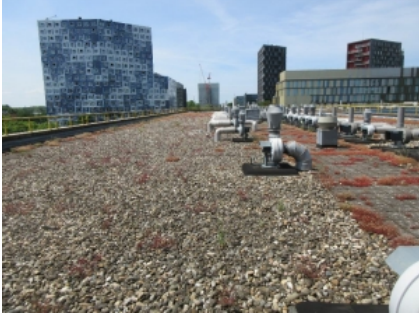
| All exhaust pipes for hoods of the higher roof | | |
