The information in this report is based on a site visit and information provided by University Utrecht (hereafter: UU). A good impression could be gained from the housekeeping, risk awareness, fire protection installations, and fire compartmentation based on the visit. During the visit, the emphasis was on a random review of technical areas, fire-resistant separations, catering and areas for practicums. The survey has been supplemented with information insofar as it is provided by UU. The EML and MPL scenarios at the end of this report are based on these gathered impressions. The survey is held during the COVID epidemic. As a result, the occupancy of the buildings was less than normal.

Willem C. Schimmelgebouw (Yalelaan 112-114). In this building:

Dr. H. Jacobgebouw (Yalelaan 108-110). In this building:

Jeannette Donker-Voet gebouw (Yalelaan 104-106 / Munsterlaan 1). In this building:

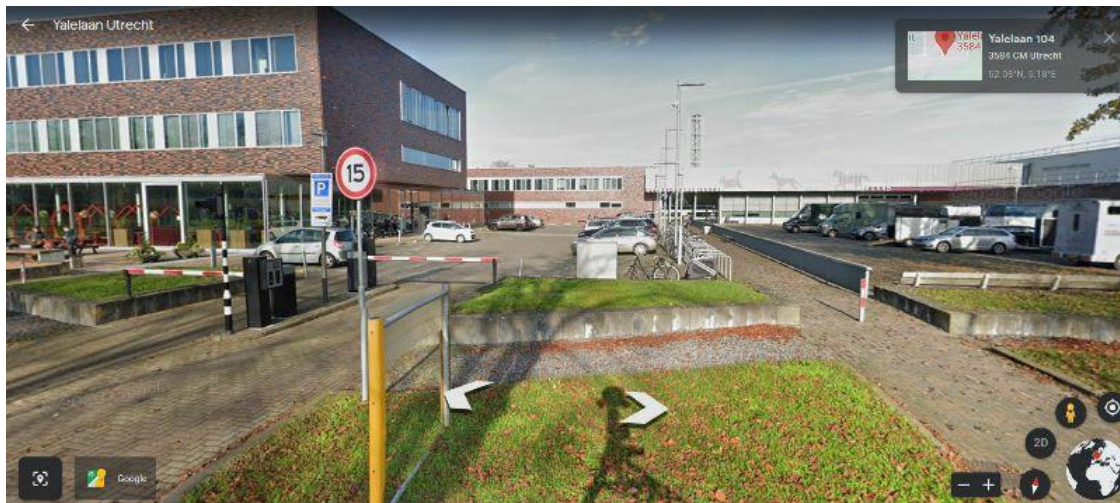
At the left the 'Jeanette Donker Voet' building, in the middle 'Dr. H. Jacob' building and on the right the 'Willem C. Schimmel' building.

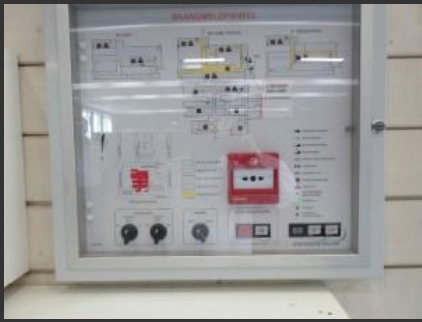
| Horse practise hall | | One of the fire alarm panels |

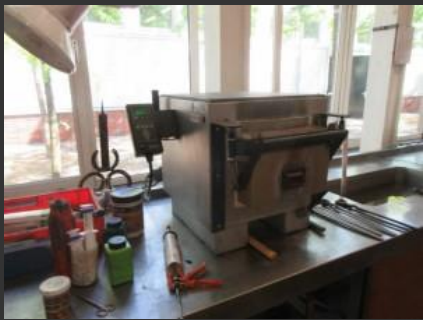
| Small oven for forge | Stables area | The surgery department at the Dr H. Jacobgebouw |
