# NL Utrecht Universiteitsbibliotheek Risk Summary Report 2021 Aon

| <b>Location:</b> | Heidelberglaan 3<br>UTRECHT<br>Netherlands |
| <b>Survey date:</b> | 2021-06-09 |
| <b>Report date:</b> | 2021-07-14 |

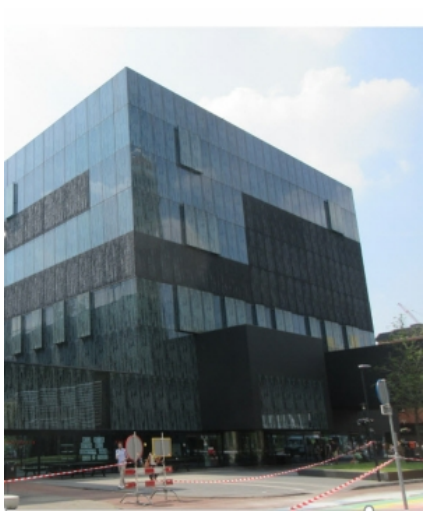
| Front side | West side façade | Stairs to reception - main entrance |

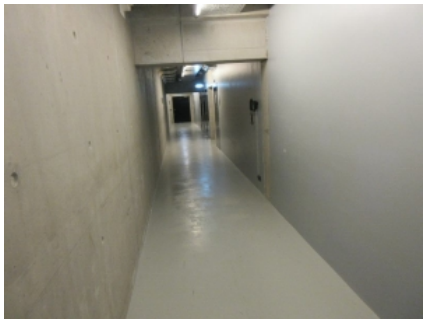
| Concrete hallways | One of the vaults for the storage of (very) old and high value books | The corridor between Van Unnikbuilding and Library |

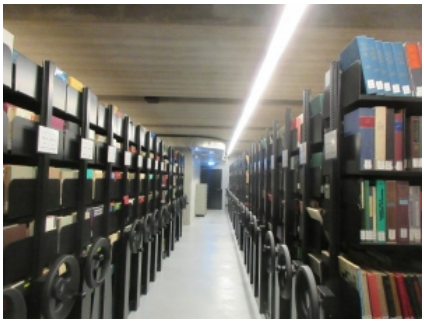
| 6-07 | <b>Specific object fire protection</b><br>In the storage rooms for unique (ancient) books a clean agent total flooding fire suppression systems are installed. These are in general the books that were made before 1900. The rooms are provided with over pressure relieve venting. The system is checked twice per year by a contractor and also by a notified body. | Peter Uri |

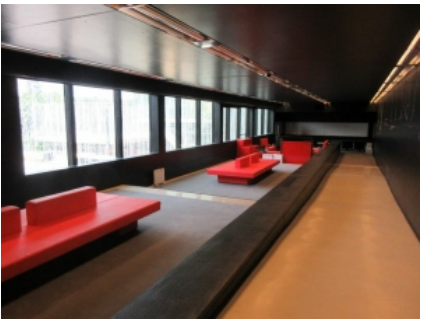
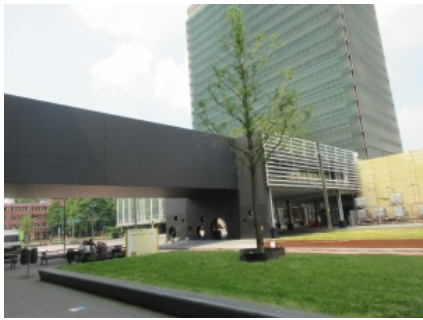
| 1-05 | <b>Adjacent buildings / exposures</b><br><u>North:</u> there is the Van Unnikbuilding that is interconnected by a single story overhead bridge. The bridge is not sprinkler protected but is provided at both sides with 60 minutes fire retardant sliding doors. The van Unnikbuilding is located at more than 50 meters distance and we classify these two buildings as different fire area's.<br><u>East:</u> There is a parking garage at about 10 meters distance, however the cars are parked at more than 20 meters distance. The parking has an open structure. and is not sprinkler protected. However due to the opening between the buildings it is expected under normal circumstances that heat and smoke will be adequately vented but can still result into damage to the insured building. The parking is not sprinkler protected. The risk is somewhat increased.<br><u>West</u> of the insured property is another building of the university located at 12 meters distance. The next door building has three floors. This belongs officially to the same fire area but does not represent an increased risk.<br><u>South:</u> At a remote distance a dormitory for students at more than 80 meters distance. | Peter Uri |

| The corridor between Van Unnik building and Library | PV-installation | Extinguishing gas cylinders |

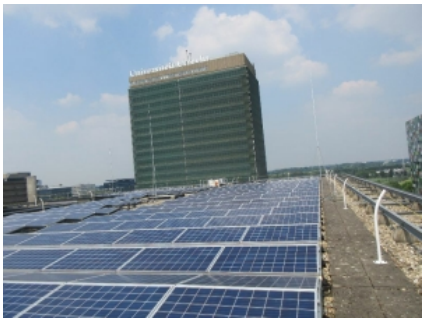
| 4-06 | <b>Solar panels</b><br>The building has a PV installations. Recently a Scope 12 inspection has been conducted. During the survey the report was not available. | Peter Uri |

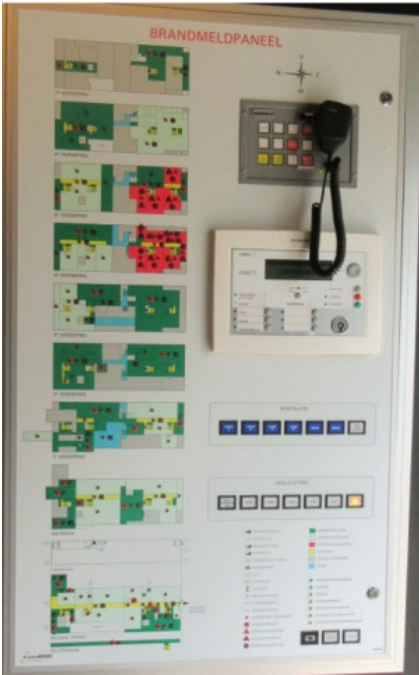
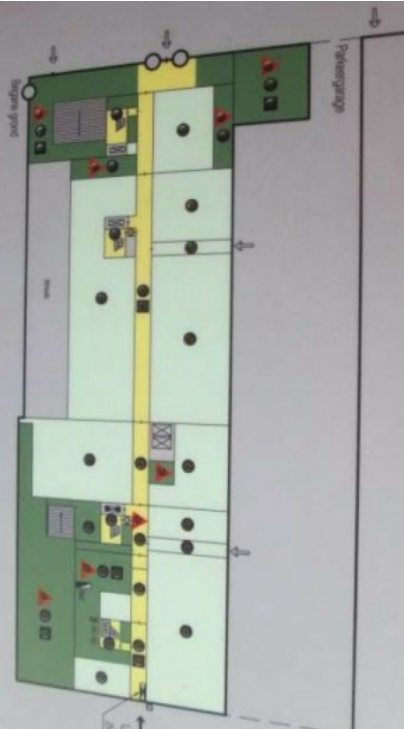
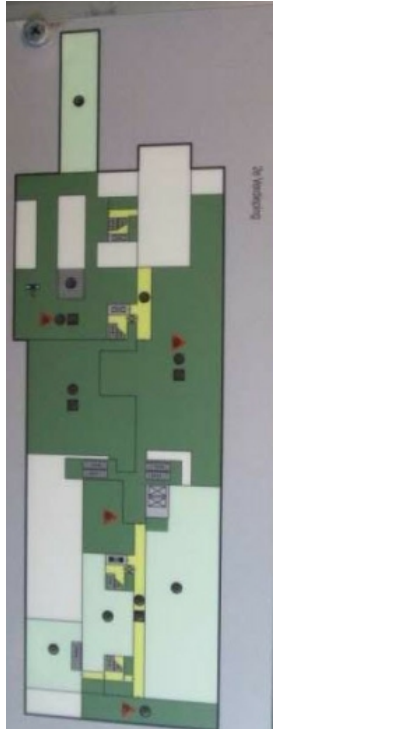
| <p>Plans of several floors of building Red = clean agent total flooded storage rooms, dark green = sprinkler protected areas, light green is only fire detection and white is atrium.</p> | <p>Ground floor</p> | <p>Second floor area with connection to van Unnikbuilding</p> |

Chubb: Parts of the building lack sprinkler protection. Uncontrolled fires in non sprinkler protected areas can spread rapidly, and in some cases, to the sprinkler protected areas at which point the installation may not be able to cope with such a large fire. We recommend that the sprinkler installation be extended to currently unprotected areas in full accordance to codes and standards.

The total fire prevention concept is based on the minimum required safety for life safety. About 60 % of the site is in open connection with each other. As a requirement of the Authority Having Jurisdiction (AHJ) this large part is provided with sprinkler protection. The sprinkler is designed to control the fire to prevent further fire spread (so that the fire brigade can extinguish the fire). During this period smoke and soot will spread through the building resulting into a large financial damage and a long lasting business interruption. To prevent smoke and soot spread it is recommended to install additional fire or at least smoke retardant compartmentalization.

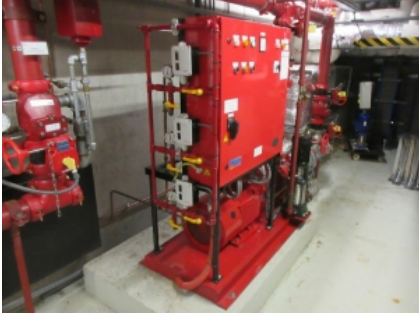
| <p>Sprinkler pump</p> | <p>Library (view from Van Unnikbuilding)</p> | <p>3 commercial shops at Ground floor level</p> |

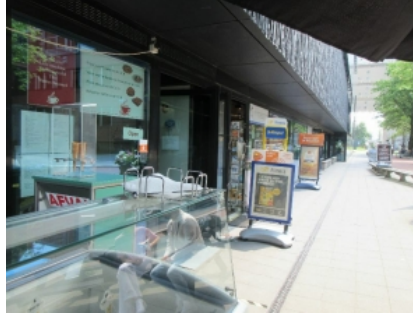
It was identified that there is no 'connected' automatic fire alarm (smoke detection) system in the small commercial shops at ground level. The shops are in a separate 60-minute fire resistant compartment. Nevertheless, it is recommended to extend the automatic fire alarm to all areas according to the Dutch NEN 2535. And connect it to an addressable alarm receiving panel (UU) located in 24 hr manned location. An addressable system will allow the security guards to identify the location of a (starting) fire quickly.
