# Borescope Inspection Report

July 3, 2024

**Unit 52**

**ESN 192-229**

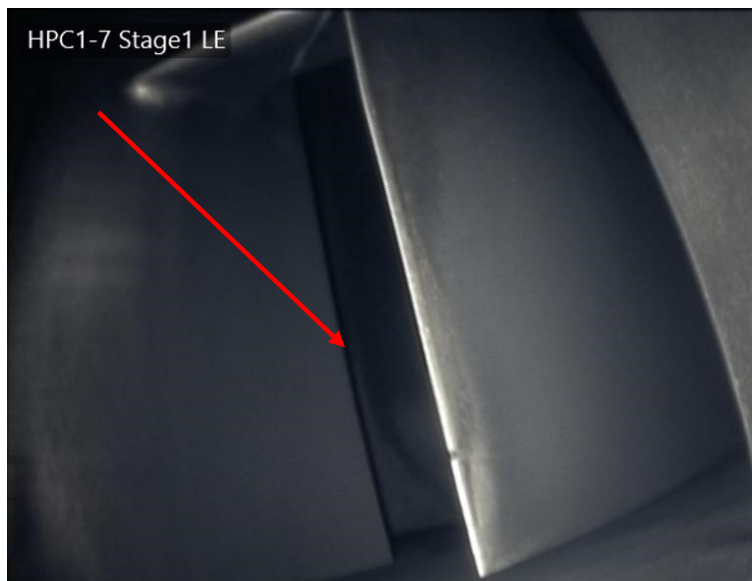
hpc1-7\_stage1\_le001.jpg

2 nicks found at stage 1 LE.

| Defect | NICK |

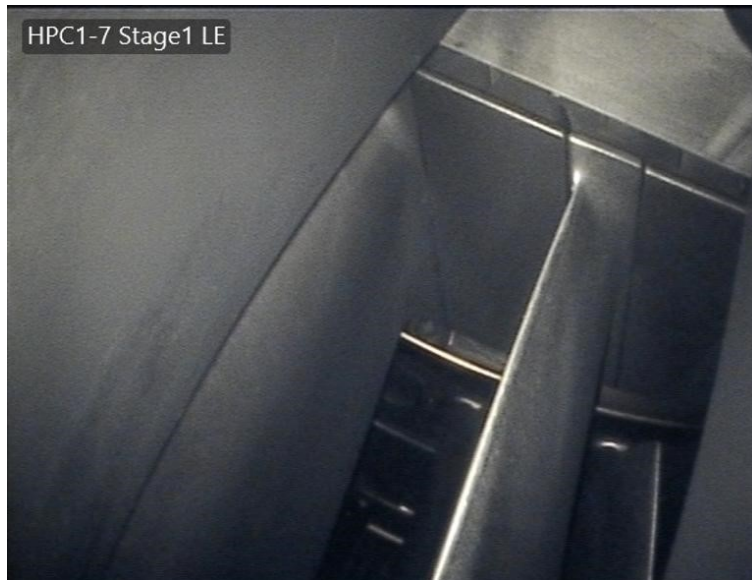
hpc1-7\_stage1\_le005.jpg

| Defect | NICK |

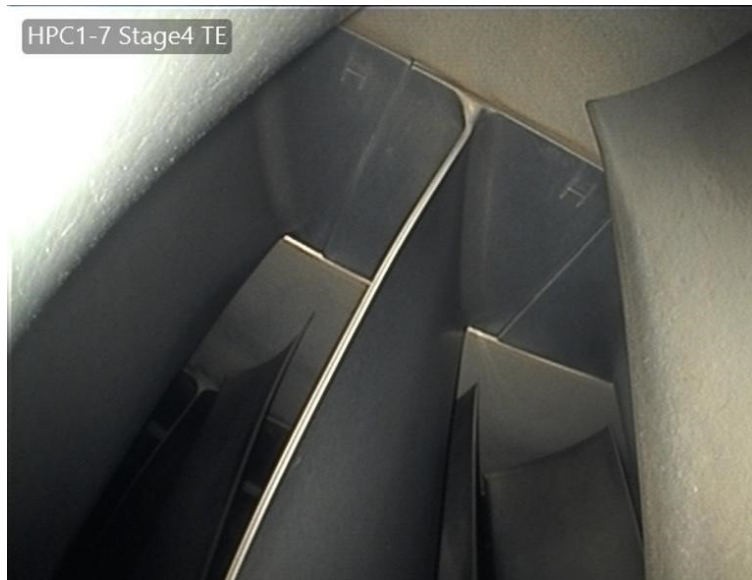
hpc1-7\_stage4\_te002.jpg

| Defect | BURN |

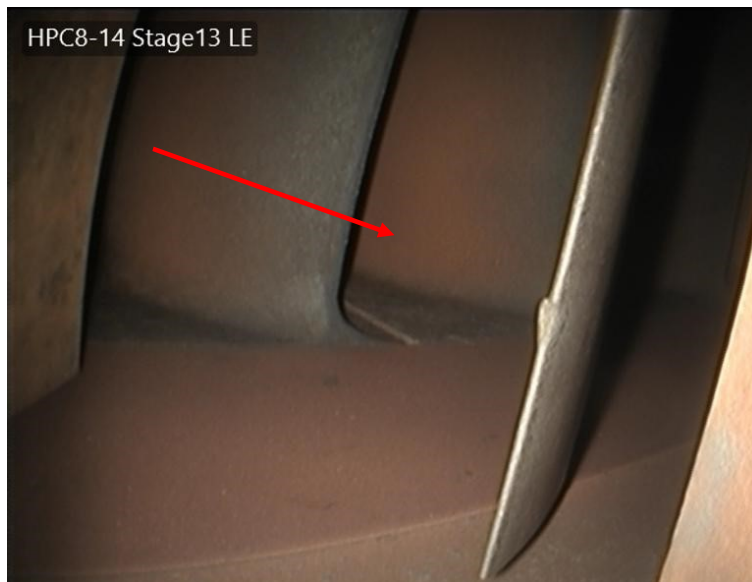
hpc8-14\_stage13\_le002.jpg

2 nicks found at stage 13 LE (1 nick was also found at last BSI).

| Defect | NICK |

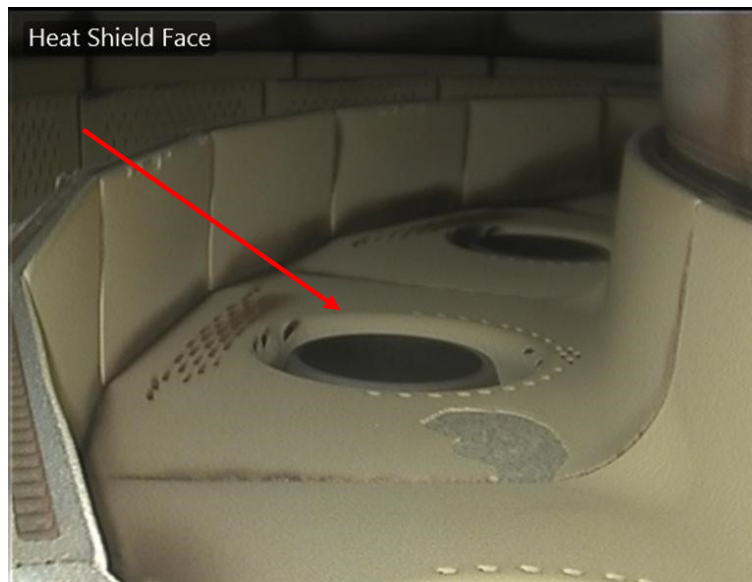
heat\_shield\_face001.jpg

Some TBC missing at Heatshield Wings and Heatshield Face.

| Defect | TBC LOSS |
| <b>Comments:</b><br><b>TBC missing.</b> | |

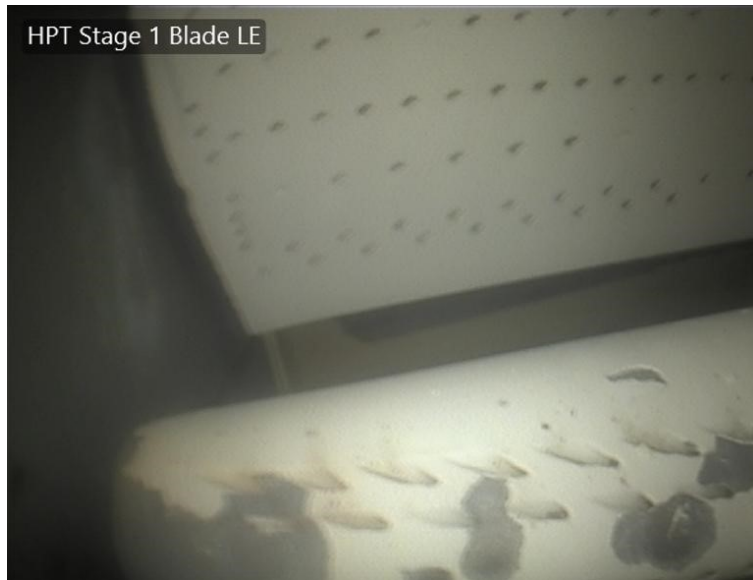
hpt\_stage\_1\_blade\_le008.jpg

TBC missing found at LE HPT stage 1 Blades.

| Defect | TBC LOSS |
| <b>Comments:</b><br><br><b>TBS missing.</b> | |

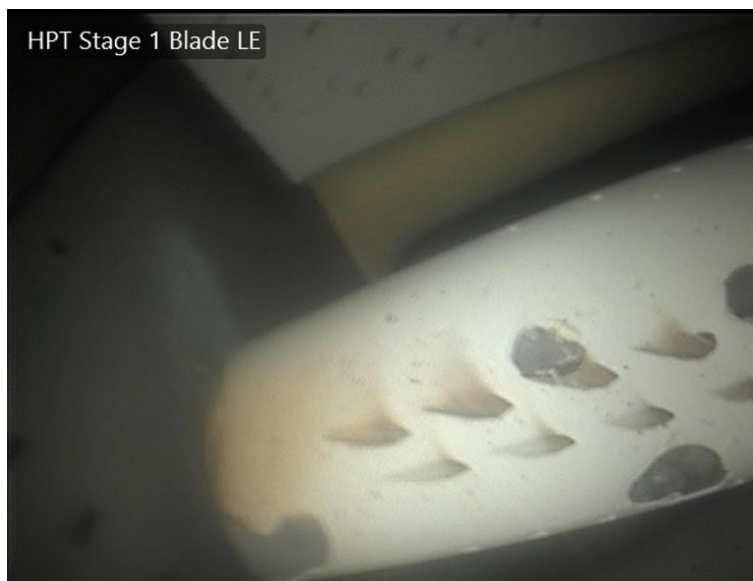
hpt\_stage\_1\_blade\_le007.jpg

| Defect | TBC LOSS |
| <b>Comments:</b><br><br><b>TBS missing.</b> | |

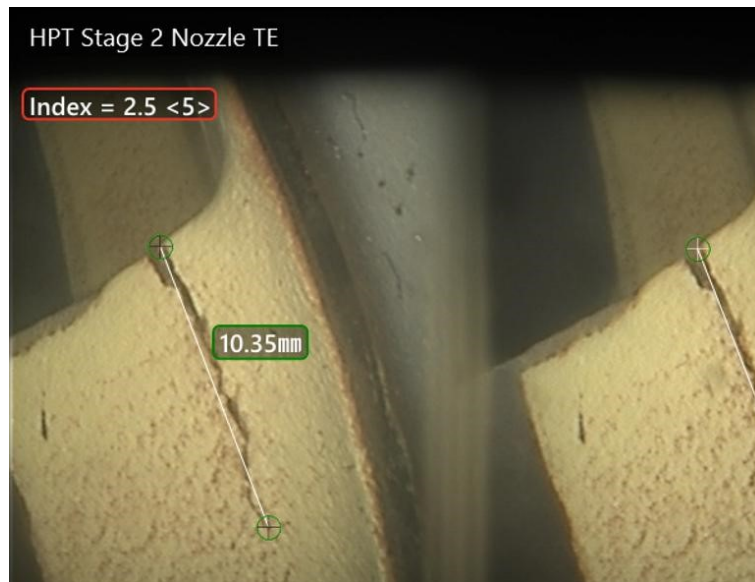
hpt\_stage\_2\_nozzle\_te019.jpg

Erosion and cracks found at several S2N TE.

| Defect | EROSION |
| <b>Comments:</b><br><br><b>Erosion and material missing, serviceable.</b> | |

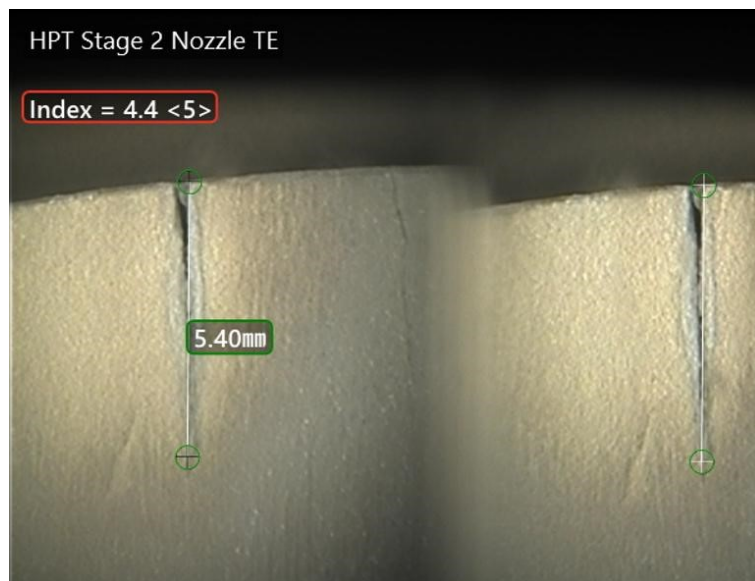
hpt\_stage\_2\_nozzle\_te020.jpg

| Defect | CRACK |

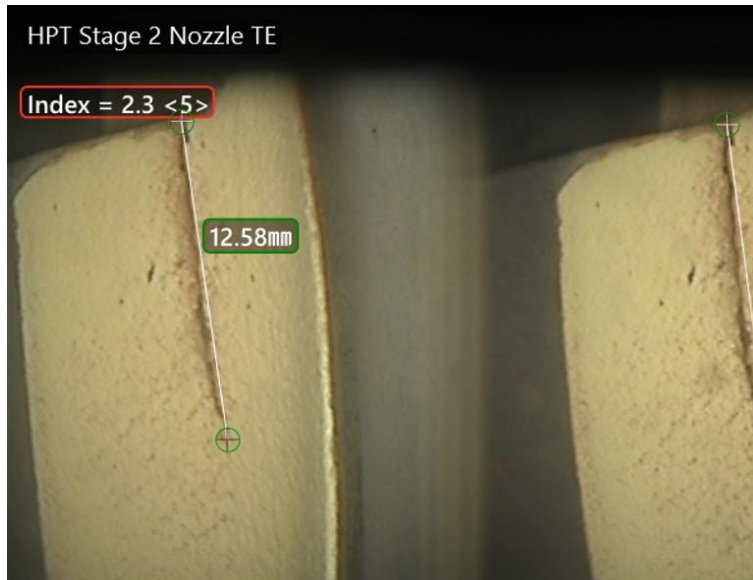
hpt\_stage\_2\_nozzle\_te021.jpg

| Defect | CRACK |

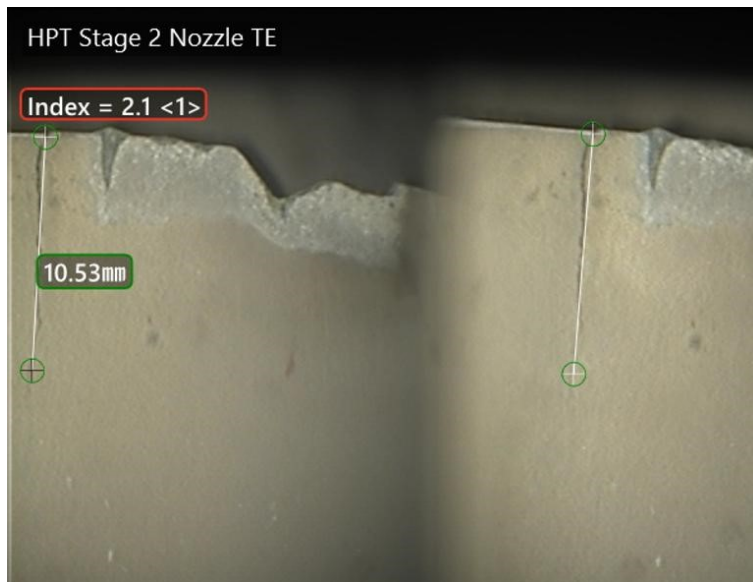
hpt\_stage\_2\_nozzle\_te023.jpg

| Defect | CRACK |

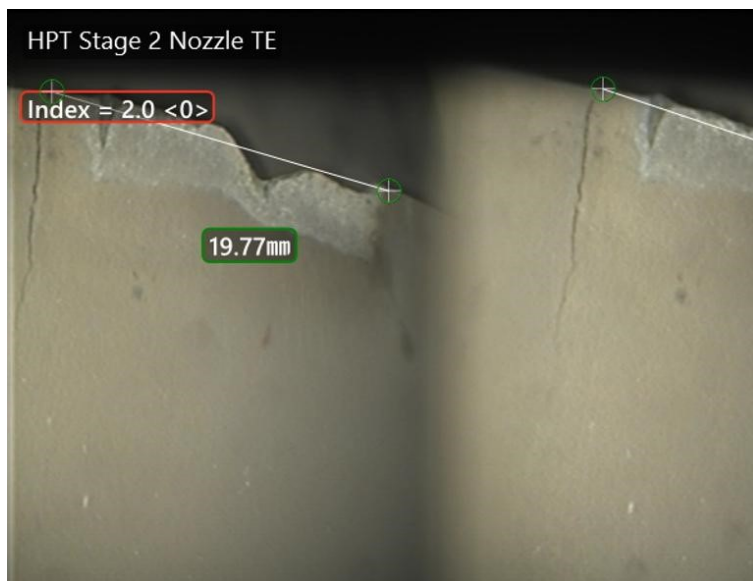
hpt\_stage\_2\_nozzle\_te024.jpg

| Defect | CRACK |

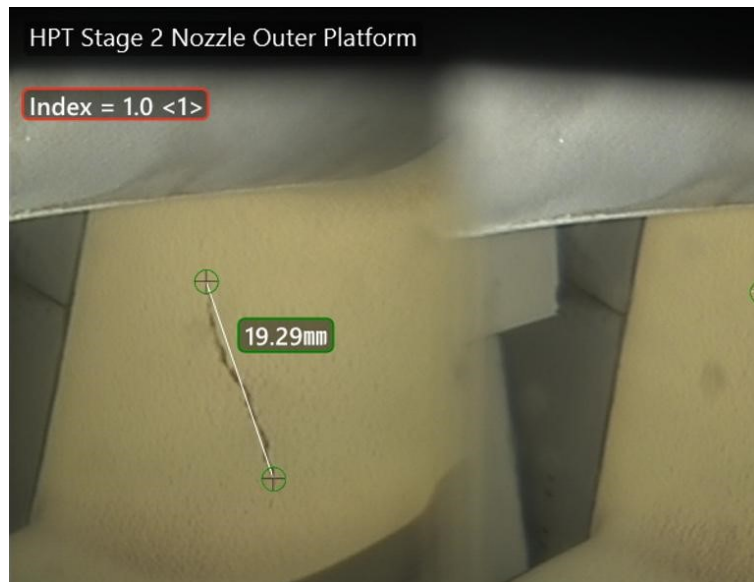
hpt\_stage\_2\_nozzle\_outer\_platform003.jpg

**Cracks found at several S2N Outer Platforms between the Vanes, can't see if cracks is only in the coating, AERO-20240704-0131**

| Defect | CRACK |
| <b>Comments:</b><br><br><b>Cracks at Outer Platform<br/>between the Vanes.</b><br><br><b>Can't see if crack is only in the<br/>coating.</b><br><br><b>Aero case logged, AERO-<br/>20240704-0131.</b> | |

Advise what to do with these cracks.

Contact engineering about these cracks and make plan for future inspections.

**Aero-case logged (AERO-20240704-0131) for the cracks at S2N Outer Platforms between the Vanes, can't see if cracks are only in the coating, need advise from engineering what action need to be taken.**

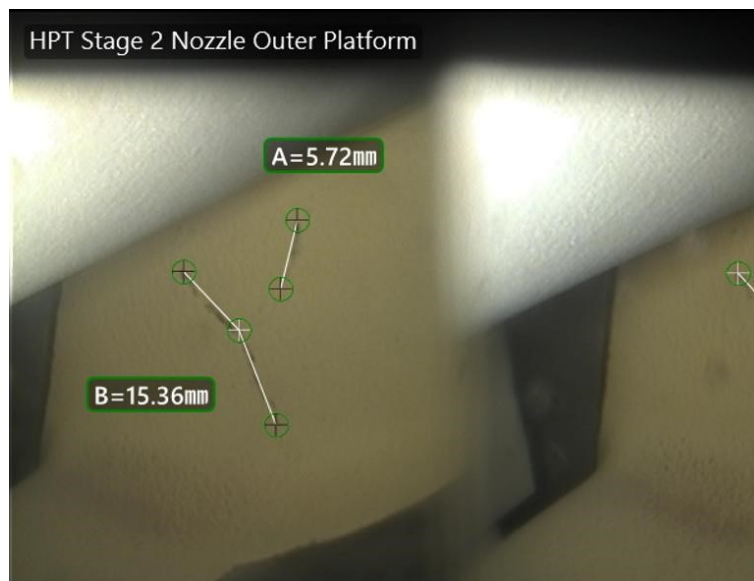
hpt\_stage\_2\_nozzle\_outer\_platform006.jpg

| Defect | CRACK |

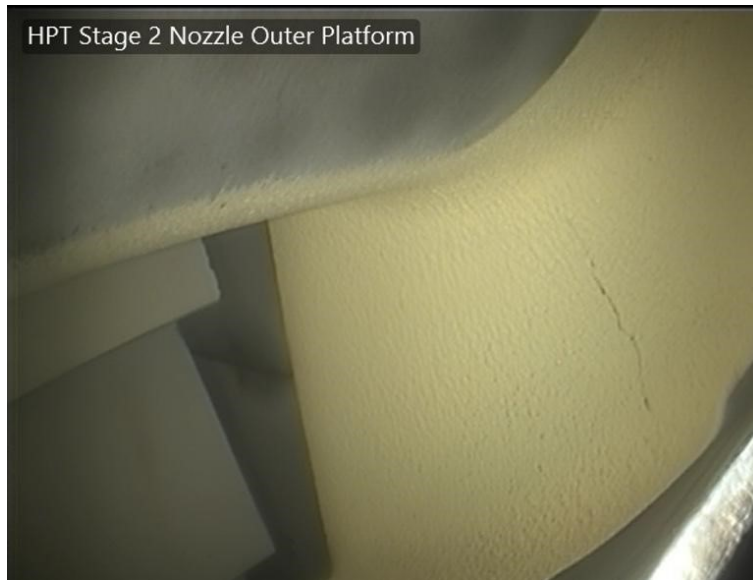
hpt\_stage\_2\_nozzle\_outer\_platform013.jpg

| Defect | CRACK |
| <b>Crack at Outer Platform between the Vanes.</b> | |
| <b>Can't see if crack is only in the coating.</b> | |
| <b>Aero case logged, AERO-20240704-0131.</b> | |

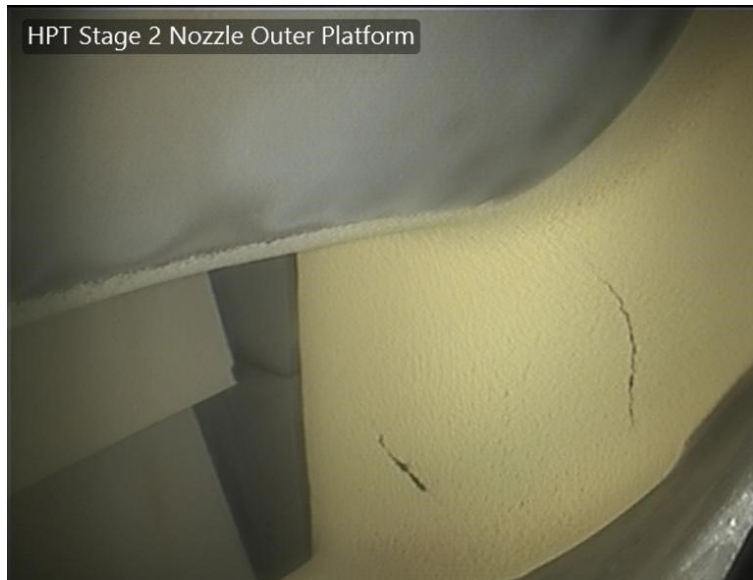
hpt\_stage\_2\_nozzle\_outer\_platform016.jpg

| Defect | CRACK |
| <b>Comments:</b><br><br><b>Cracks at Outer Platform between the Vanes.</b><br><br><b>Can't see if crack is only in the coating.</b><br><br><b>Aero case logged, AERO-20240704-0131.</b> | |

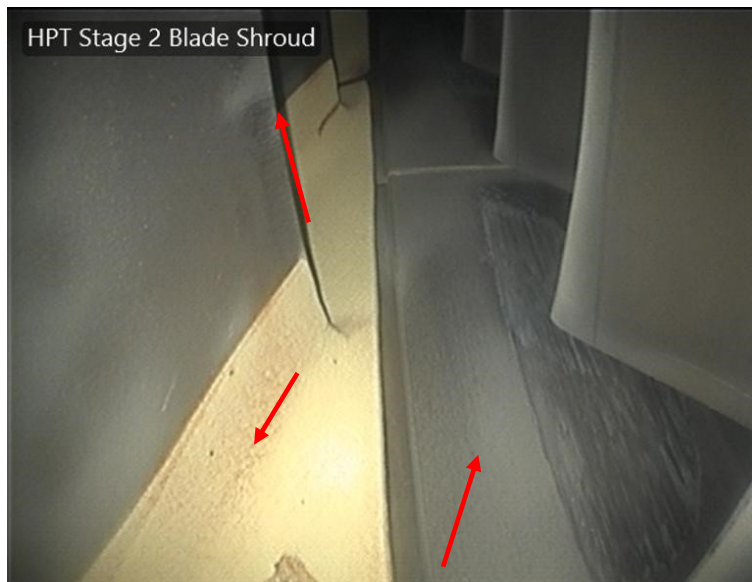
hpt\_stage\_2\_blade\_shroud004.jpg

Rubbing found at HPT stage 1 Shrouds. Rubbing found at HPT stage 2 Shrouds.

| Defect | RUB |
| <b>Comments:</b><br><br><b>Rubbing.</b> | |
