# Risk Engineering Report

**STICHTING FONTYS**

**Site Name:** Professor Goossenslaan 1 Tilburg

**Survey Type:** Property All Risk - Initial

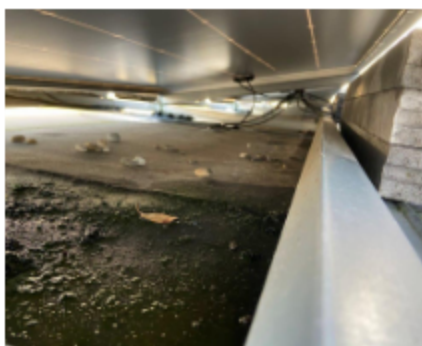
On the roof of P8 a PV system is installed, unknown status of scope 12 inspection. The parts viewed (< 5%) are considered visual acceptable. A risk improvement for a scope 12 inspection (or report of already conducted inspection) is noted.

Underneath PV (solar) panel

### Summary

Conduct a scope 12 inspection of the photovoltaic (PV) system of building P8 (if not conducted). And if applicable solve/repair deviation noted in the scope 12 report.

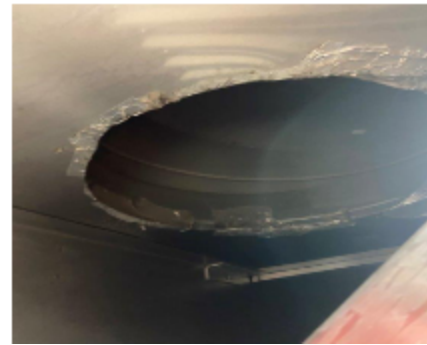
There is one professional kitchen in building P1 on the ground floor. It contains electrical and gas fired kitchen equipment like an oven (electrical) and deep fat fryer (gas). In other buildings there is only small electrical equipment, like ovens. The professional equipment in the kitchen is well maintained and is always operated under supervision of professionals. High temperature limit switches are reportedly available. Fire blankets and adequate portable fire extinguishers have been provided. Periodic inspection and cleaning of the exhaust ducts is subcontracted to a professional company (reportedly once every year). The kitchen is not provided with a local extinguishing system (recommended only as best practice).

Duct of kitchen

Protect the commercial cooking equipment (i.e. deep fat frying equipment) in the kitchen area with an ANSI/UL 300 compliant wet chemical extinguishing system interlocked to shut off the fuel supply to the equipment upon system actuation in accordance with NFPA 96. Also for new tenants at street level in the public area this should be part of the negotiations/ standard for new renting contracts.

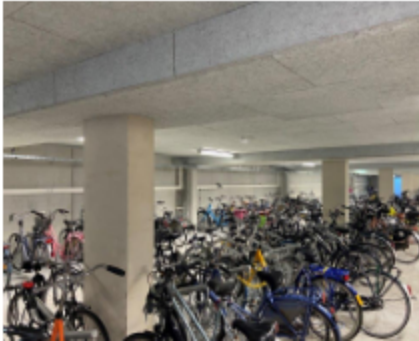
The bicycle parking is currently not adequately monitored. Should a fire or trouble condition occur, response by building or campus emergency response personnel could be delayed. This could result in increased damage to property and impact on business operations.

the parking facility. Extending the automatic fire detection in to the garage could have a positive effect. A risk improvement noted.

Detection missing

Extend the automatic fire detection system to monitor the bicycle parking underneath P8.

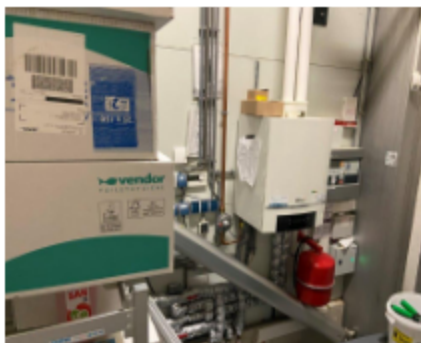
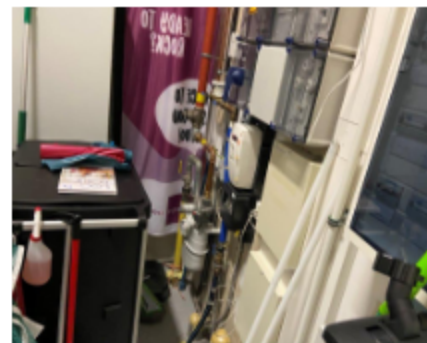
A fire involving the combustible materials may contribute to the smoke contamination of the equipment within the room.

Storage in technical room P7

Remove the combustible materials from the technical room in building P7.
