# Risk Engineering Report

**STICHTING FONTYS**

**Site Name:** Rachelsmolen 1Eindhoven

**Survey Type:** Property All Risk - Initial

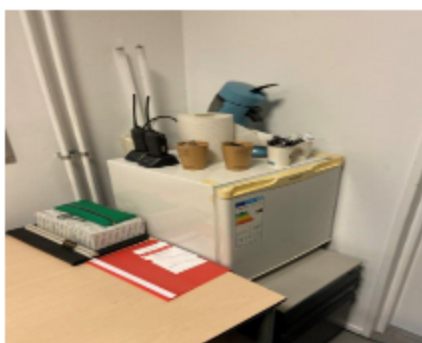
Example of home appliances

During the site visit different private appliances were noted. This is an enhanced risk a risk improvement is noted and discussed during the site visit.

Inform employees that it is forbidden to use home appliances at work because of the (fire)risk. After a certain period remove all private owned home appliances like the coffee machines, radio's, toasters, microwaves, fridges, and so on.

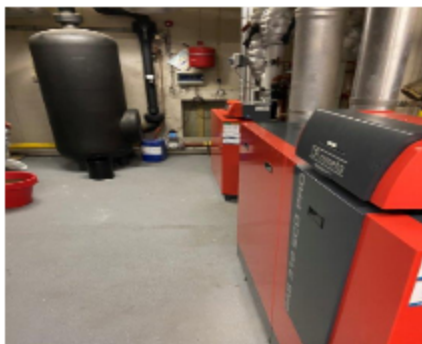
Status of installations are managed and monitored via the building management systems. Equipment appears visually in a good state of repair. Periodic maintenance is contracted out to specialized contractors.

Heating

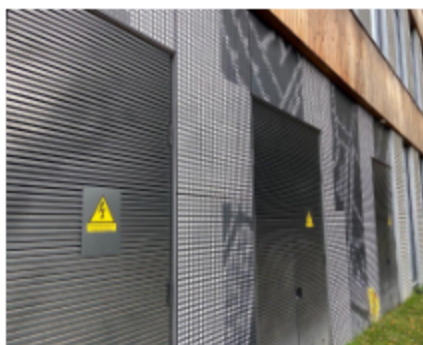
The electrical installations appear visually in a good state of repair. Penetrations for electrical cables were found to be adequately fire stopped, including inside vertical utility shafts. The electrical installation is subjected to inspection according to the Dutch standard NEN 3140, which comprises visual inspection of all installation parts and checks by measurements. The periodicity is set to according the NEN3140. Inspections are done by third party and include thermographic surveys. Recommendations are followed.

Trafo

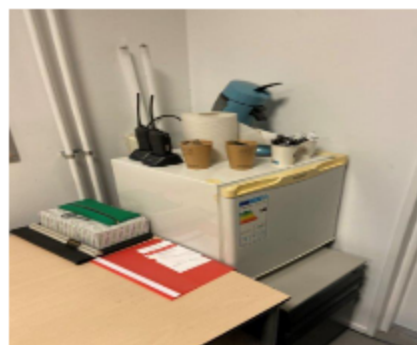
Private equipment

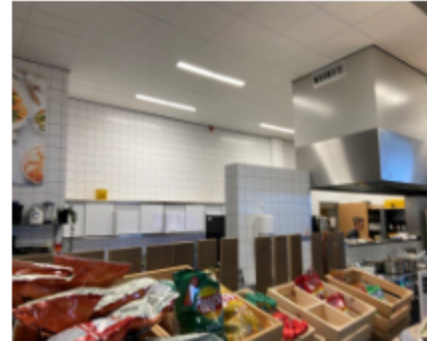
There is one professional kitchen in building R4 on the ground floor. It contains electrical and gas fired kitchen equipment like an oven (electrical) and deep fat fryers (gas). In other buildings there is only small electrical equipment, like ovens. The professional equipment in the kitchen is well maintained and is always operated under supervision of professionals. High temperature limit switches are reportedly available. Fire blankets and adequate portable fire extinguishers have been provided. Periodic inspection and cleaning of the exhaust ducts is subcontracted to a professional company (reportedly once every year). The kitchen is not provided with a local extinguishing system (recommended only as best practice).

Restaurant - deepfat fryer (R4)

Protect the commercial cooking equipment (i.e. deep fat frying equipment) in the kitchen area with an ANSI/UL 300 compliant wet chemical extinguishing system interlocked to shut off the fuel supply to the equipment upon system actuation in accordance with NFPA 96. Also for new tenants at street level in the public area this should be part of the negotiations/ standard for new renting contracts.

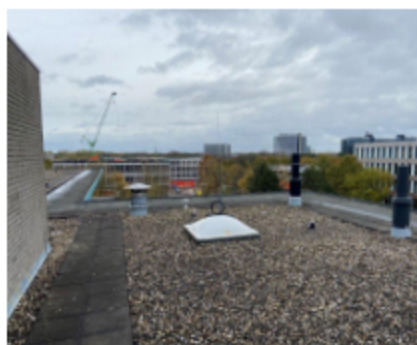
Roof covering

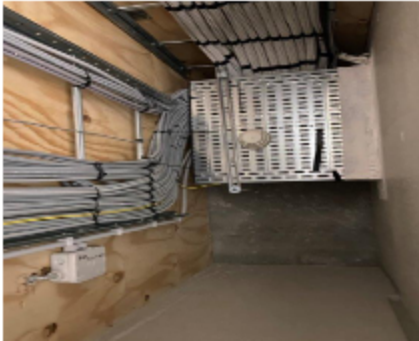
Example AFD in shaft
