# Risk Engineering Report

**STICHTING FONTYS**

**Site Name:** Random 1Eindhoven

**Survey Type:** Property All Risk - Initial

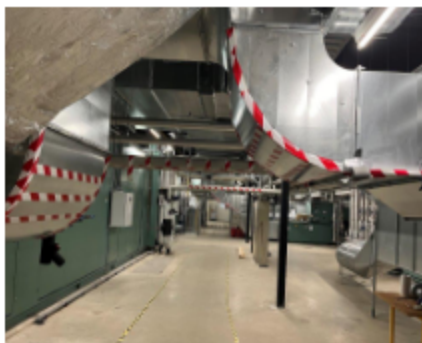
Heating of the buildings is by means of natural gas fired boilers and air handling units, which are located the technical rooms at top floor level. Cooling compressors (chillers with a Freon replacement medium) and cooling towers are located on top of the roof. Air ventilation ducts are reportedly equipped with fire dampers.

Heating

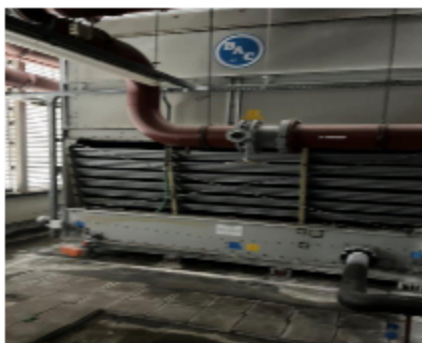
Cooling towers

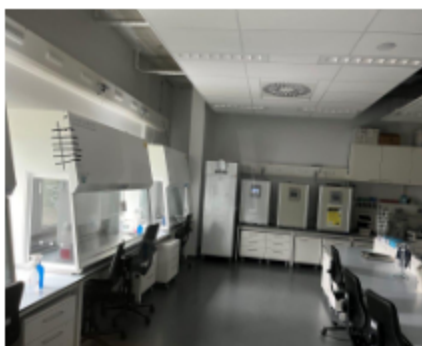
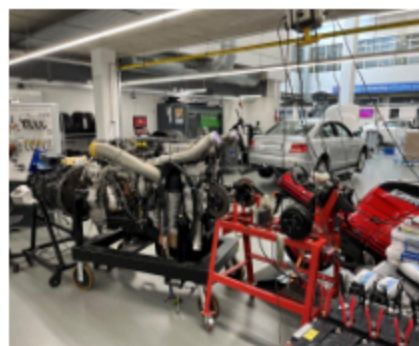
Beside theory classrooms, project group rooms, meeting space, media library, and offices there are different practical classrooms throughout the building. Practical class rooms range from labs to a garage. A large variety equipment and machines are present and used, for instance fume cupboards, saw machine, welding machines, 3D printers but also different handheld equipment. Basic safety provisions in place. Limited quantities of hazardous substance are present. Some labs have an emergency button. Machines are not operational after working hours. All research freezers are reportedly equipped with temperature monitoring with external notification. Students work under the guidance and supervision of teachers. Machines and equipment is checked and maintained by specialized contractors.

Practical classroom

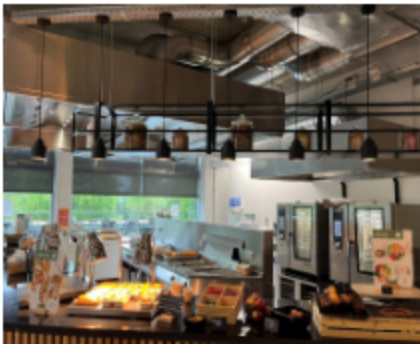
There is one professional kitchen in the building and a small bar/ coffee corner. The restaurant contains electrical, and gas fired kitchen equipment like an oven (electrical) and deep fat fryers (gas). The cafe only have small electrical equipment, like ovens. The professional equipment in the kitchen is well maintained and is always operated under supervision of professionals. High temperature limit switches are reportedly available. Fire blankets and adequate portable fire extinguishers have been provided. Periodic inspection and cleaning of the exhaust ducts is subcontracted to a professional company (reportedly once every year). The kitchen is not provided with a local extinguishing system (recommended only as best practice).

Kitchen

Protect the commercial cooking equipment (i.e. deep fat frying equipment) in the kitchen area with an ANSI/UL 300 compliant wet chemical extinguishing system interlocked to shut off the fuel supply to the equipment upon system actuation in accordance with NFPA 96. Also for new tenants at street level in the public area this should be part of the negotiations/ standard for new renting contracts.

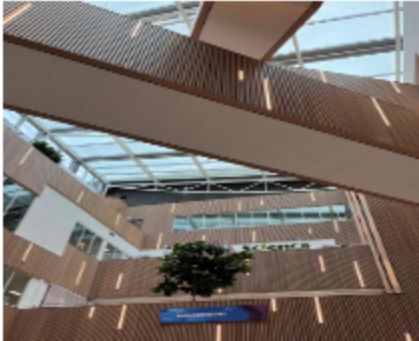
Atrium

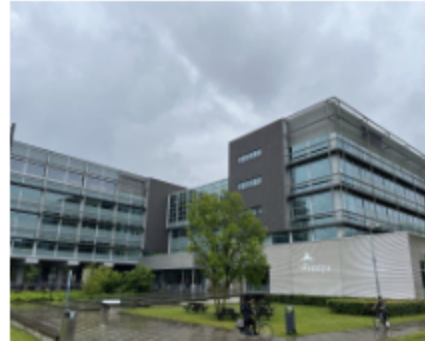
Fontys Rondon 1
