# Risk Engineering Report

**STICHTING FONTYS**

**Site Name:** Mgr Claessenstraat 4Sittard

**Survey Type:** Property All Risk - Initial

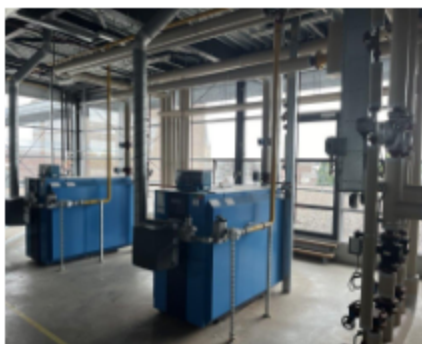
Heating of the buildings is by means of natural gas fired boilers and air handling units, which are located in the technical rooms at top floor level. Cooling compressors (chillers with a Freon replacement medium) are located on top of the roof. Technical rooms fitted with water leakage detection.

Status of installations are managed and monitored via the building management systems. Equipment appears visually in a good state of repair. Periodic maintenance is contracted out to specialized contractors.

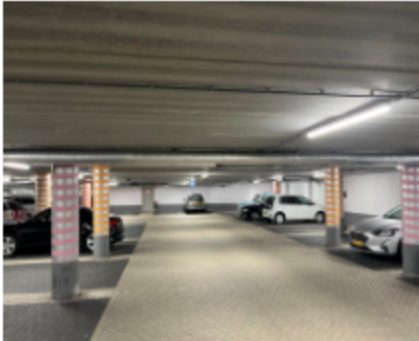
Parking

At basement a parking garage for staff and students. During events at the theater the garage is open to guests. The parking has a capacity of about 90 passenger cars, no charging facilities. The garage is equipped with automatic fire detection, CO and LPG detection at multiple locations in the parking. In the basement there is a smoke extraction system that - with a smoke extraction system (ventilators) to the exit/entrance of the garage. The parking garage is not equipped with sprinkler protection; a risk improvement (advisory) to install it has been made.

Extend the existing sprinkler system in the basement to protect the garage. Extend the system in accordance with NFPA 13, design 8.1 mm/min @ 140 m<sup>2</sup> (will fit existing system).

The garage is lacking sprinkler protection. Extending the existing sprinkler system will increase the likelihood that the sprinkler system will control a fire starts in the area.

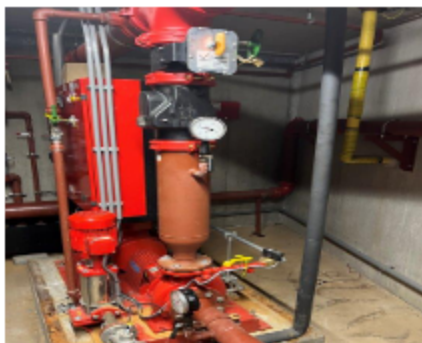
Sprinkler pump

Hydrants in the public road in front of the building. The sprinkler water supply consist of one electric pump connected to the public water supply. The pump room is in the basement (parking) of the building.

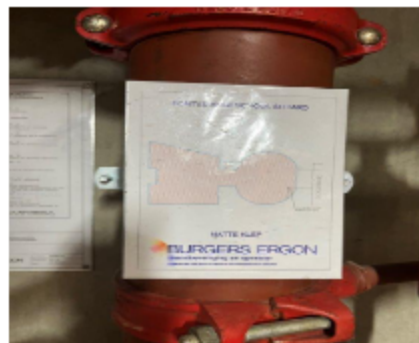
Riser with protection area

The building excluding the basement (about 3.000 m<sup>2</sup>) is fitted with a sprinkler system. The system is designed and maintained according the NEN-EN12845+1073 and TB80. The protection of the building (excl. parking) is adequate, the parking is not sprinkler protected and therefore inadequate, best practice is to extend the sprinkler. The sprinkler water supply is a electric drive pump with a connection to the public water supply. The sprinkler system is maintained and checked by a specialized contractor. They also conduct test bi-weekly. The following test, inspection, and maintenance protocol is in place:
