COPE Report Bergmanianum Building (Radboud University)
Adress: Houtlaan 4, 6525 XZ Nijmegen, Netherlands

Report of [REDACTED] date of visit 17/04/2024
Participants: [REDACTED] (Facility Manager Radboud University),
[REDACTED] (Aon Account manager)
[REDACTED] (Aon risk engineer)
[REDACTED] (Chubb Risk Engineer, writer of this report)

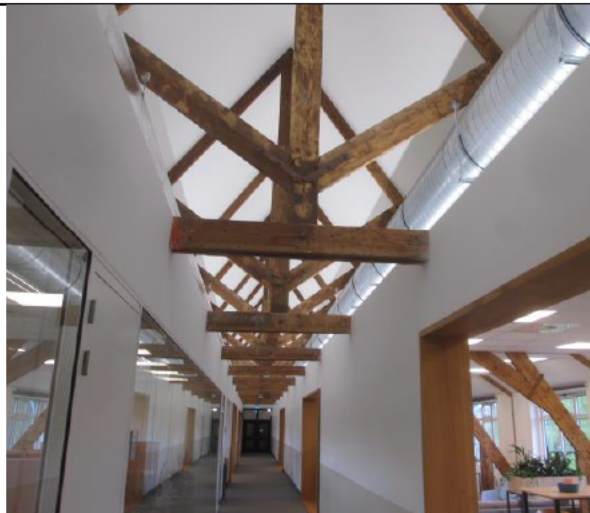
One of the attics with office space

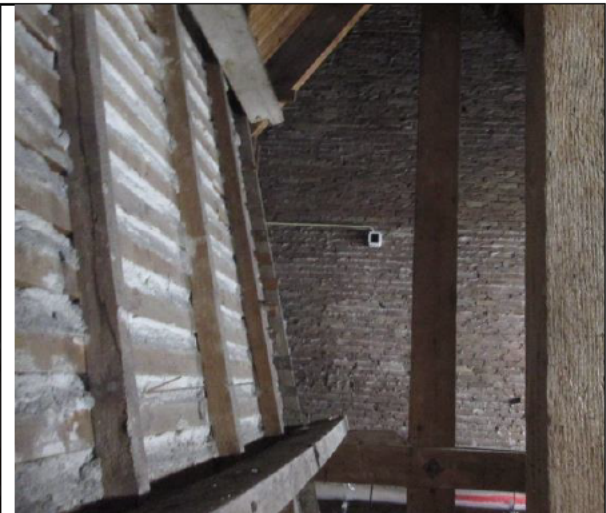
The attic above the previous chapel with beam detection

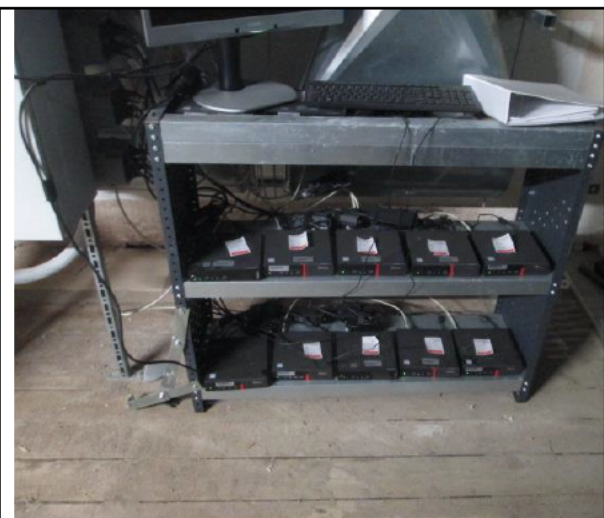
At the attic is a corner in use as server area. This part is not fire retardant separated and there is no (aspiration) detection (see rec.).

Server: As mentioned above there is a kind of server constructed in the attic, but not fire retardant separated and not provided with detection. The installation looks amateurish and is classified as a potential ignition source.

Server like equipment at the attic (see rec.)

2024-02 Server op de zolder

Op de zolder is zeer provisorisch een soort server kast gebouwd (zie foto). Voor een houten zolder met een houten vloer zien wij dergelijke apparatuur als van een mogelijke ontstekingsbron waarbij een brand zich kan uitbreiden tot de gehele zolder. Ontstekingsbronnen op zolder dienen zo veel mogelijk voorkomen worden. Daarom wordt met klem geadviseerd de apparatuur te verplaatsen naar een onbrandbare ruimte of de kast aan alle zijden (dus ook de vloer en het plafond) te omkleden met 60 minuten brandwerende scheidingsen (bijvoorbeeld dubbele gipsplaat) en de ruimte te voorzien van branddetectie. Uiteraard dienen kabeldoorvoeren brandwerend afgesmeerd te worden door een professionele organisatie.

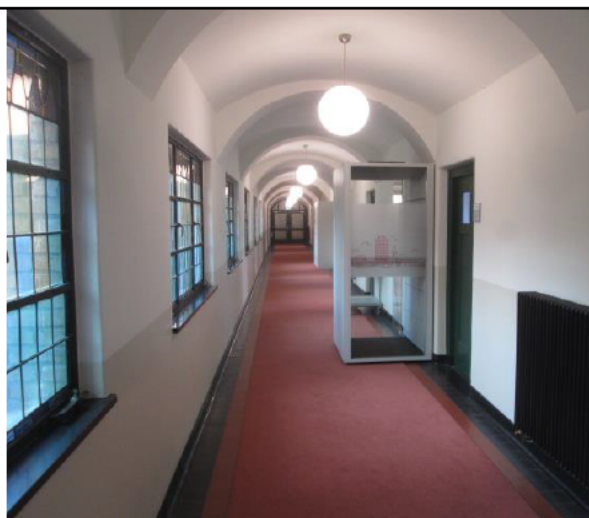
One of the corridors with aspiration detection

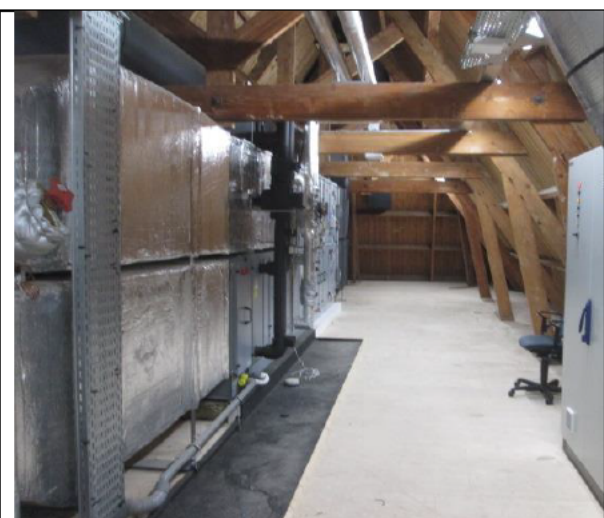
Air treatment system in the attic

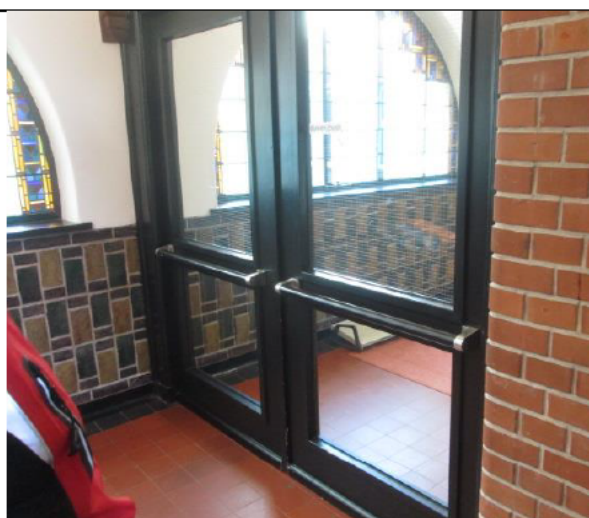
Compartmentation: Most of the internal partitions contain wired glass. Wired glass has a very limited fire and smoke rating and is not classified reliable anymore. Although the local construction standard allows a limited surface of these wired windows. In general every partition contains the maximum surface of wired glass (the weakest point of failure), while the rest of the surface is modified to glass with a better fire rating.

Partly wired glass, partly fire retardant glass (see rec.).

AANBEVELINGEN:**2024-01 Brandwerende scheidingsen**

De brandwerende scheidingsen zijn een mix van draadglas en brandwerende ruiten. Draadglas werd lang geleden geclassificeerd als brandwerend maar al lange tijd (meer dan twintig jaar) is bekend dat draadglas enigszins rookwerend is, maar slechts enkele minuten brandwerend. Het is dan ook onbegrijpelijk dat bij de renovatie van 2016 gekozen is om draadglas niet te vervangen en alleen daar waar het toelaatbare oppervlak draadglas, volgens het bouwbesluit, werd overschreden brandwerende ruiten toe te passen.

Afgezien dat het voor een dergelijk klassiek gebouw afbreuk doet aan de uitstraling vinden wij de algehele brandpreventie daardoor ook beneden peil. Dringend wordt geadviseerd alle brandwerende scheidingsen minimaal 30 minuten maar bij voorkeur 60 minuten brandwerend uit te voeren.

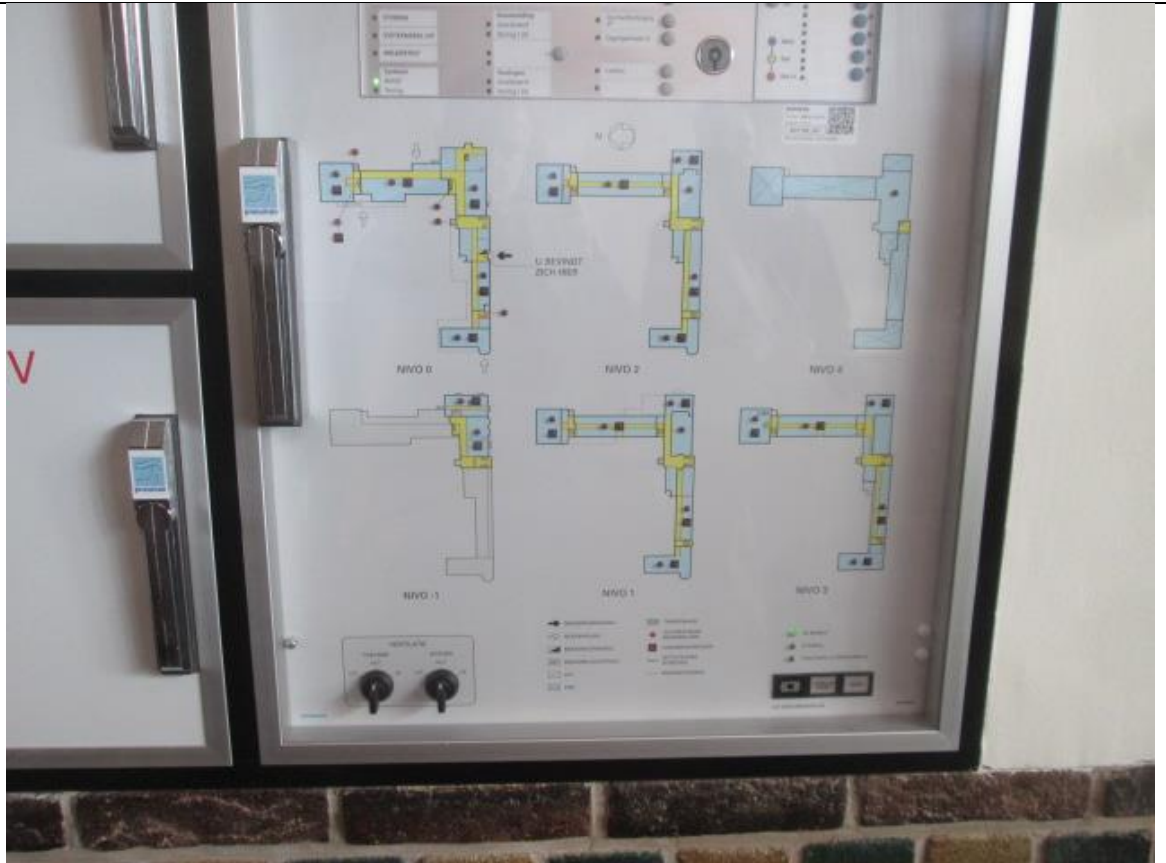
Fire detection panel.
