COPE Report Erasmus building and Library (Radboud University)
Adress: Erasmusplein 1 /Erasmuslaan 36 / Mercatorpad1
Nijmegen, Netherlands

Report of [REDACTED] date of visit 17/04/2024
Participants: [REDACTED] (Facility Manager Radboud University),
[REDACTED] (Aon Account manager)
[REDACTED] (Aon risk engineer)
[REDACTED] (Chubb Risk Engineer, writer of this report)

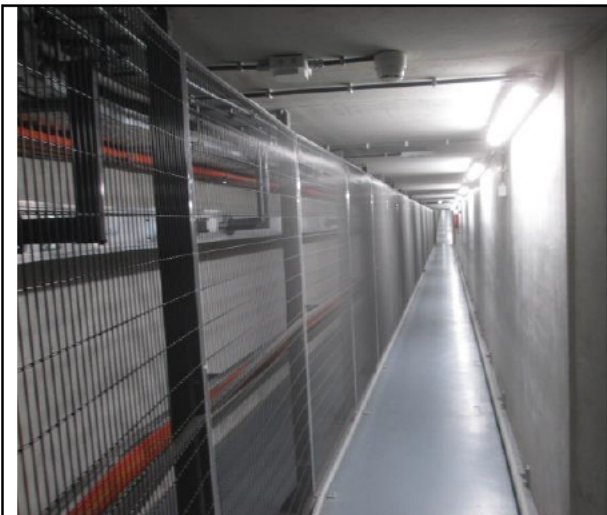
Exterior exposures: The library is interconnected to the Gymnasion building across the street by means of an underground concrete tunnel with a length of about 100 meters. The tunnel contains hardly any fire load and has four automatic closing partitions every 25 meters with a fire rating of 30 minutes. In respect of the low fire load and the many fire retardant partitions behind each other in a concrete tunnel the tunnel can be classified as a fire area separation.

The tunnel between Gymnasium and library

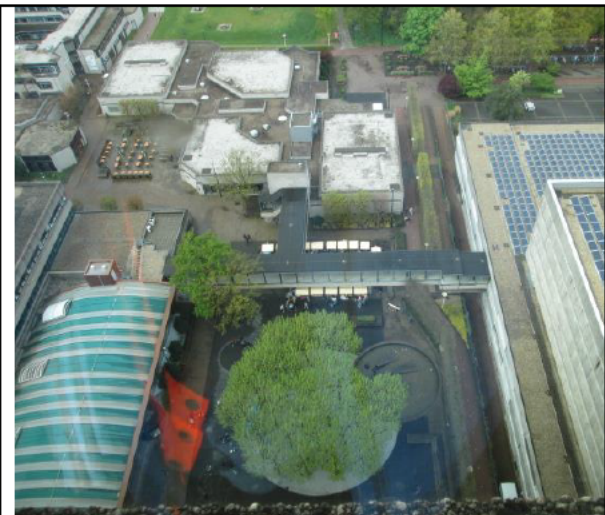
The overhead corridor between the restaurant (left) and the library (right)

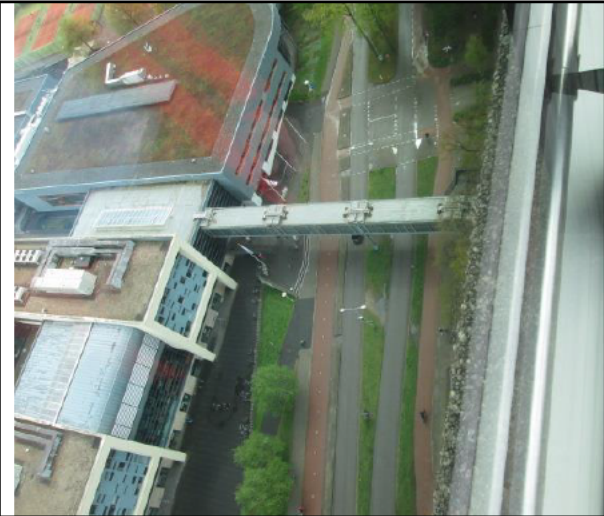
The Erasmustower is interconnected to the Gymnasion building (across the street) by means of an overhead single floor corridor that four 30 minutes fire retardant partitions. The walls of the corridor are made of glass façade walls and the roof contains combustible foam plastic but is interrupted at 6 locations by 2 meter wide smoke and heat ventilating hatches including make up air louvres in the walls. This in combination with the length of the corridor of 80 meters results into a fire area separation.

At the other side of the road the Gymnasion. Photo taken from the Erasmus tower. In between the overhead corridor.

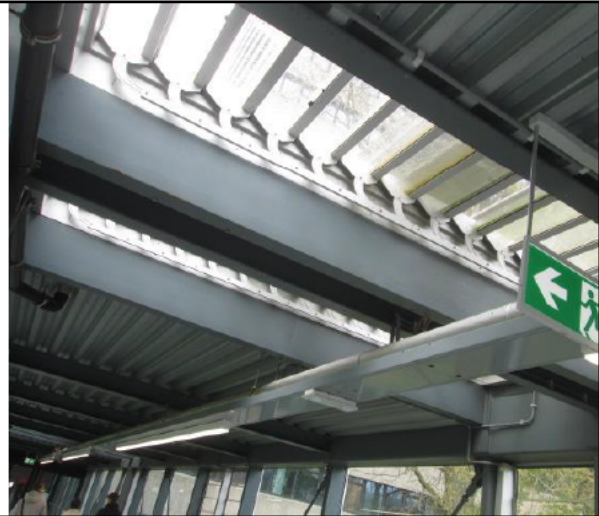
The smoke hatches in the corridor to the Gymnasion.

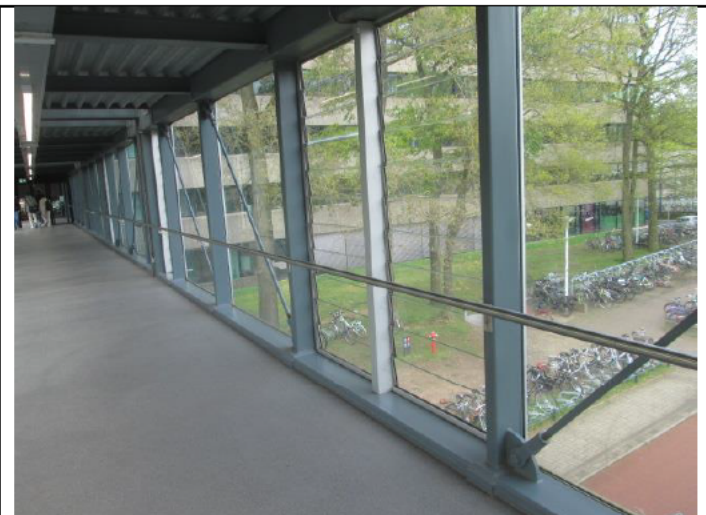
Louvre panels for make up air (in combination with the smoke hatches)
