COPE Report Huygens building (Radboud University)
Adress: Heyendaalseweg 135
Nijmegen, Netherlands

Report of [REDACTED] date of visit 17/04/2024
Participants: [REDACTED] (Facility Manager Radboud University),
[REDACTED] (Aon Account manager)
[REDACTED] (Aon risk engineer)
[REDACTED] (Chubb Risk Engineer, writer of this report)

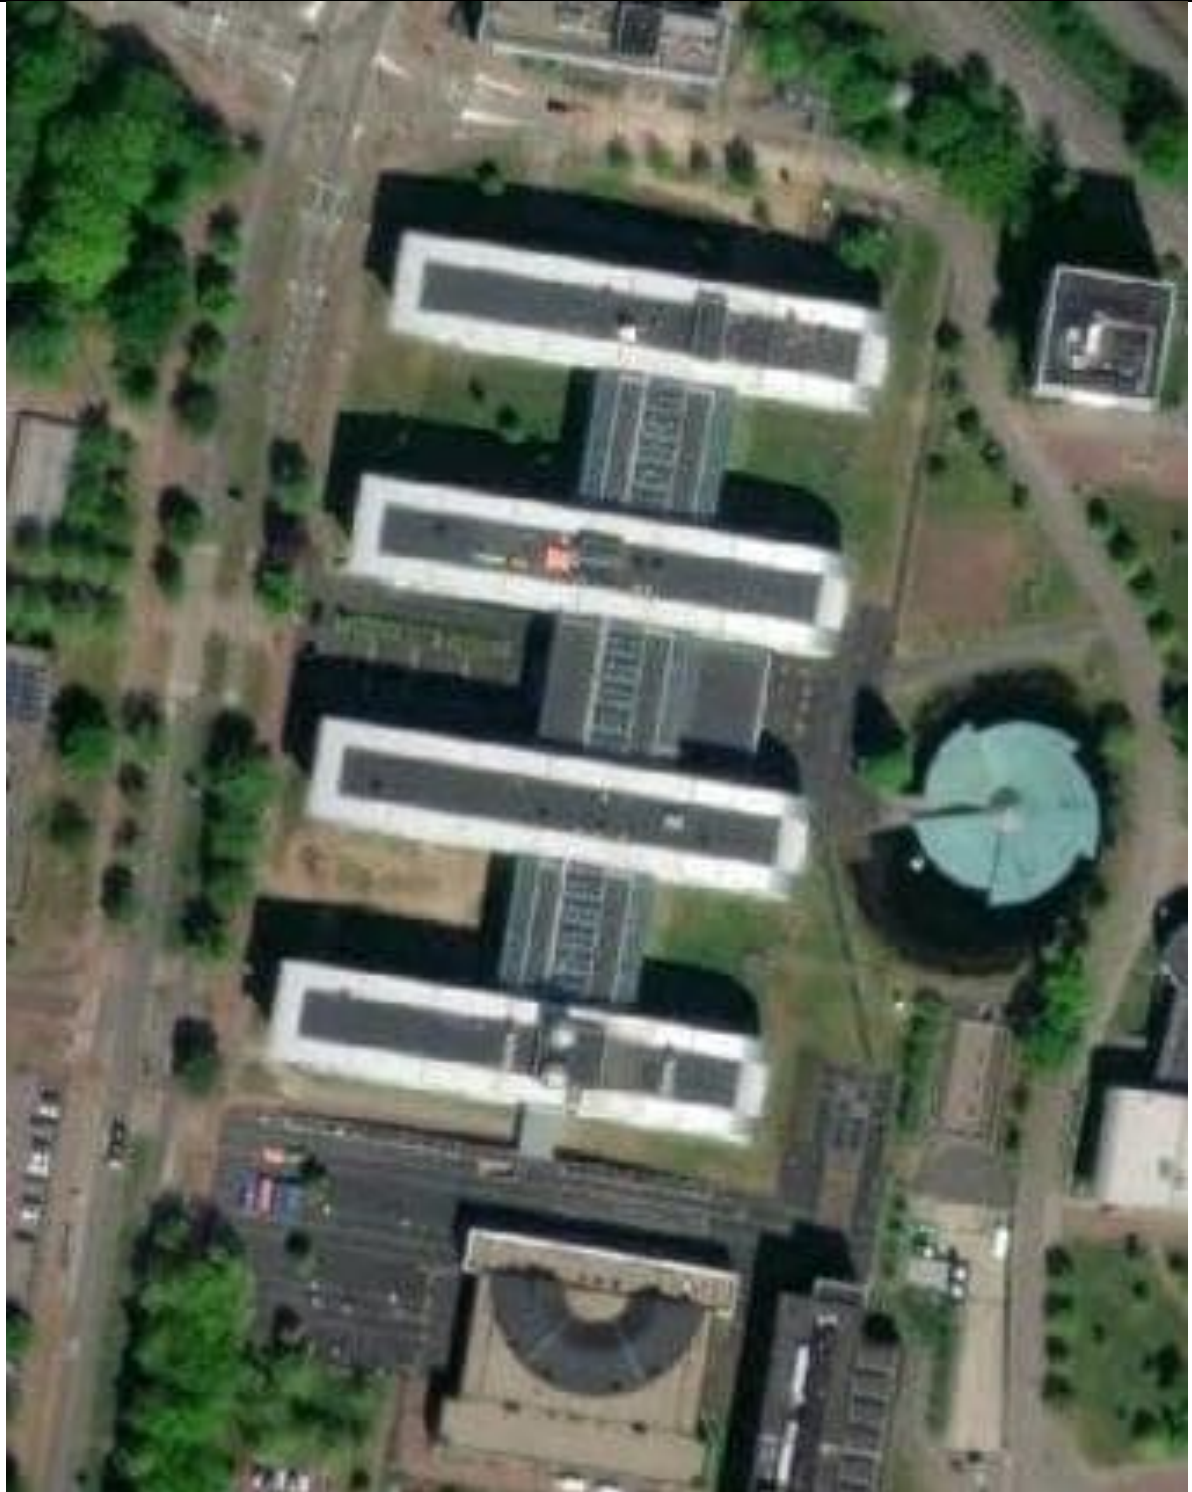
Exterior exposures: The buildings at the East of the Huygens building are interconnected to the site by means of concrete tunnels without any fire load. The partitions at both sides are 60 minutes. The length of the tunnel is 60 meters. The NMR/MRI building (green roof in the Nearmap photo) is more at basement level and only a limited part of the roof and exterior wall is above the pond and grade level. Therefore this building is classified as a separate fire area.

Overview of the Huygens building. At the right (green roof) is the MRI building. This is at basement level and just a minor part is above the pond/grade level) Therefore this exterior exposure is classified as separate fire area.

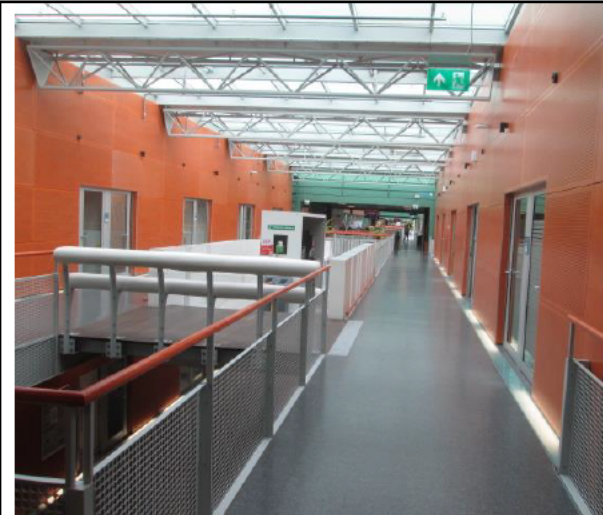
The connecting corridor has glass façade walls that will probably break in case of a fire and therefore the heat will be released to the open. The fire load in the connecting corridor building is very low.

The connecting corridor between the four wings.

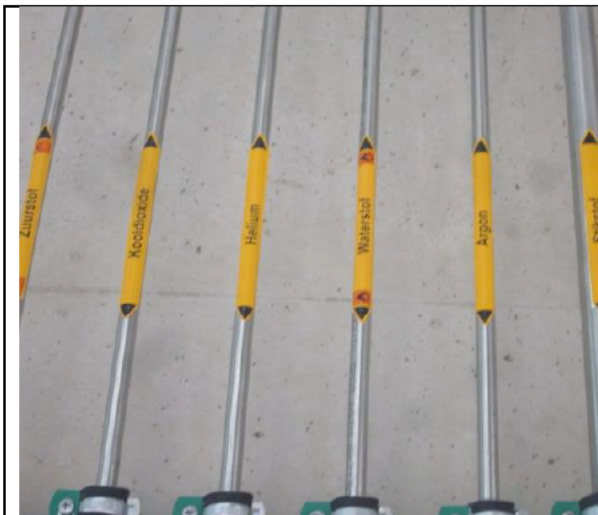
Different kinds of gases with central and decentral valves

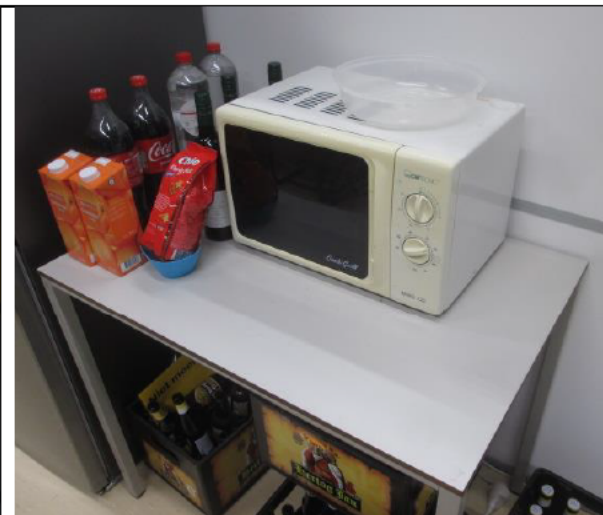
- Electrical appliances: staff take electrical appliances such as toasters, sandwich grills, microwaves, etc. into the building for personal use. These type of equipment should be removed and periodical surveys need to be done to prevent that new equipment will be installed or all equipment need to be checked by an electrician once per two years (see rec.).

Example of personal electrical appliances

2024-02 Controle elektrische apparatuur.

In het gebouw zijn diverse elektrische apparaten aangetroffen die eigendom zijn van personeelsleden en studenten, waaronder tosti ijsers, broodroosters, magnetrons en radio's. In veel gevallen is de apparatuur te oud voor thuis maar nog goed genoeg voor op het werk. Dit soort verouderde apparaten kan een ontstekingsbron voor brand zijn. Geadviseerd wordt om dergelijke apparatuur te verbieden OF minimaal eens per twee jaar door een deskundige te laten controleren en na goedkeuring te laten voorzien van een sticker.

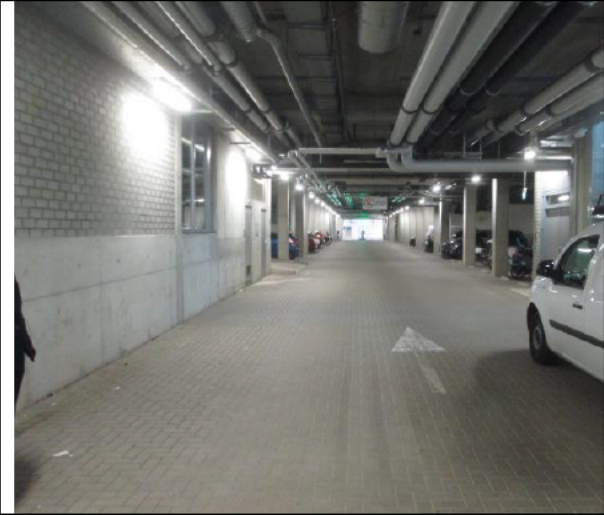
Underground parking garage

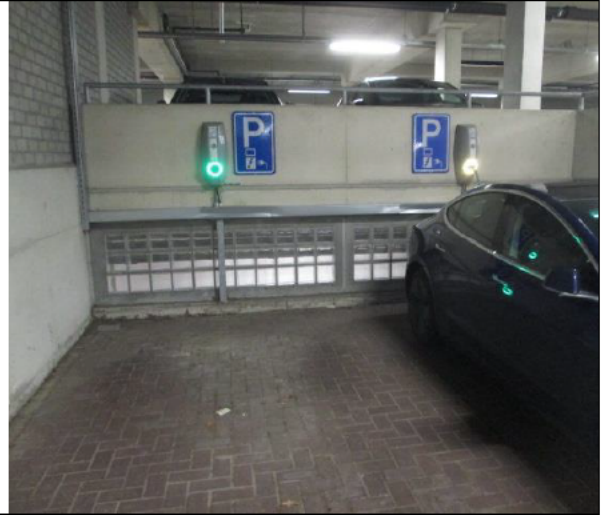
- Electrical cars can be parked in the underground parking. There are only four charging stations available in the middle of the parking garage (see rec.). The parking is provided with heat and smoke removing ventilation system. According to our latest standards charging stations for EV's in underground parkings should be 120 minutes fire retardant separated to the floors above and the charging stations shall be provided with automatic sprinkler protection.

Charging stations

AANBEVELINGEN:**2024-01 Laden van elektrische voertuigen in de ondergrondse parkeergarage**

In de ondergrondse parkeergarage zijn vier laadplekken voor elektrische voertuigen aanwezig. Van elektrische voertuigen is bekend dat deze relatief vaker tijdens het laadproces in brand raken en dat een brand bij dergelijke voertuigen zeer moeilijk te beheersen is. Daarom hebben wij een aantal preventiemaatregelen opgesteld om de schade bij een dergelijke brand zo beperkt mogelijk te houden:

- De laadpalen kunnen buiten het gebouw op minimaal 10 meter afstand van de gevel geplaatst worden OF
- Alle hieronder genoemde maatregelen dienen getroffen te worden:
 - o De laadplekken dienen voorzien te worden van automatische sprinklers met een sproeidichtheid van 12 mm/min over minimaal 140 m², met een minimale sproeitijd van 120 minuten.
 - o De brandwerende wanden van de trapopgangen naar de bovenliggende verdieping dienen opgewaardeerd te worden tot 120 minuten brandwerendheid. Dit kan gerealiseerd worden door de wanden 120 minuten brandwerend te maken of door aan de garagezijde sprinklerkoppen te plaatsen die de wand gaan koelen in geval van brand waardoor de brandwerendheid toeneemt.
