Risk Engineering Report

STICHTING HZ UNIVERSITY OF APPLIED SCIENCES

Date of Survey: September 16, 2022

Survey Type: Property All Risk - Initial

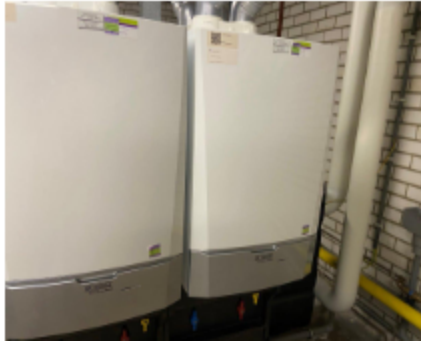
Status of installations are managed and monitored via the building management systems. Equipment appears visually in a good state of repair. Periodic maintenance is contracted out to specialized contractors.

Boilers

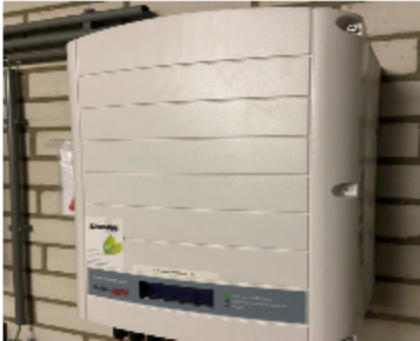
On top of building part V PV panels are installed. The inverter (with arc protection) is in the technical room. It is unknown if a scope 12 inspection is conducted. Based upon a limited view underneath the panels it is probably not done. It looks like not all connectors were free from the roof. The scope 12 report is requested during and after site visit. No reaction and therefore as discussed a risk improvement is noted in this report. For this a risk improvement is noted and to repair all deviations. There are also plans to install additional PV panels on other roof parts. Probably this will be on roof A or PE. It is discussed that AIG should be involved in plan decision-making, Aon will provide the PV panel brochure. If constructively possible, gravel should be left on the roof when PV panels are installed.

Inverter

Conduct a scope 12 inspection of the photovoltaic (PV) system. And if applicable solve/ repair deviation noted in the scope 12 report.

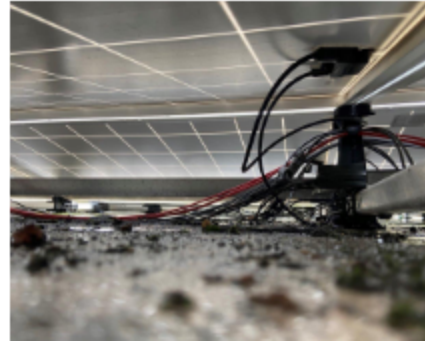
Cable connectors

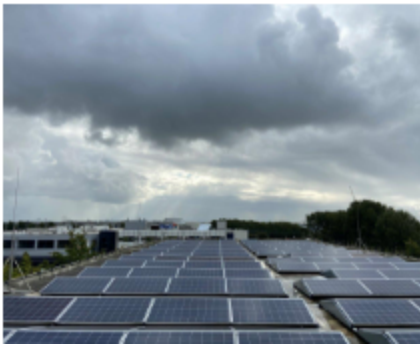
Solar panels

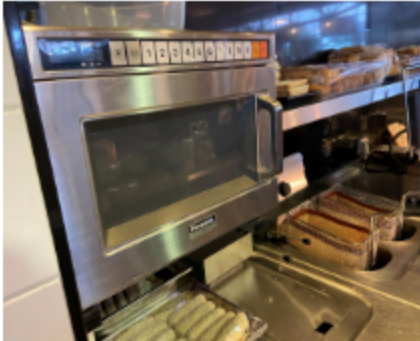
The kitchen is not provided with a local extinguishing system (recommended only as best practice).

Kitchen

Protect the commercial cooking equipment (i.e. deep fat frying equipment) in the kitchen area with an ANSI/UL 300 compliant wet chemical extinguishing system interlocked to shut off the fuel supply to the equipment upon system actuation in accordance with NFPA 96. Also for new tenants at street level in the public area this should be part of the negotiations/ standard for new renting contracts.

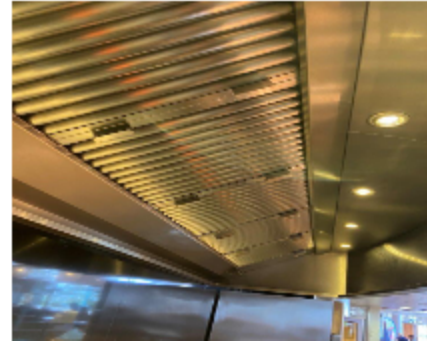
Hood

In th kitchen the deep fryer (and hood) is not provided with an automatic extinguishing system based on wet chemical extinguishing agent (or suitable foam). Best practice risk improvement discussed and noted.

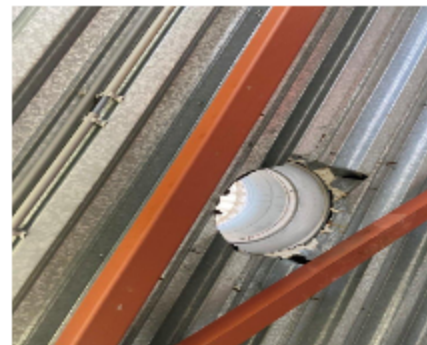
EPS insulation material is exposed around roof penetrations, in case of a fire in the technical room it can quickly spread into the insulation material. Roof fires generally expand rapidly and are difficult for firefighters to control or extinguish.

In the technical room (a roof structure on top of the building), several roof penetrations are inadequately finished. For this a risk improvement is discussed and noted.

roof penetration (RI)

Finish the exposed combustible insulation material at (roof) penetrations in the roof structure of the technical rooms on top of the building with a noncombustible material (like mineral wool).
