Risk Engineering Report

STICHTING HZ UNIVERSITY OF APPLIED SCIENCES

Site Name: Middelburg Het Groene Woud 1

Survey Type: Property All Risk - Initial

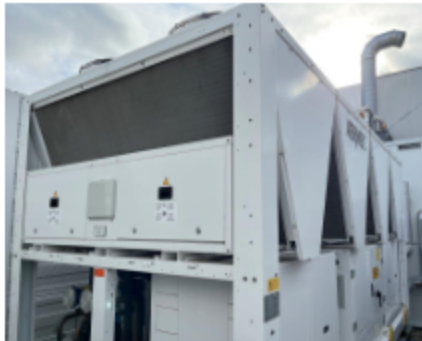
Heating of the buildings is by means of natural gas fired boilers (for HZ), heat pumps (JRCZ) and air handling units, which are located the technical rooms at top floor level. Cooling compressors (chillers with R410A medium) are located on top of the roof. Air ventilation ducts are equipped with fire dampers. The technical rooms are supervised by automatic smoke detection. The compartmentation and housekeeping in the technical rooms visited is adequate. Equipment appears visually in a good state of repair. Periodic maintenance is contracted out to specialized contractors. Status of installations are managed and monitored via the building management systems, alarms are transmitted to the technical department. It was unclear if all rooms are fitted with water detection, a risk improvement is discussed and noted.

Install water detection in the technical rooms of the JRCZ part and connected it to the building management system.

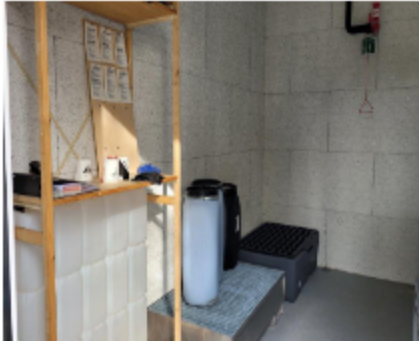
On the ground floor there two dedicated rooms for the for storage of gasses and other hazardous chemicals. Fitted with mechanical ventilation and detection. At the lab level there are dedicated cabinets with the different type of gas cylinders. All storage is monitored and in case of an alarm valves (type: normally closed) of the lines going into the labs are closed.

Chemical storage

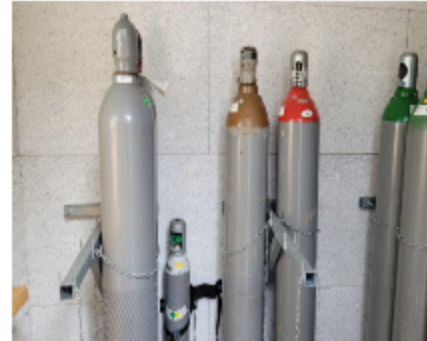
Chemical storage

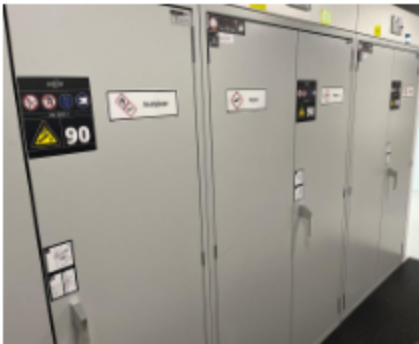
Practical classroom cabinets

In the JRCZ part there are practical classrooms for chemistry, engineering, etc. In these classroom technical equipment is present like fume cupboard, computers, a sawing machine, 3D printers and so on. Students of the three organizations (and in some cases third parties) work under the guidance and supervision of employees of the JRCZ. The quantities of hazardous materials are limited and only provided by the supervisor. At the end of a class or day hazardous materials are moved into safe storage. Machines and equipment are maintained by specialized contractors. The labs only work with cylinders stored in dedicated cabinets with shut of in case of an alarm, there is no gasconnection to the public grid.

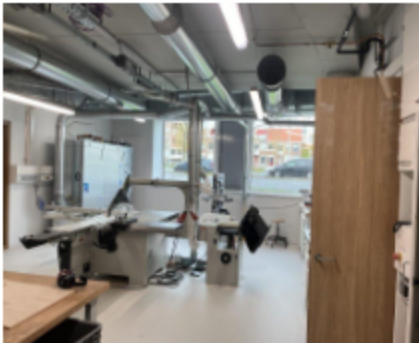
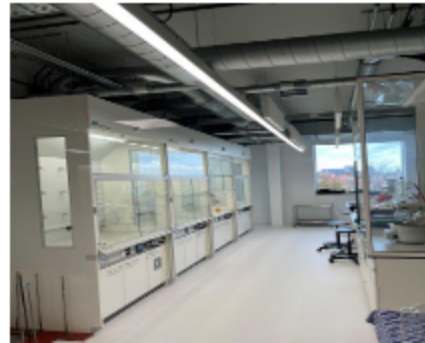
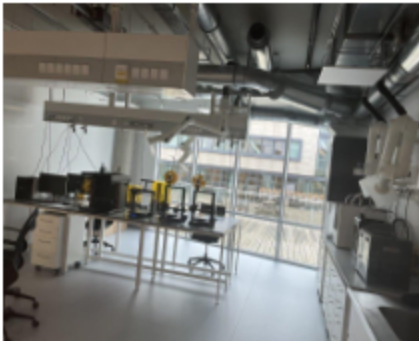
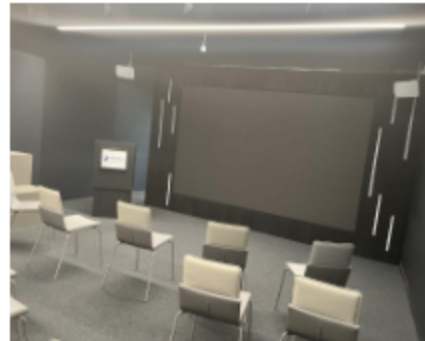
Practical classroom
