# Chubb Risk Control Program

## AAA Property Risk Report

Prepared for  
Gemeente Amsterdam  
Carré  
Amstel 115 -131  
Amsterdam, 1018 EM  
Netherlands

Inspection Date: 24 November 2023

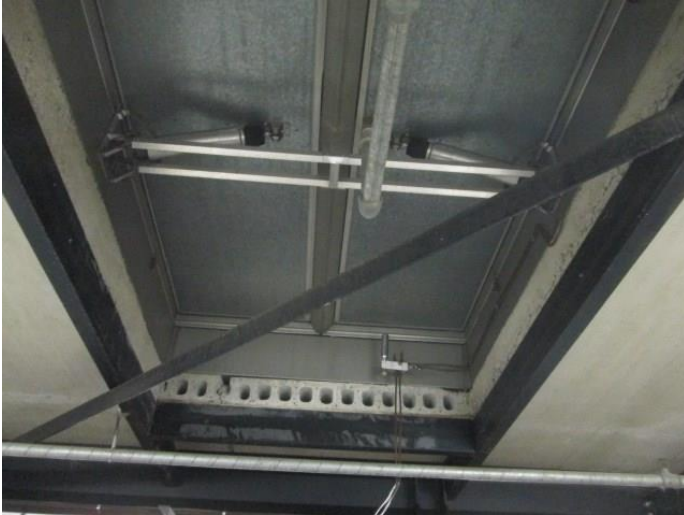
Smoke hatches above the stage

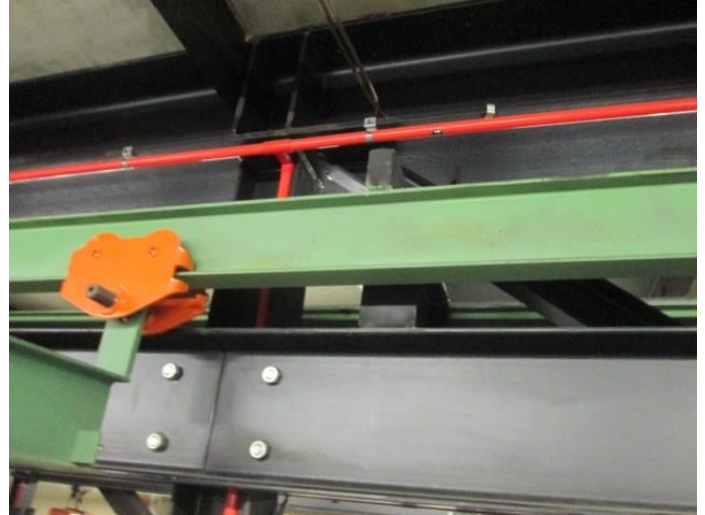
Aspiration detection above the stage

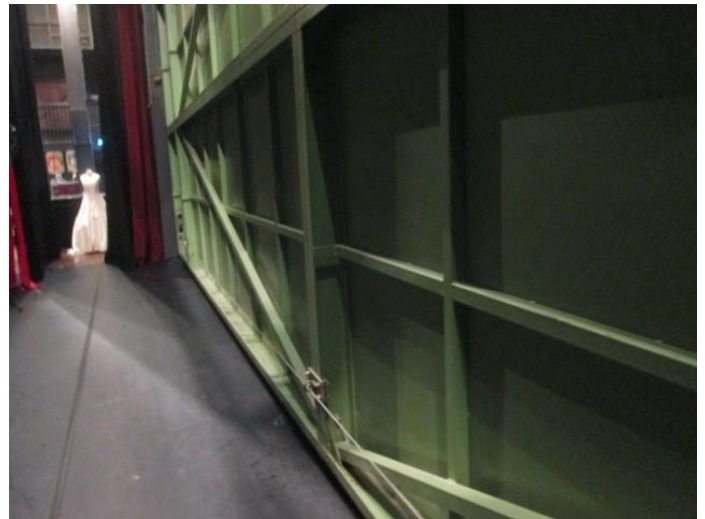
The automatic sprinkler is more installed as a life safety requirement by the local authorities. The stage and audience are separated by a steel self-closing door. The steel door is cooled by the sprinklers above the stage and therefore it is expected that the door will withstand a fire for some time.

A steel shutter between the stage and the audience as fire retardant barrier.

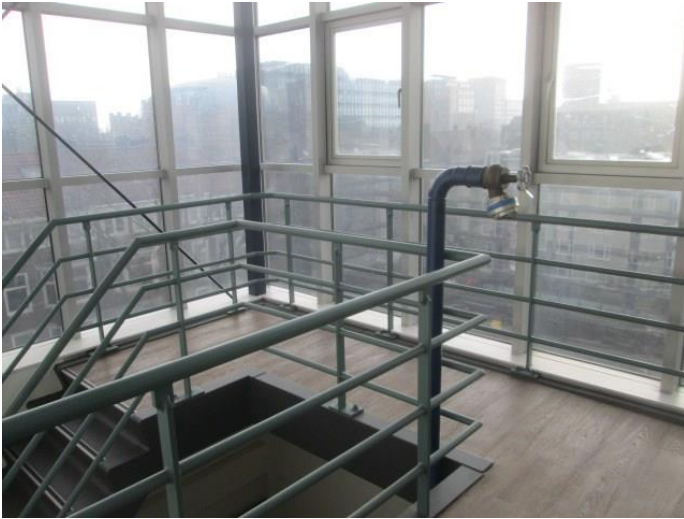
Dry risers in the stairs

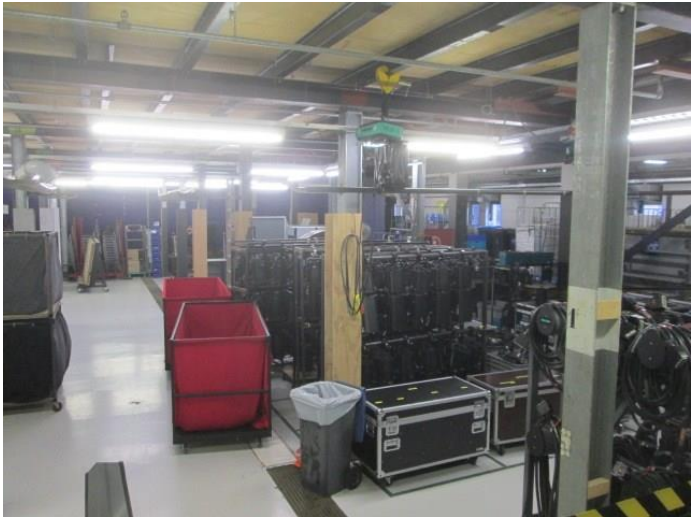
Storage Notes: A small storage facility under the stage with sprinkler protection.

Storage facility under the stage is sprinkler protected.

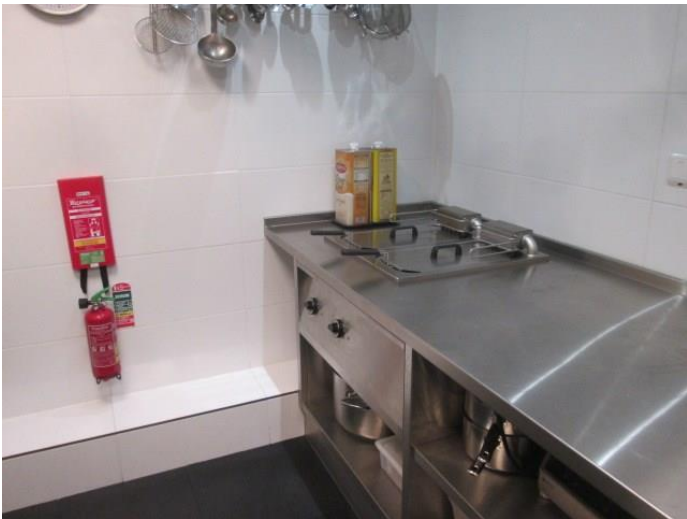
Binnen het theater zijn vele blusapparaten beschikbaar. Tijdens de rondgang is vastgesteld dat nabij frituurinstallaties in de drie verschillende keukens veelal het juiste blusapparaat ontbrak. Dringend wordt geadviseerd in elke keuken minimaal één blusapparaat nabij de frituurinstallatie beschikbaar te hebben die voldoet aan de volgende voorwaarden:

An adequate number of hose reels and extinguishers are installed. Although many F-type extinguishers are present in the building they are often missing in the kitchens with deep fat fryers (see rec.). Fire blankets are present close to the deep fryers.

One of the three kitchens with deep fat fryers

- Het bevat minimaal 6 kg blusmiddel
- Het blusmiddel is een schuimvormend middel
- Het blusapparaat heeft een F-type goedkeur (dat houdt in dat de sproeitraal fijn minder kracht heeft waardoor het blusmiddel op het vet gaat drijven (en daar de zuurstoftoevoer afsluit)

Zoals gebruikelijk dient het blusapparaat jaarlijks gekeurd te worden en het is raadzaam het keuken personeel te trainen in het gebruik van de F-type blusapparaten).

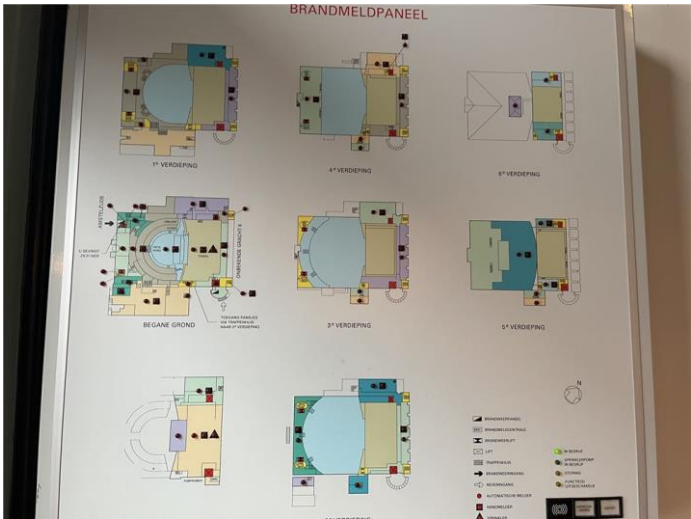
Fire alarm panel
