# Risk Engineering Report

**N.V. VERZEKERINGSBEDRIJF GROOT AMSTERDAM (VGA)**

**Site Name:** GVB Remise Havenstraat

**Survey Type:** Property All Risk - Initial

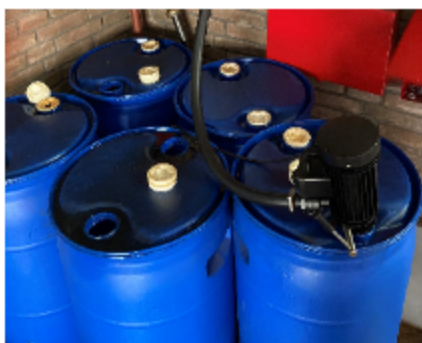
In the sprinkler room are a few storage barrels of diesel oil. According to the guidelines this is not allowed. However, they are in front of a group box. In the event of a calamity, for example a short circuit, this can cause a fire and have a stimulating effect. Place the barrel of diesel oil outside the room.

In Technical Bulletin 77B 'Pump sets for VBB systems' (TB77B) the requirements for fuel are stated in 11.5. 'The quality of the fuel to be used must always comply with EN590. There are now also engines in which fuel can be used that complies with NEN-EN 15940:2016 + A12019 + C1:2019. The fuel tank and any storage tanks must be placed in such a way that they are not exposed to direct sunlight (heating) or other heat sources. It also applies that no unnecessarily large amounts of fuel should be stored (no more than volume used in one year during testing).'

Diesel fuel storage in sprinkler room larger than required

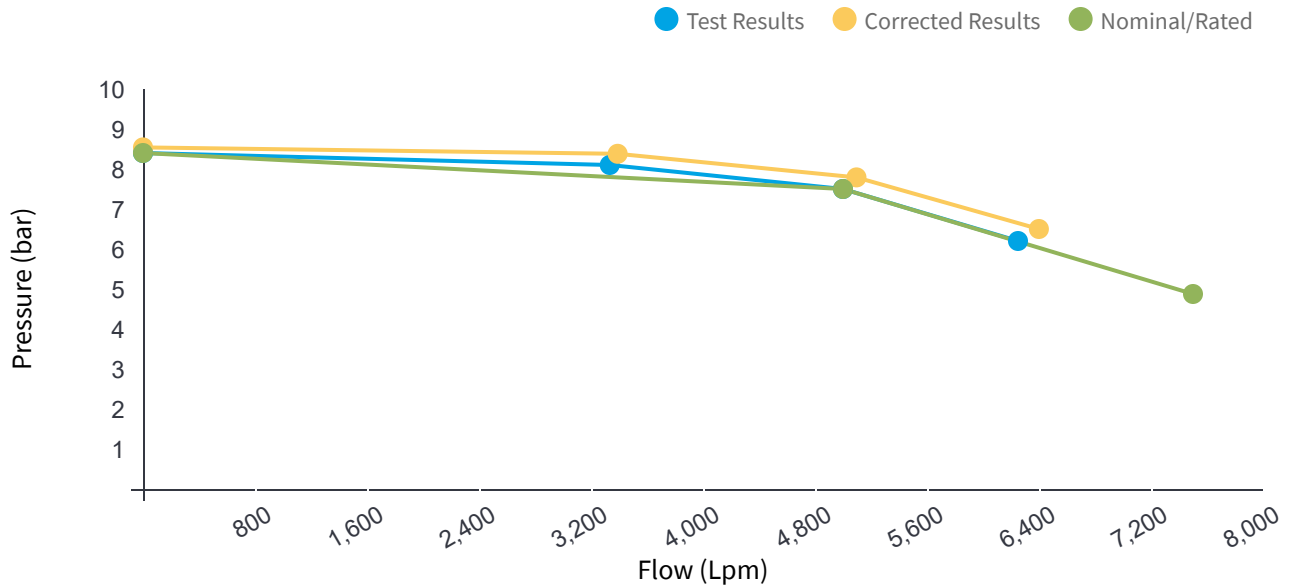
## Fire Pump Diesel #1

The sprinkler water reservoir is below the sprinkler pump room and therefore the pumps have negative suction, which is not desirable for fire fighting purposes as per NFPA 13. However the sprinkler pumps are filled using priming tanks. The total fire water supply has been designed to be in excess of 291 m3 . It has no low water detection alarm.
