# Chubb Risk Control Program

## Property Underwriting Report

Prepared for  
Gemeente Amsterdam  
Barlaeus Gymnasium

Inspection Date: 15 October 2025

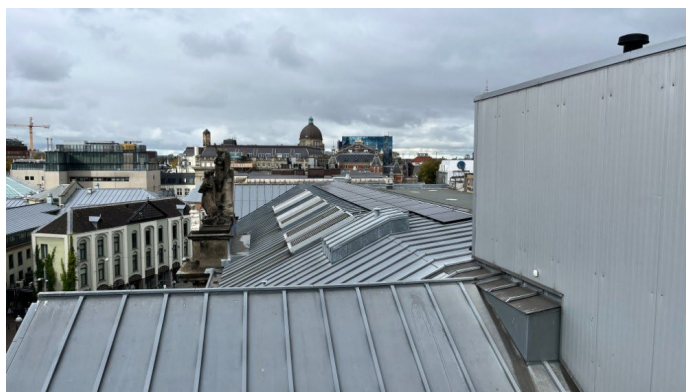
Building No 29, roof

A small number of solar panels is installed on top of the zinc covered roof of building No 29. The system has been inspected per Scope-12.

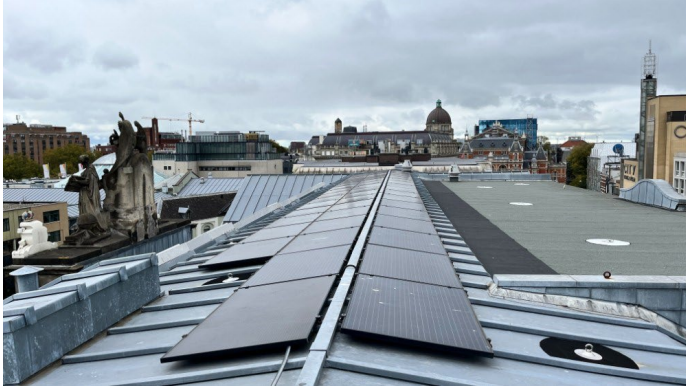
Building No 29, roof

| Windstorm | The zinc roof covering has been replaced in in recent years and appears not susceptible to damages. | |

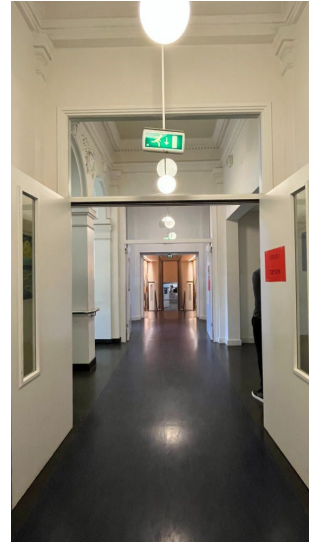
Fire partitions are made of masonry, with doors containing traditional wire-glass. The main partitions have been upgraded to 60', such as the division between building Nos. 29 and 31.

Fire separation (92x 30' fire rated doors) between building Nos 29 and 31

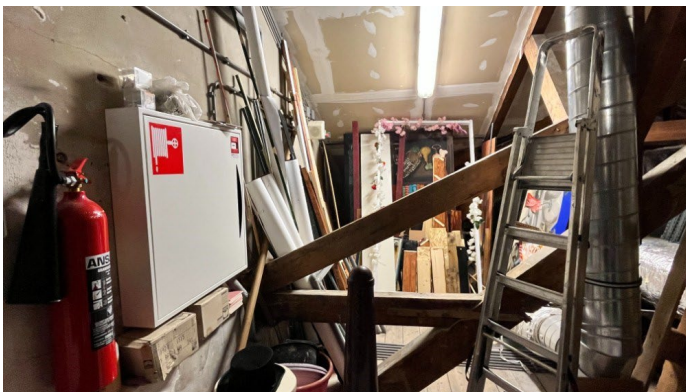
The level of housekeeping is satisfactory, although some storage on the attic is noticed; still reasonable, hence no risk improvement is made.

Attic, used for some storage. Note the fire extinguisher, hose reel and fire alarm button.

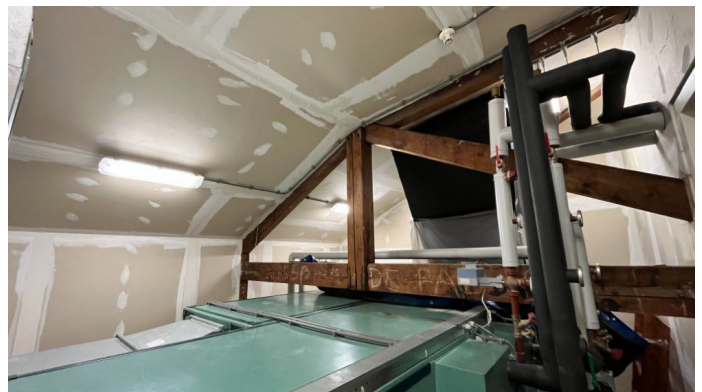
HVAC room; smoke detection fitted here

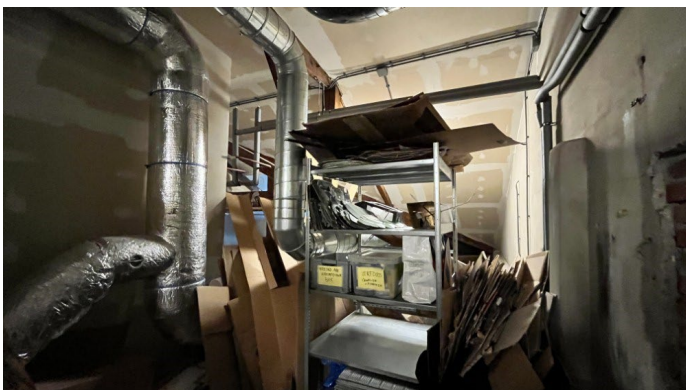
**Hazards & Exposures:** The attic of the building has a very combustible wooden structure, which is difficult for the fire brigade to reach. The attic floor is partly used for technical installations and some storage.

Attic used for some storage

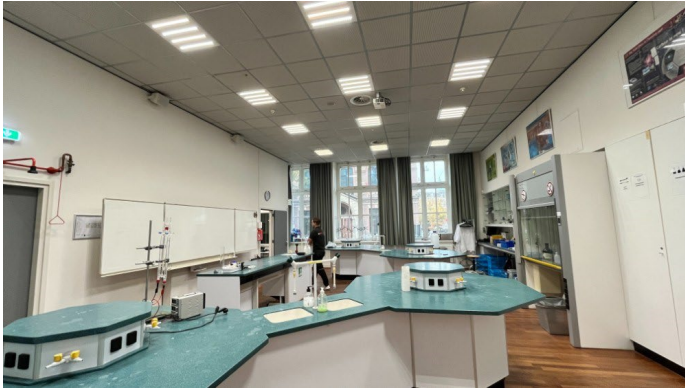
Labs where flammable liquids and natural gas are used are fitted with emergency stops with interlock to the supply. Flammable liquids are used only in very low quantities and are stored in approved safety cabinets.

Chemistry classroom

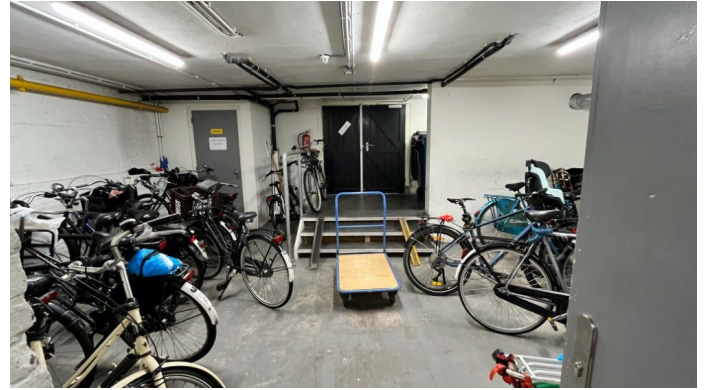
E-mobility / E-bike batteries: Barlaeus Gymnasium has a policy in place, where it is not allowed to bring in e-bike batteries inside the school building.

Bicycle parking in the basement
