# Chubb Risk Control Program

## Property Underwriting Report

Prepared for  
Gemeente Amsterdam  
Nicolaas Maesstraat 1  
1071 XL Amsterdam  
Netherlands

Inspection Date: 15 October 2025

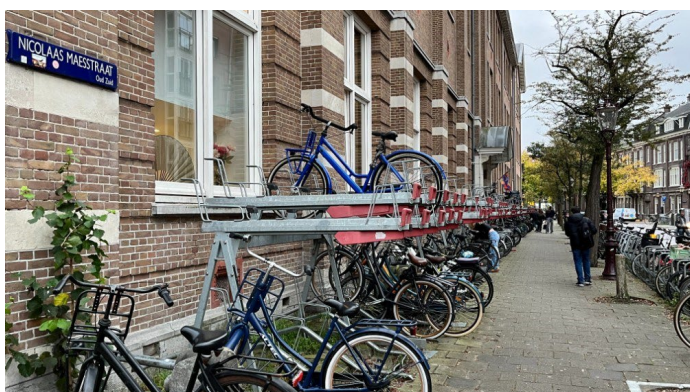
Nicolaas Maesstraat, temporary bicycle parking outside Pieter de Hoochstraat - new extension under construction

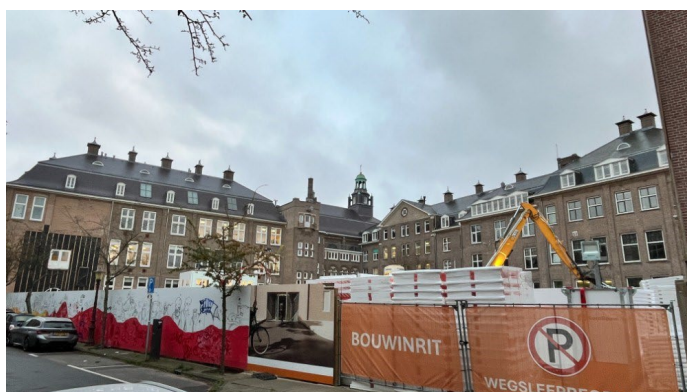
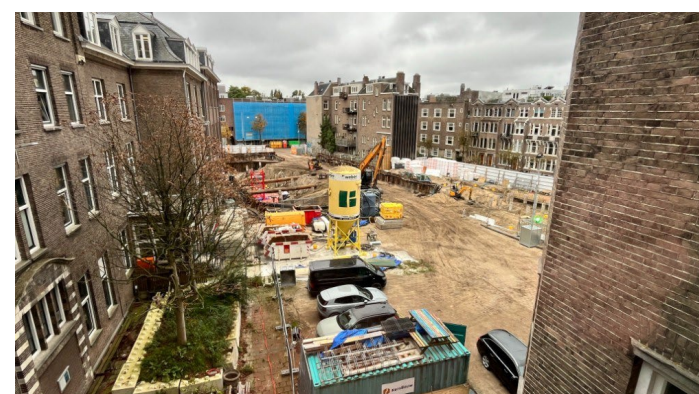
New extension (right) under construction

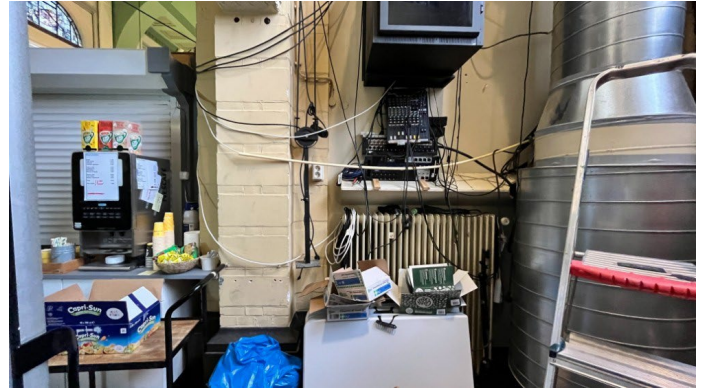
At few places, extension cords and domestic type multiplier sockets are used for permanent power connections, which if overloaded, may overheat and cause fire. A risk improvement is made for corrective action.

Electric extension cords and distribution blocks are used in the kitchen and theatre stage, introducing a fire hazard when these are overloaded. See risk improvement,

Kitchen of the lunchroom - substandard electrical connections; see risk improvement

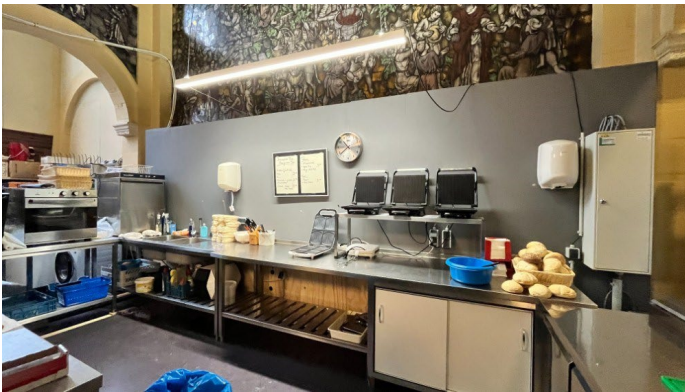
Kitchen of the lunchroom - substandard electrical connections; see risk improvement

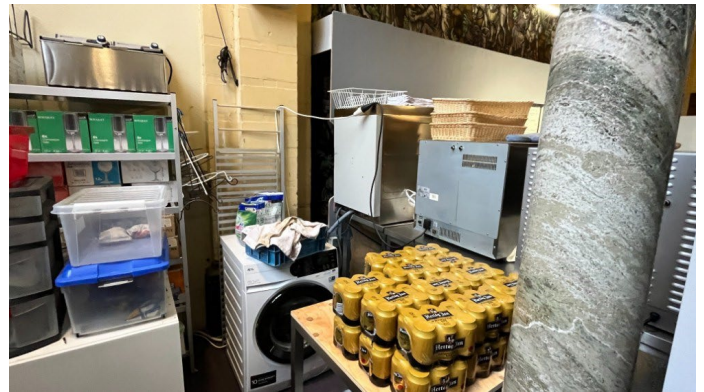
Kitchen of the lunchroom - substandard electrical connections; see risk improvement

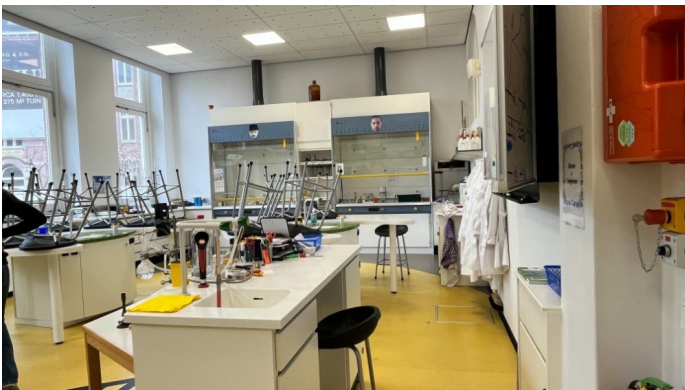
Labs where flammable liquids and natural gas are used are fitted with emergency stops with interlock to the supply. Flammable liquids are used only in very low quantities and are stored in approved safety cabinets.

One of the chemistry classrooms; note the emergency stop button (far right) cutting off supplies

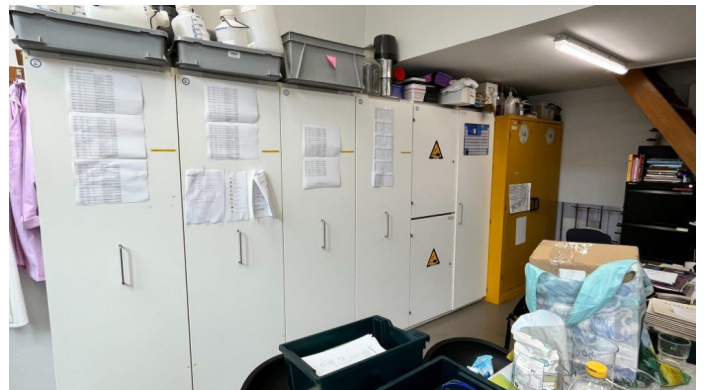
Flammable liquids stored in an approved 30' safety cabinet (yellow) with mechanical extract ventilation

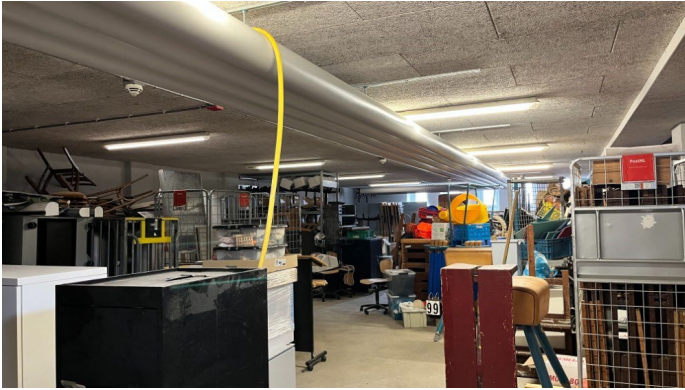
| Storage Notes: | part of the basement is in use for the storage of a variety of goods, including spare parts, excess furniture etc.<br>There are no direct ignition sources. |

Storage of excess furniture and other materials in the basement

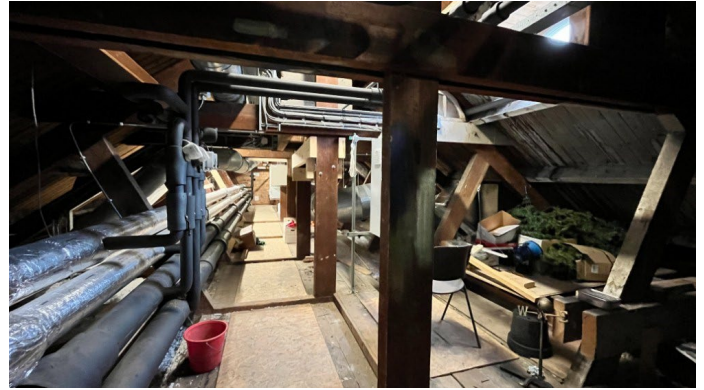
**Hazards & Exposures:** The attic of the building has a very combustible wooden structure, which is difficult for the fire brigade to reach. The attic floor is partly used for technical installations and archives.

Especially the wooden attics would certainly benefit from sprinkler protection, however this will not be considered.

Attic - technical systems and some storage

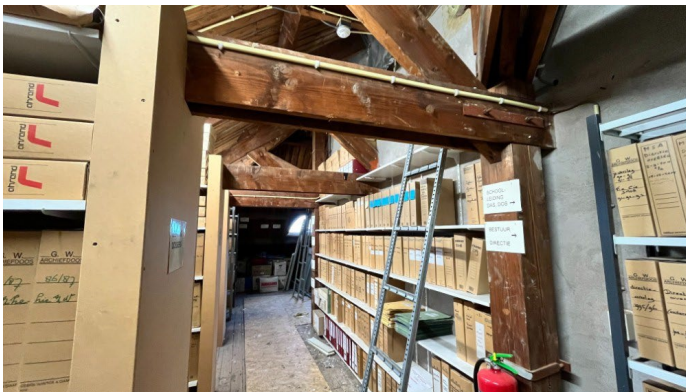
Attic - paper archives
