## Starterskit: Ortho Image Quality References

This document contains imagery references that can be used as examples of the ICC quality requirements in the tender document. These images are examples of the received **ortho** product with a **4cm resolution**. Thus, these images are to be used as examples for **Parcel 1,2 and 4**. For parcel 3 (8,5cm resolution) the same examples are used with the comment that sharpness and details are of a slightly lower level. The scope of these 4-cm examples naturally also applies to the 8.5 cm images.

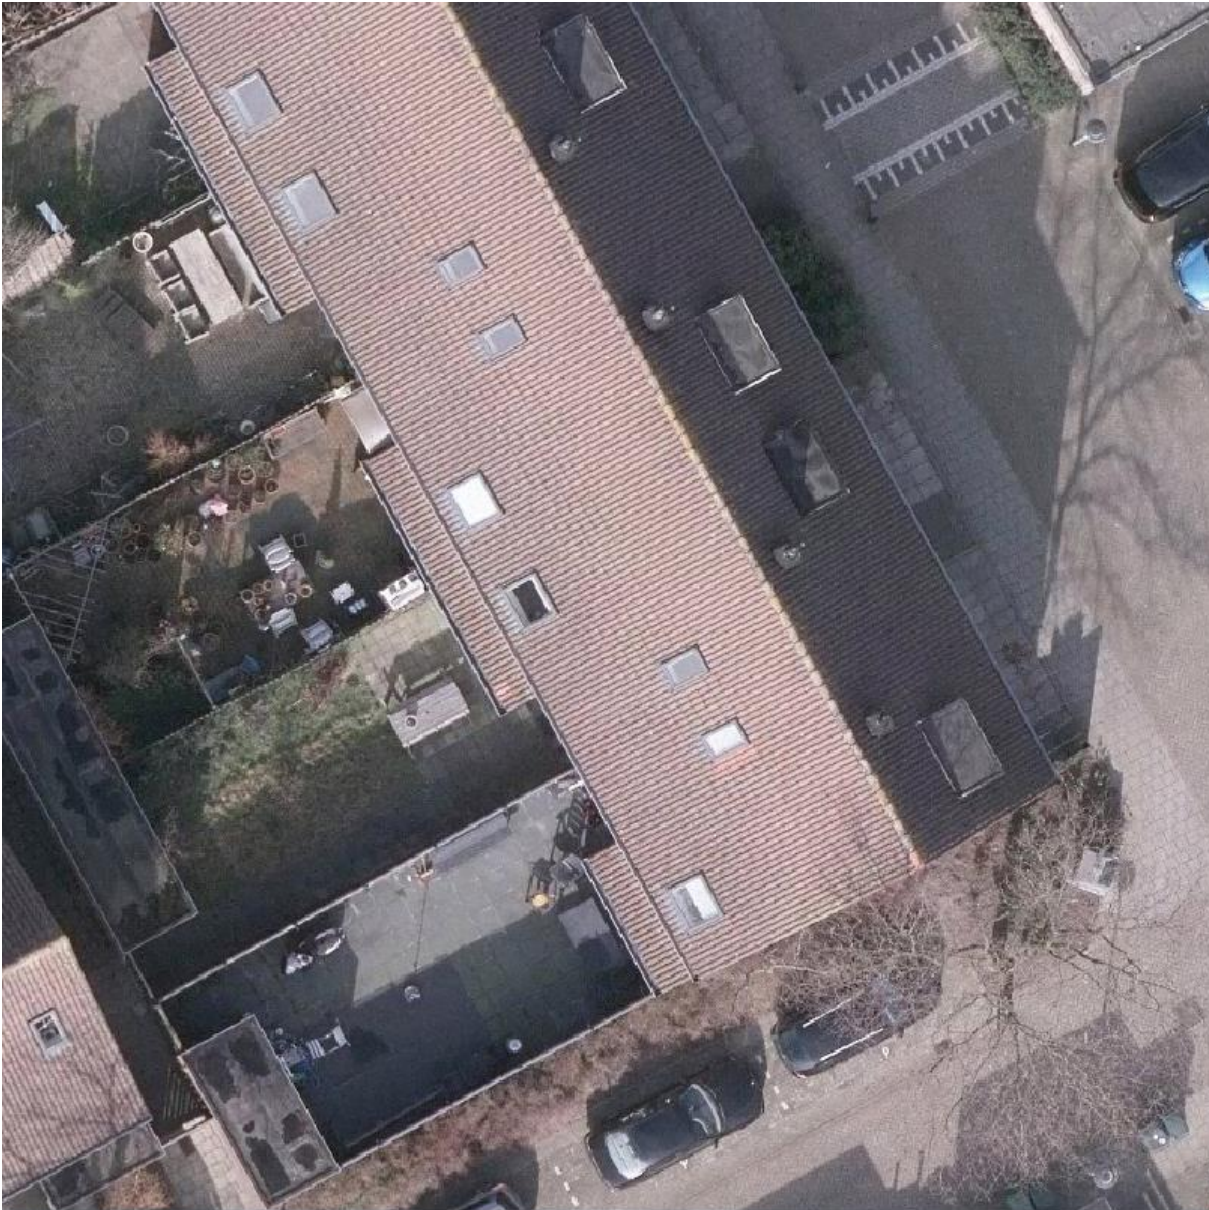
### Image Reference 1

Accepted sunlit image

- Minimal effect of shadows
- Visibility of small tiles (to a lesser extent for the case in parcel 3)
- No bright/blooming effect of white objects
- Quality is comparable to stereo imagery

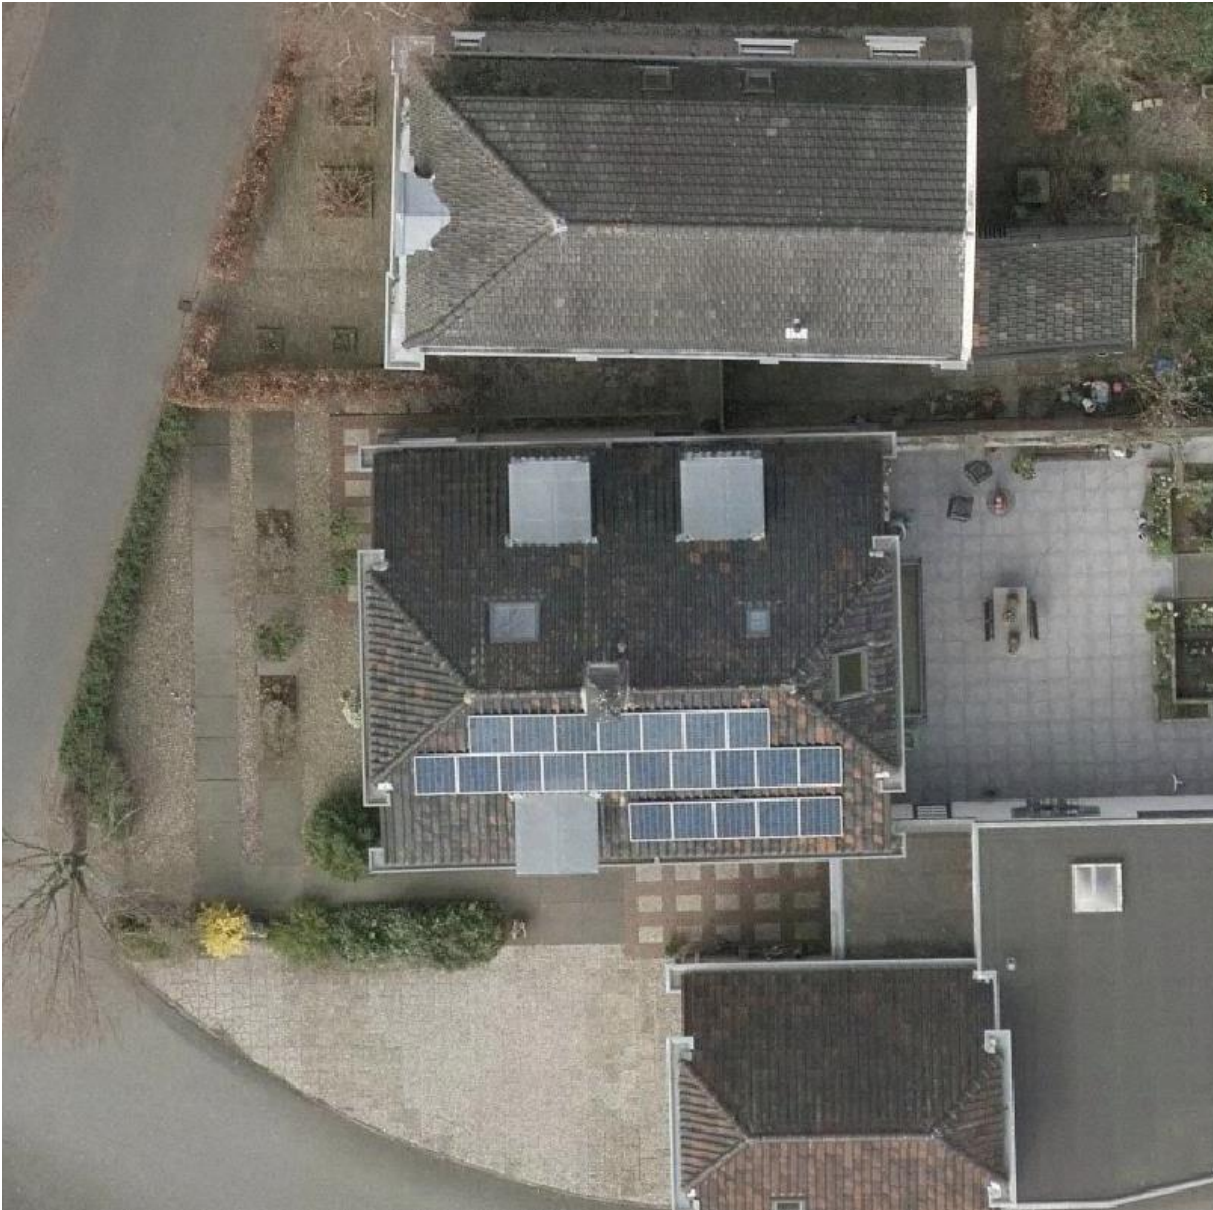
## Image Reference 2

Accepted overcast image

- Clarity in the shadows
- Visibility of small tiles (to a lesser extent for the case in parcel 3)
- No pixilation due to darker conditions
- Homogenous colouration
- Quality is comparable to stereo imagery

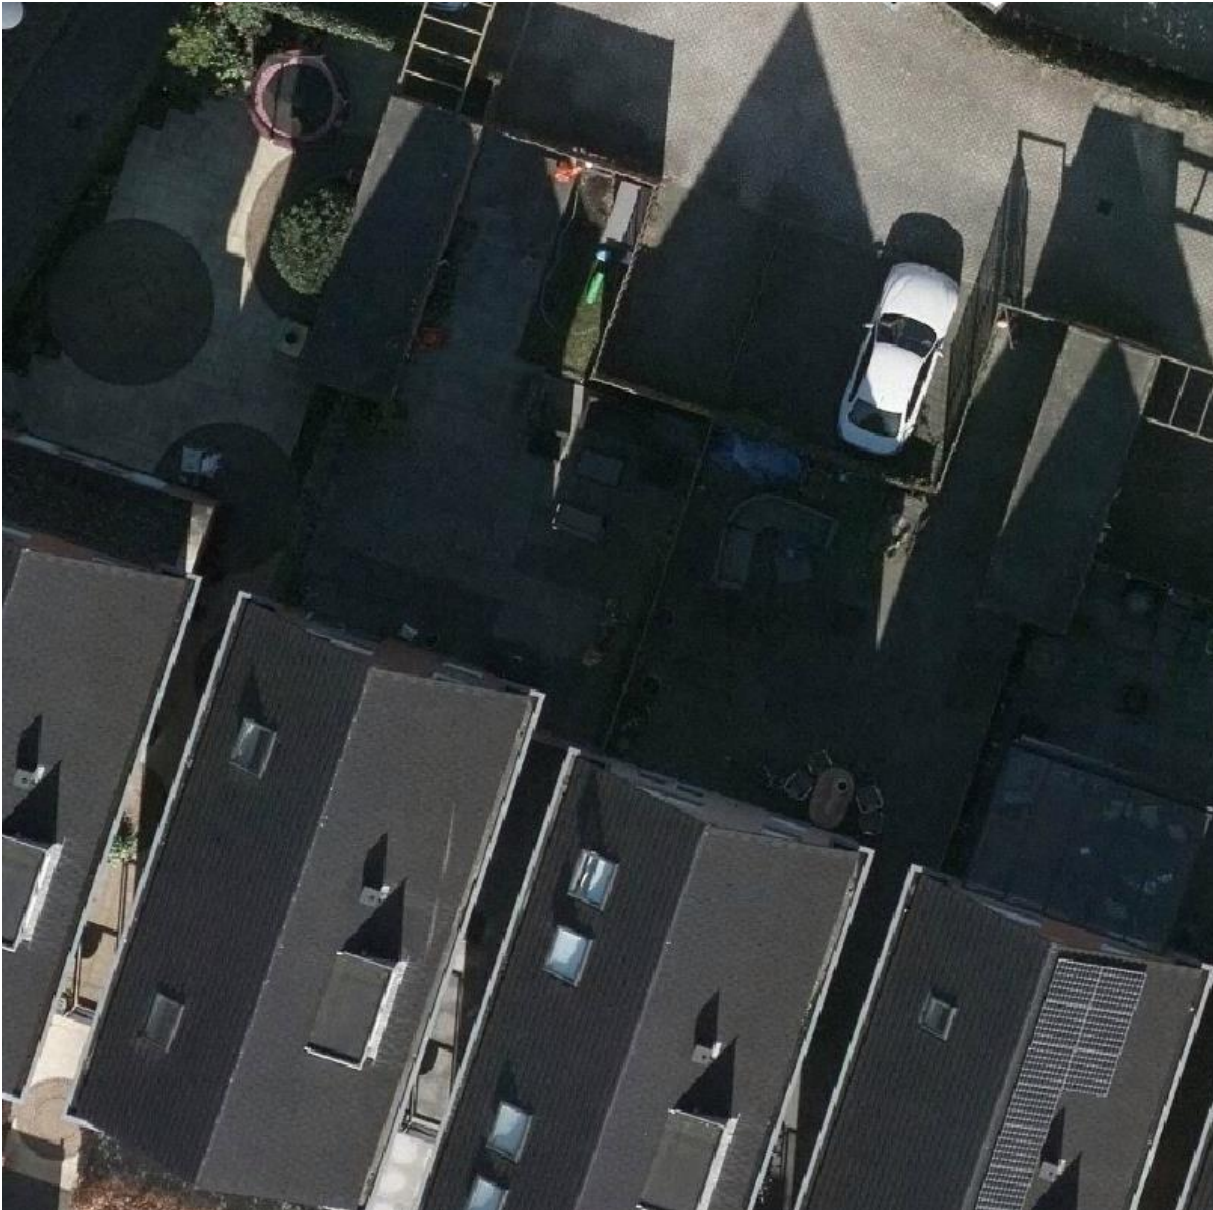
### Image Reference 3

Sample of image was discussed regarding the very low visibility in dark shadows.

- Difficult to see the objects in the shadows;
- Cannot determine boundaries of garden;
- Sharpness is good.

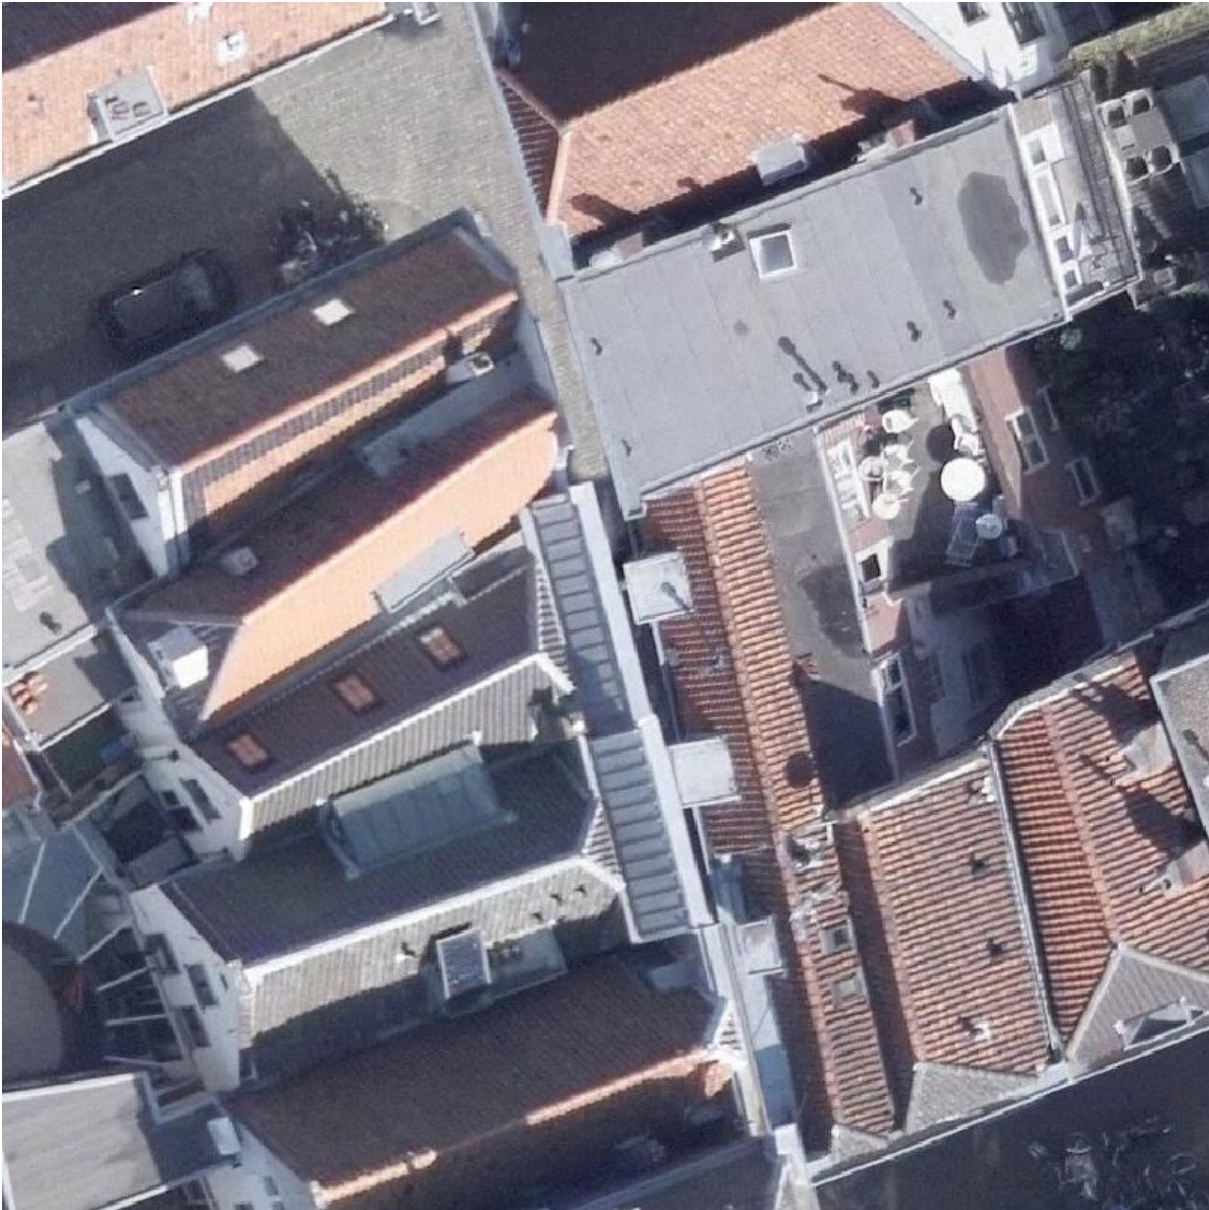
### Image Reference 4

Rejected image due to seamline issues.

- Buildings are overlapping the street and other buildings;
- Cannot accurately identify building footprints;
- Cannot accurately identify street location.

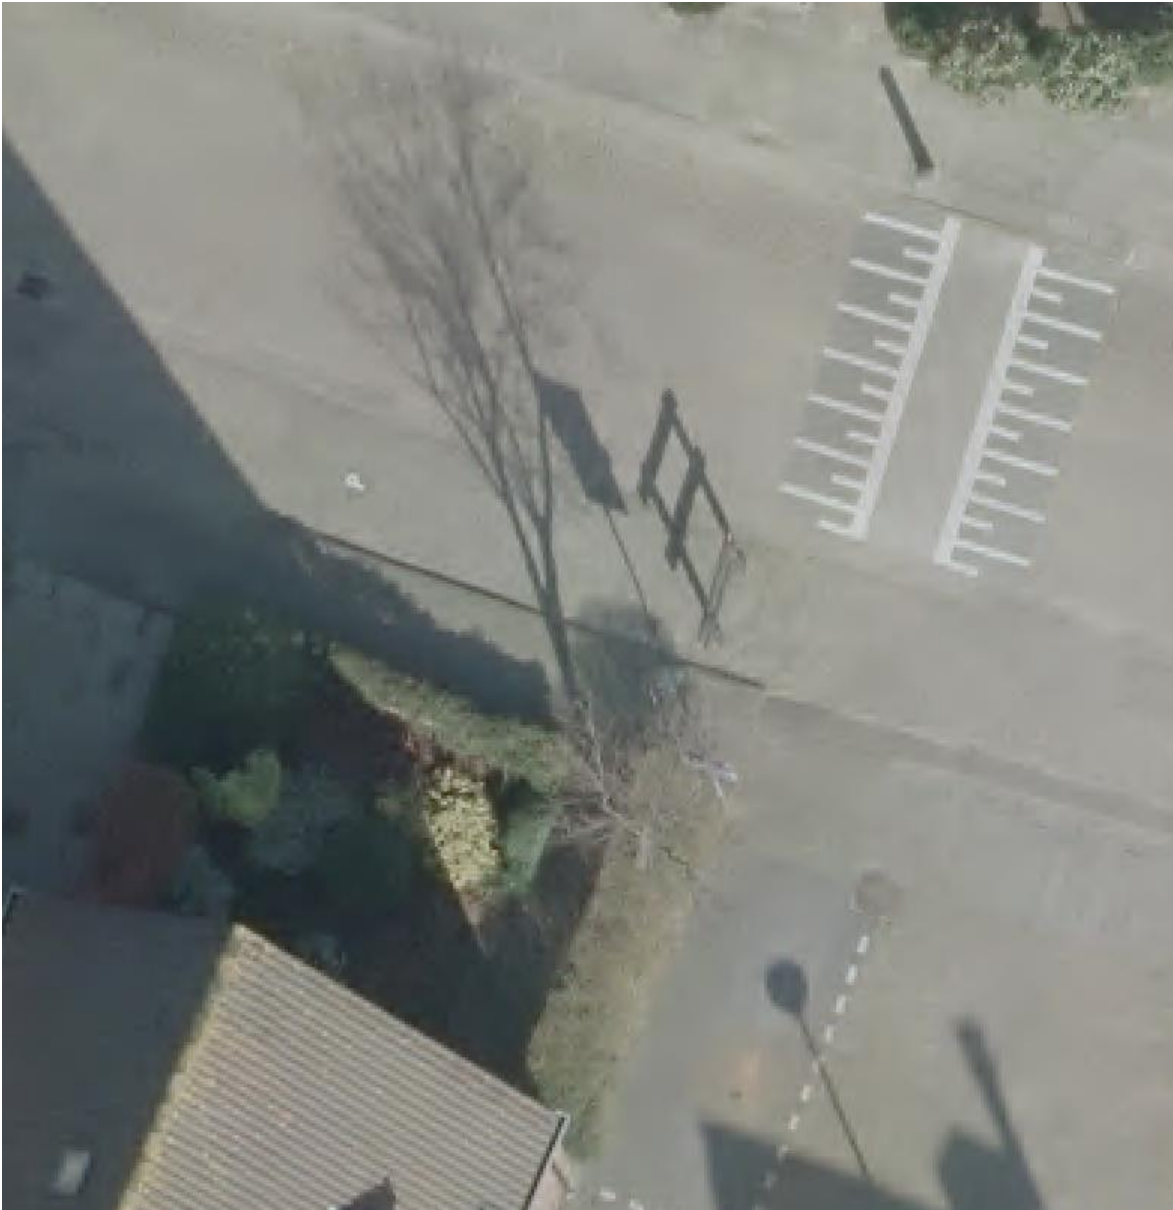
### Image Reference 5a

Rejected part of an ortho photo mosaic due to quality loss during processing (see also sample 5b).

- Zoom level adjusted to 1:95;
- Road tiles are not visible;
- Quality has been lost during ortho processing, see reference stereo below.

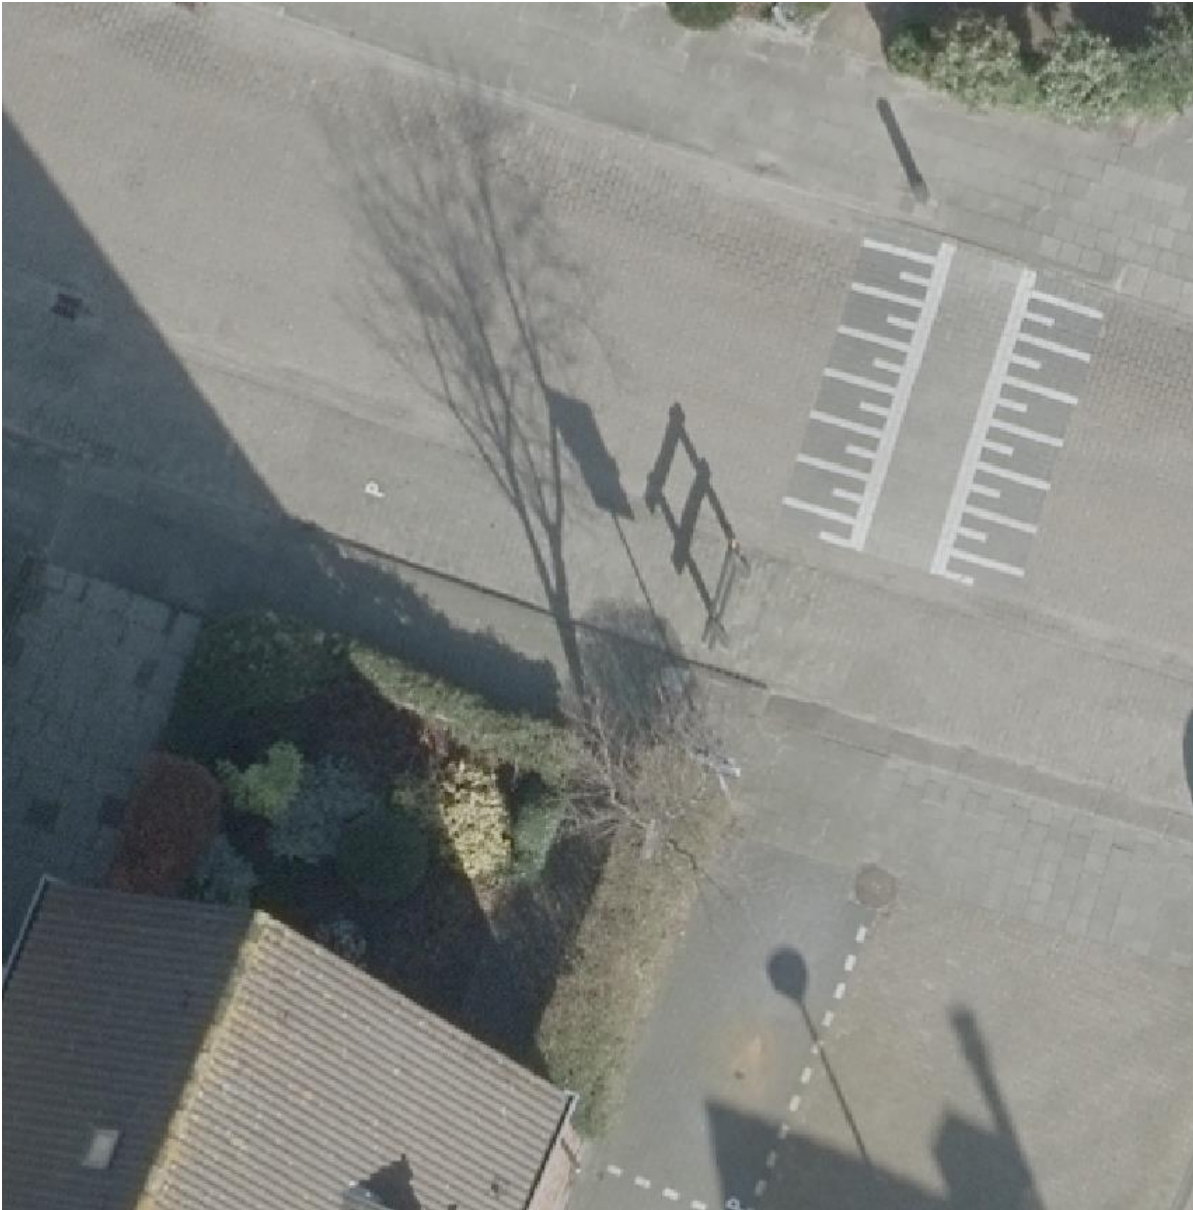
### Image Reference 5b

Reference stereo image for Image 5a

- Road tiles are visible;
- Very sharp image has been acquired in stereo phase, this is not reflected in the ortho.

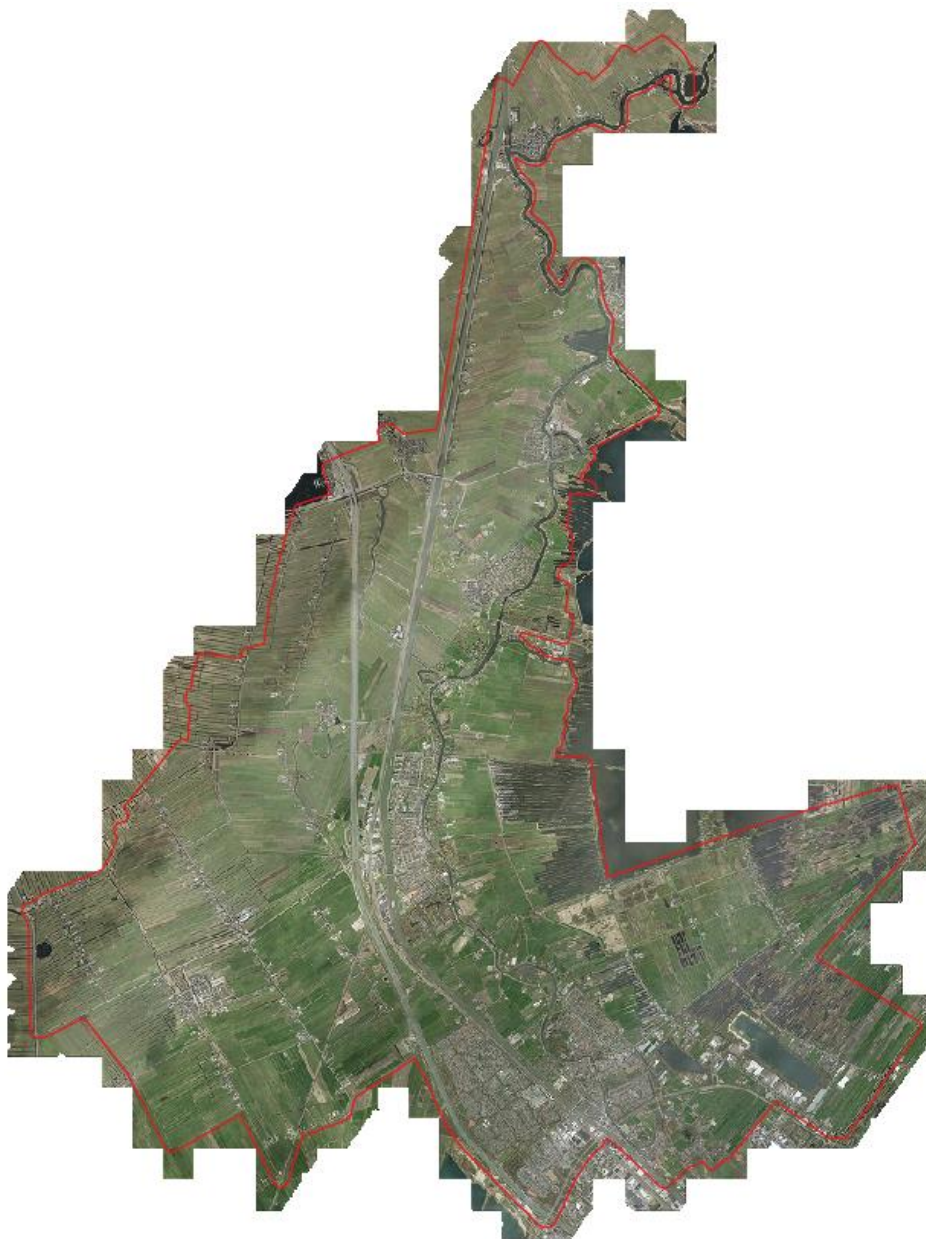
### Image Reference 6

Rejected ortho mosaic due to colour heterogeneity/differences across flightlines.

- Zoom level adjusted to show whole municipality;
- Sharp colour heterogeneity visible across municipality.

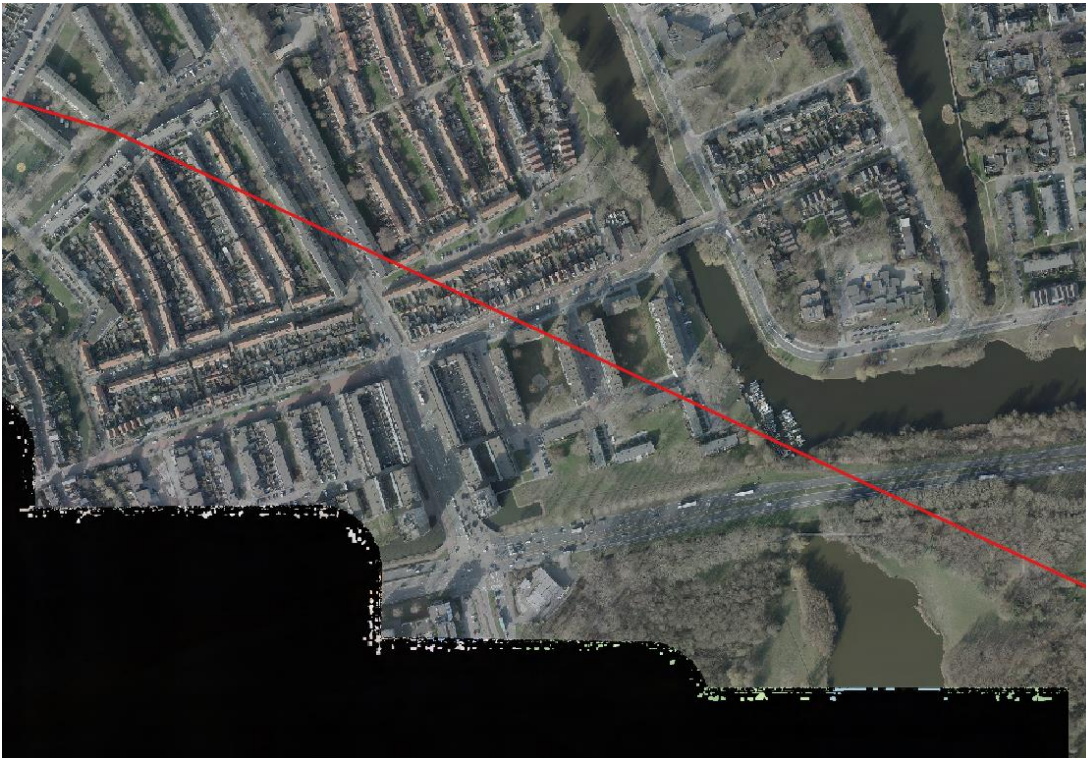
### Image Reference 7

Rejected ortho mosaic due to processing issue regarding transparency e.g. speckled borders.

- The product from the processing resulted in only partially transparent borders.
