Rosmalen \_\_\_\_\_ 2

VV RKKSv \_\_\_\_\_ 2

### Objectinformatie

| <b>Objectnr.</b> | 04 |

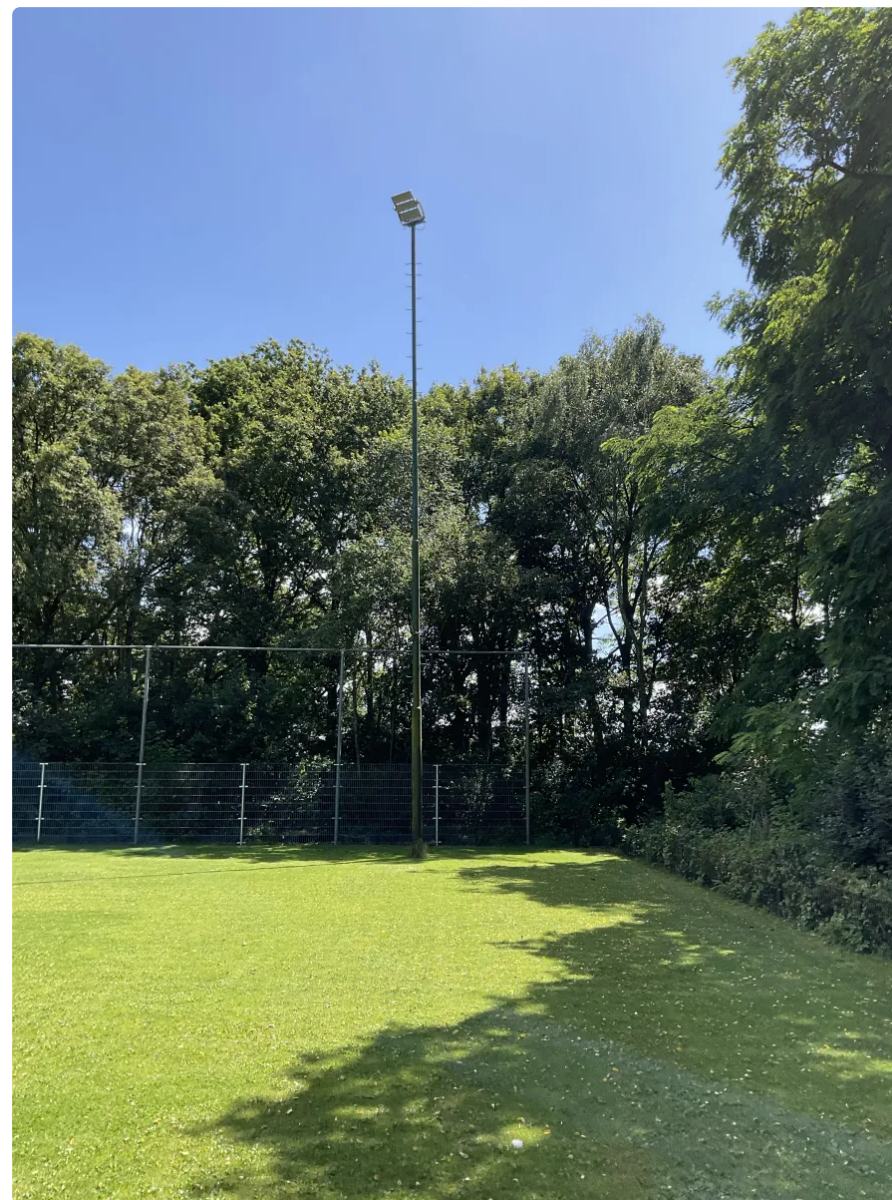
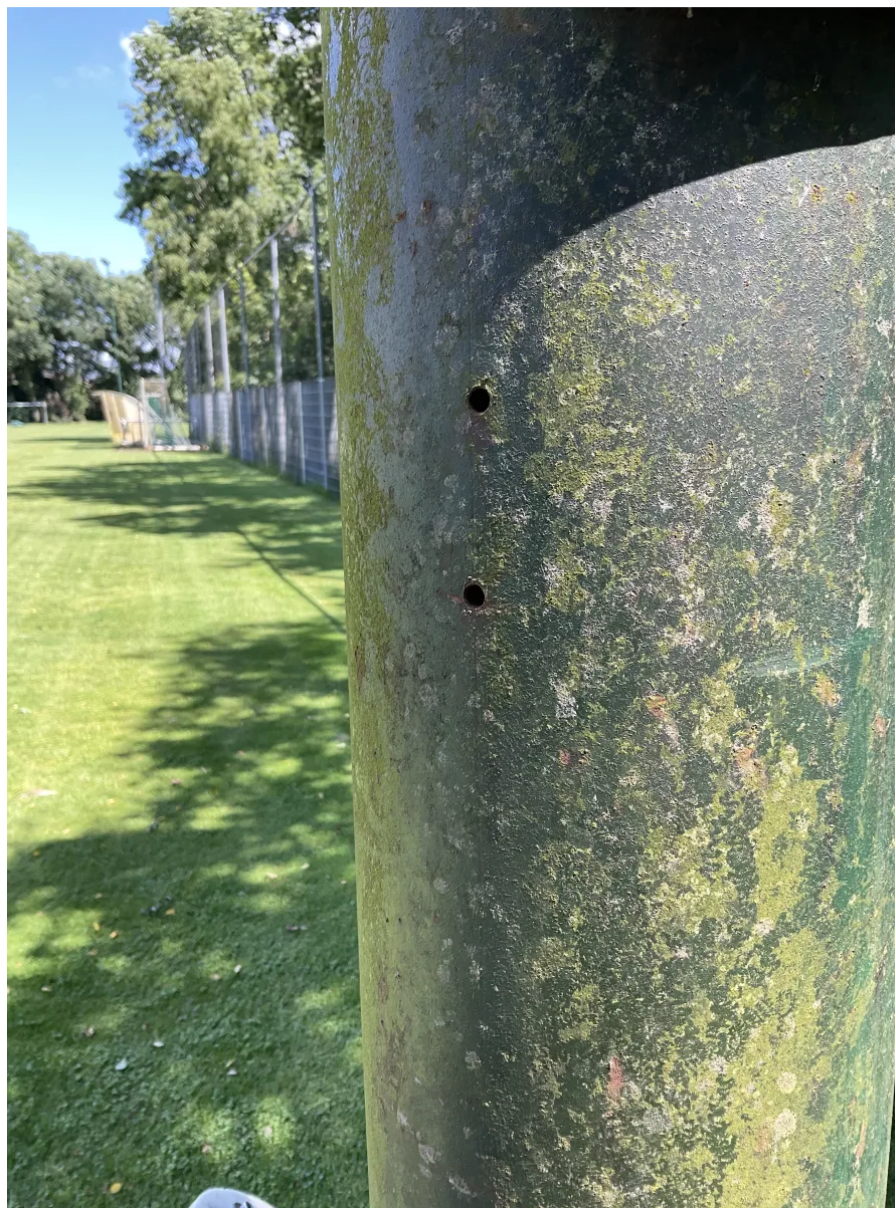
| <b>Reden</b> | 1. Ernstige corrosie -<br>gehele object |

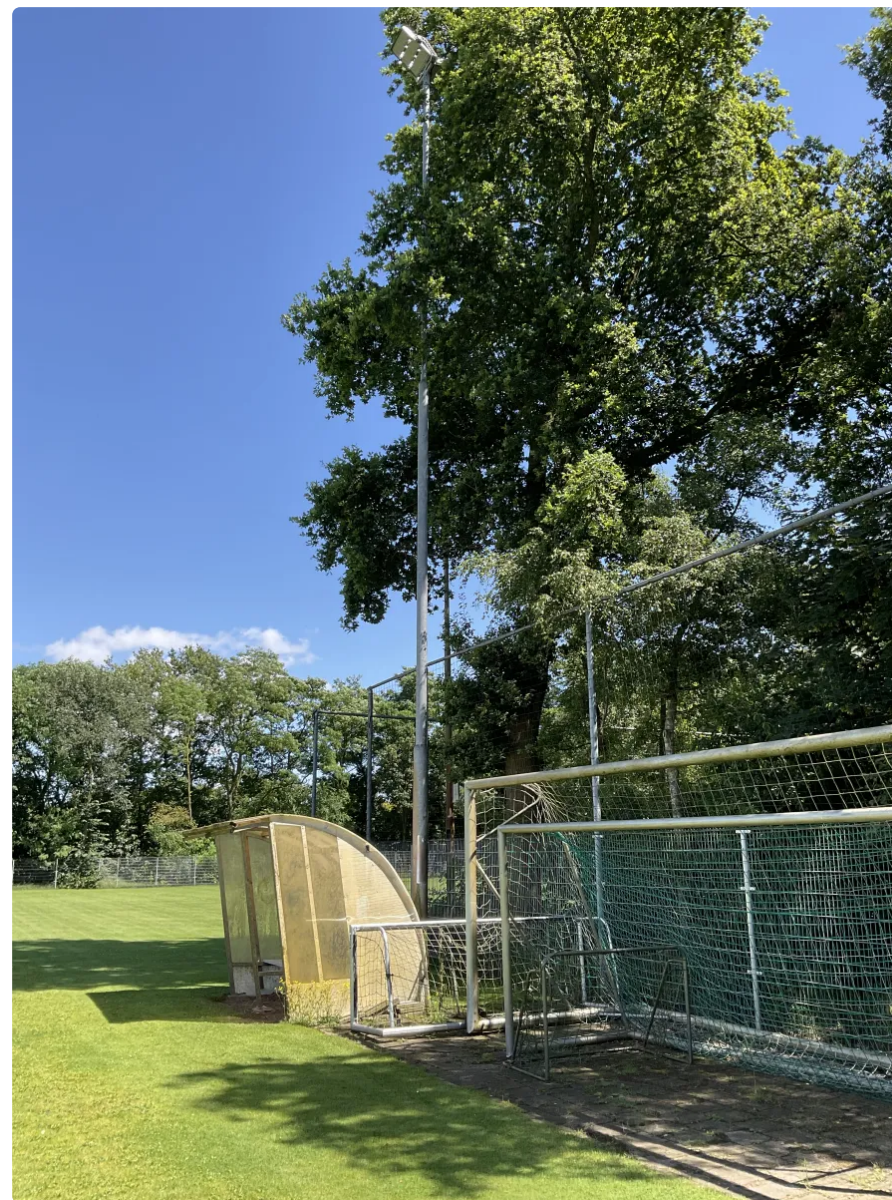
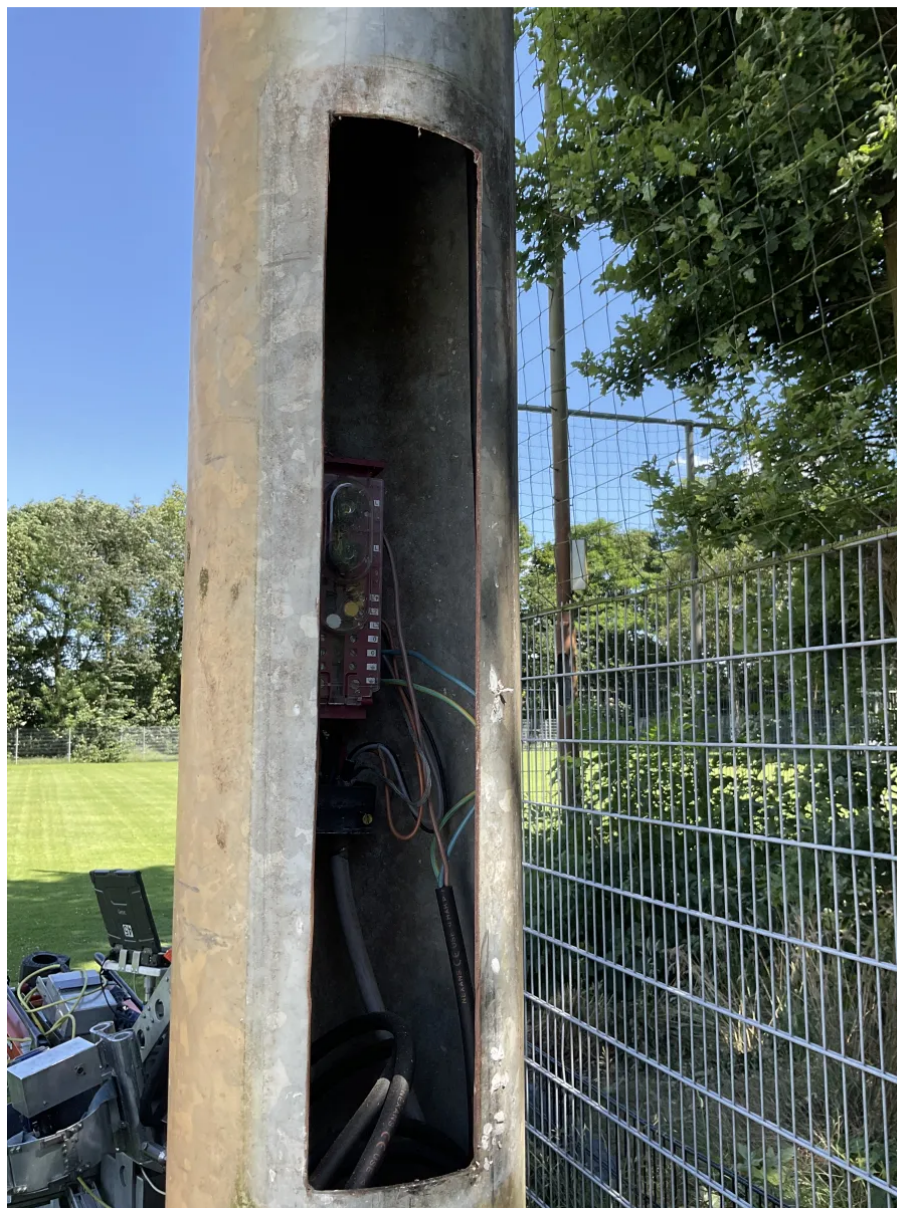
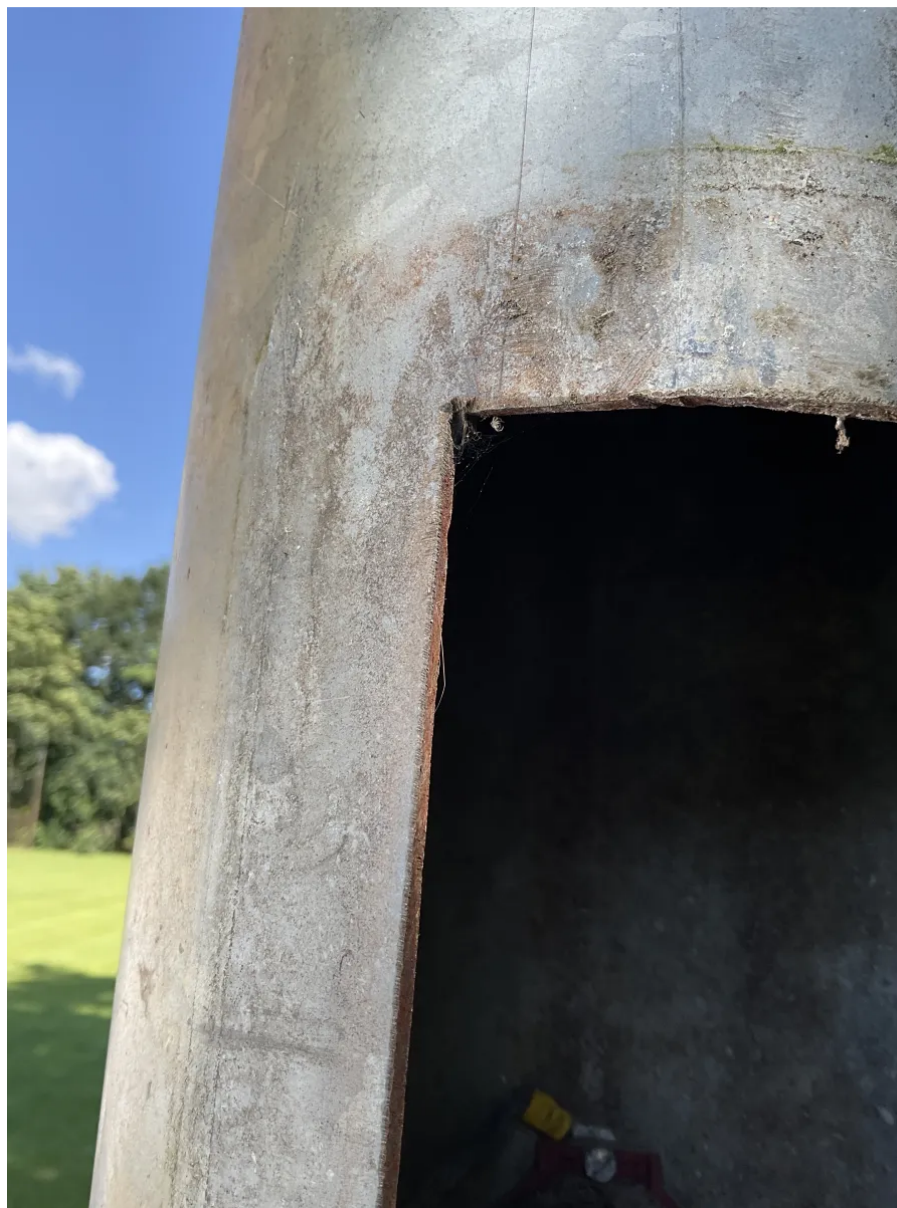
**Objectnr.** 05

1. Corrosie - 1e verjonging
2. Corrosie - 2e verjonging
3. Geslepen kabelgat(en)

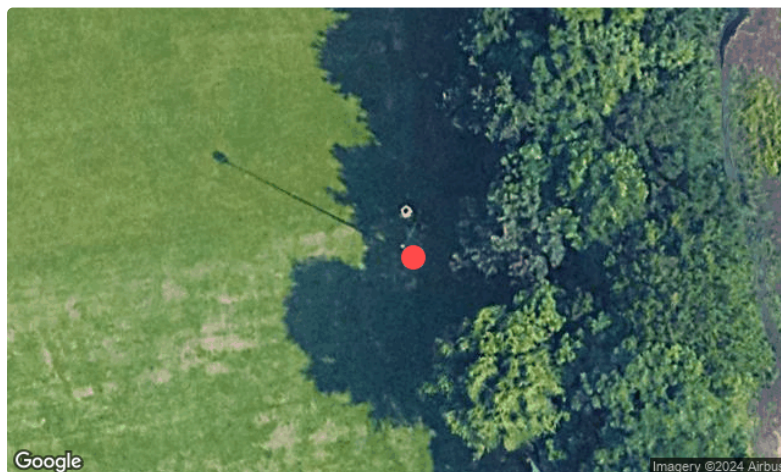
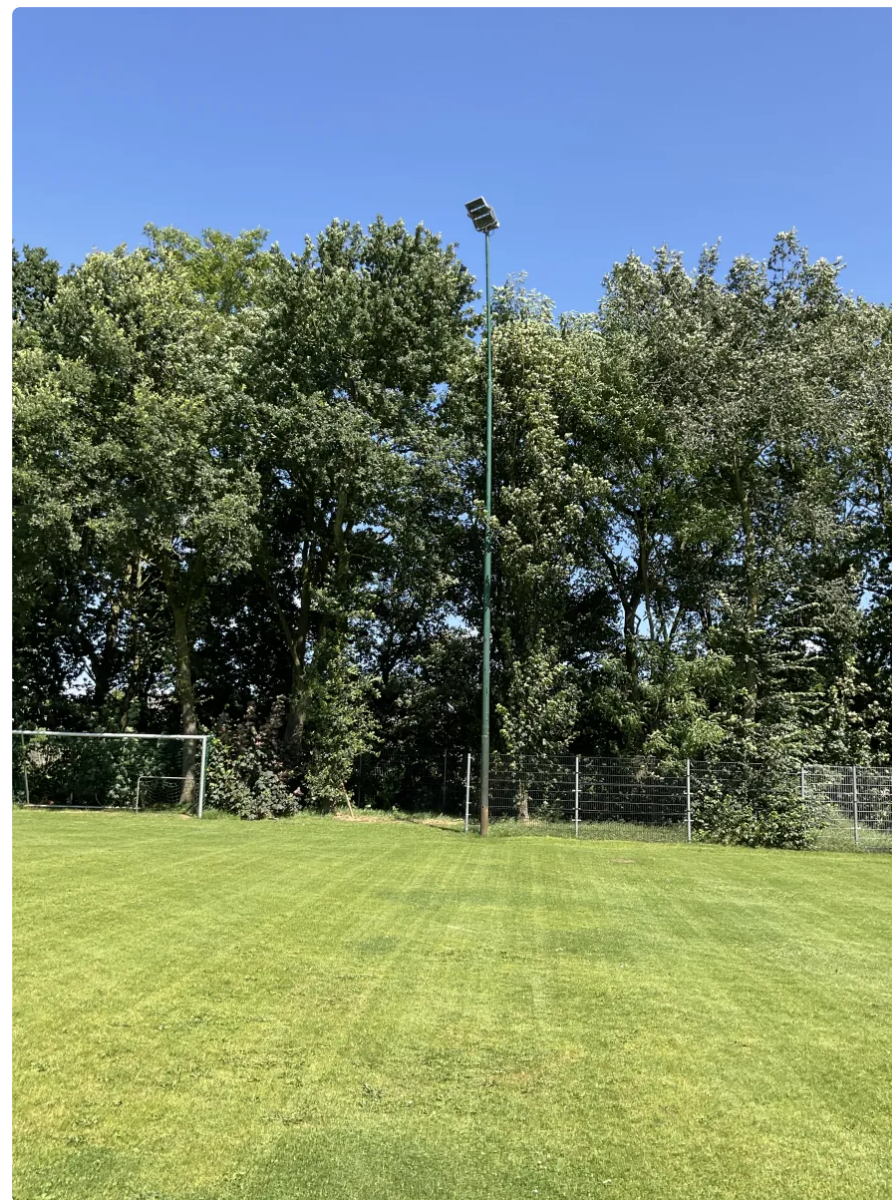
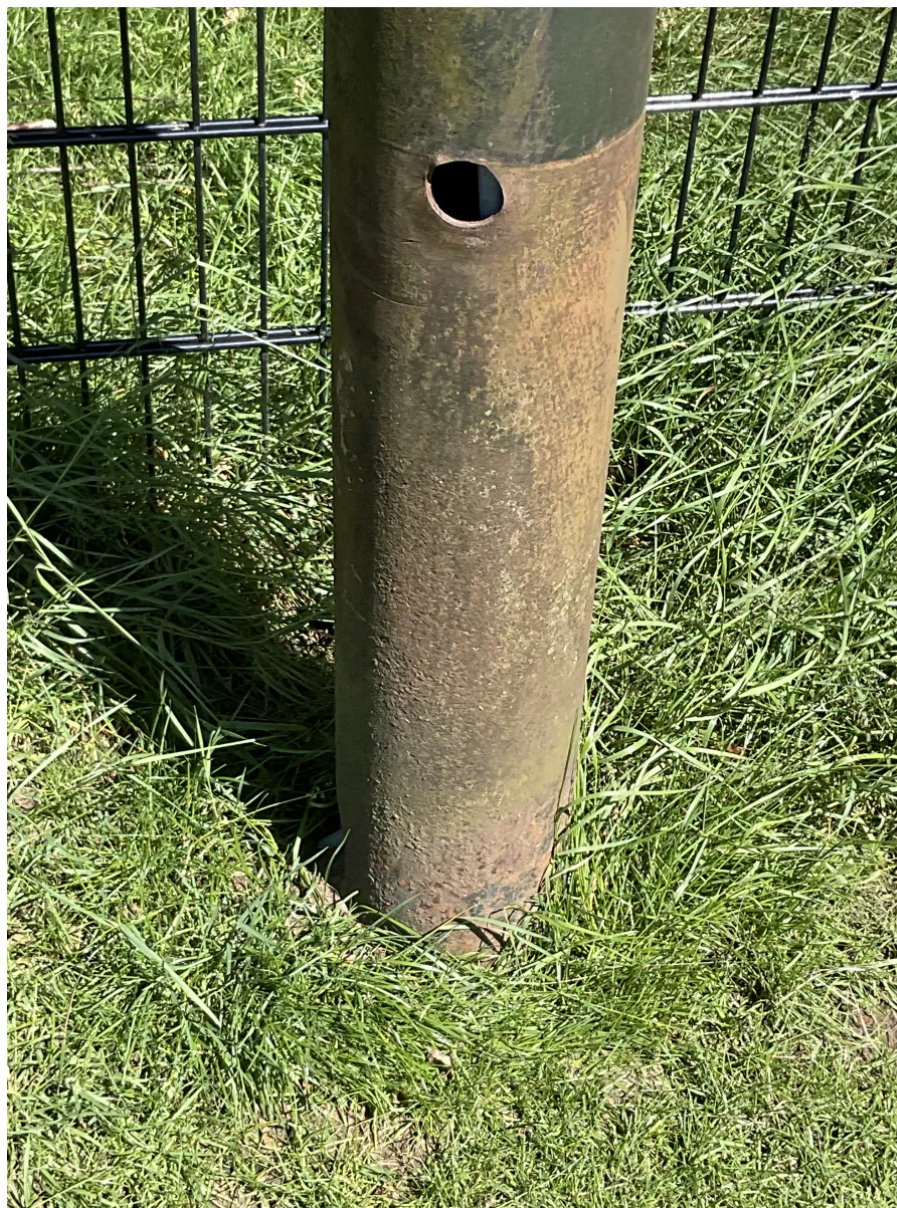
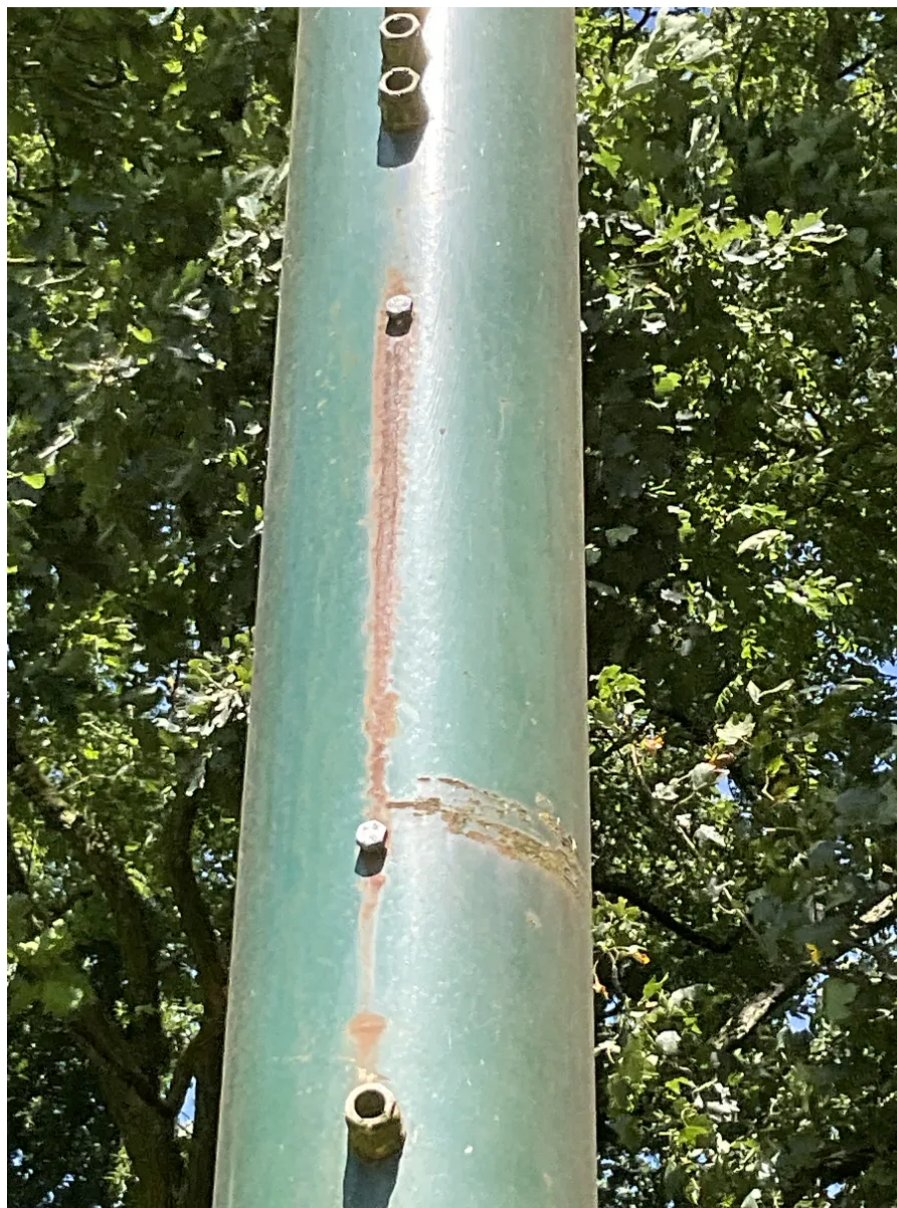
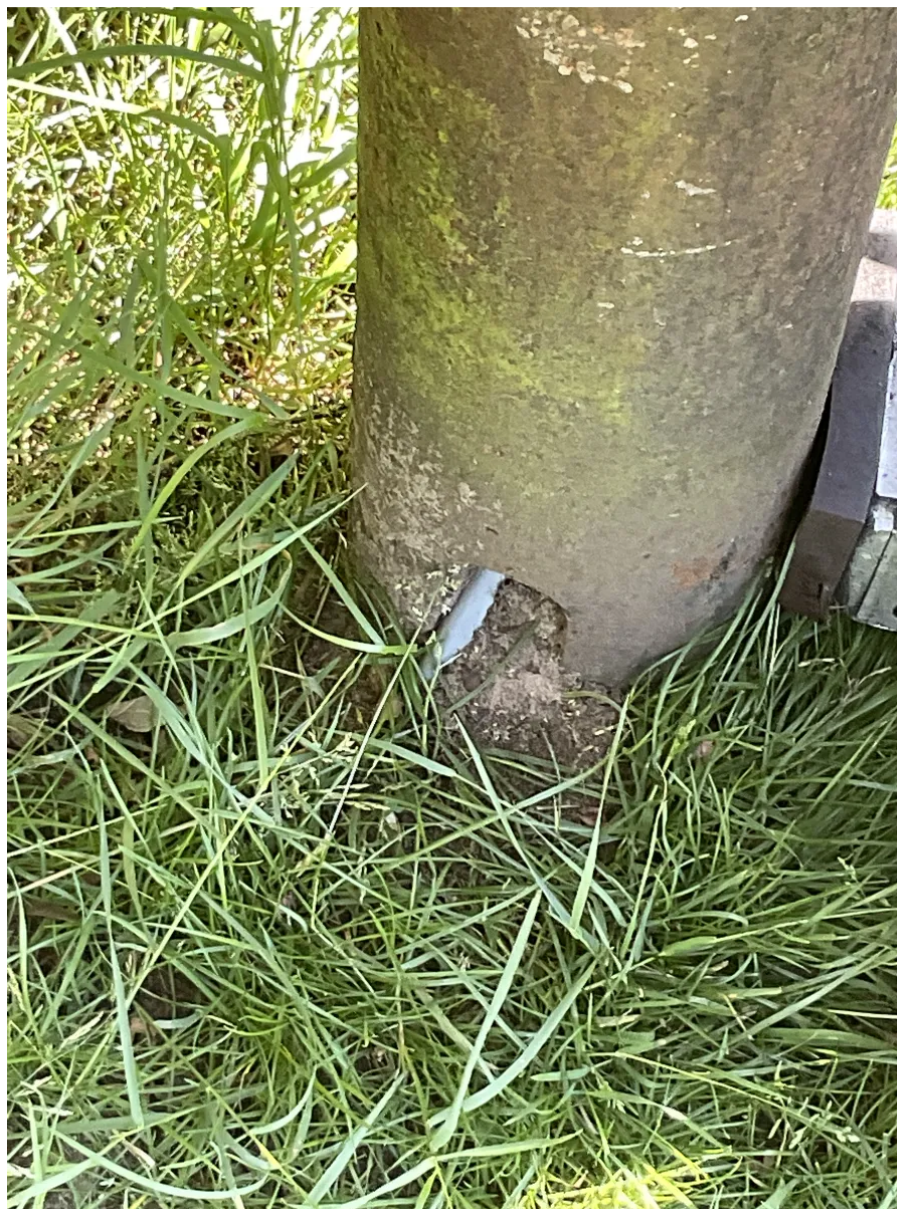
| <b>Objectnr.</b> | 06 |

| <b>Reden</b> | 1. Ernstige corrosie -<br>gehele object<br>2. Geslepen kabelgat(en) |
