## COPE Report

Alexander Numand / LSI

Yalelaan 40-60-62, Utrecht

date of visit 22/04/2024

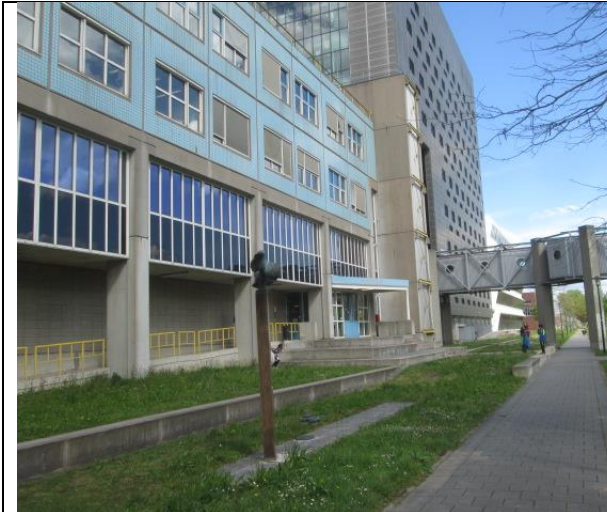
Left Nieuw Gildestein and at the rear Alexander Numan and LSI buildings including the bridge to Androclus)

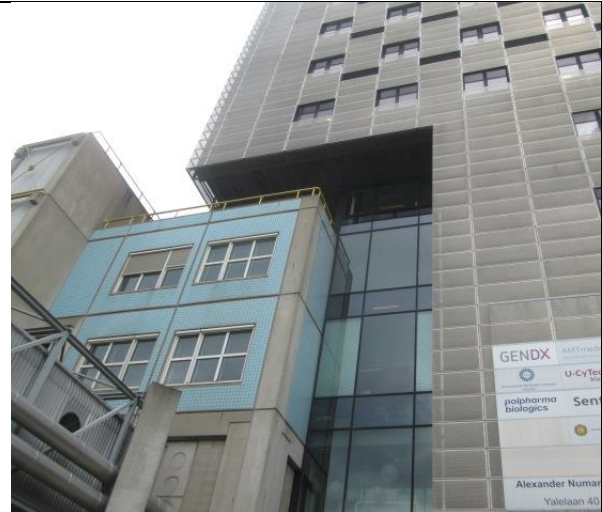
Alexander Numan (right) building is partly constructed over Nieuw Gildestein (left).

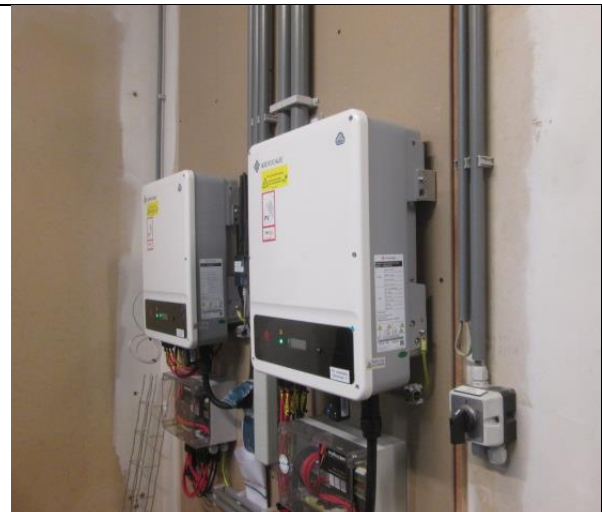
The inverters in the utility room at the top floor

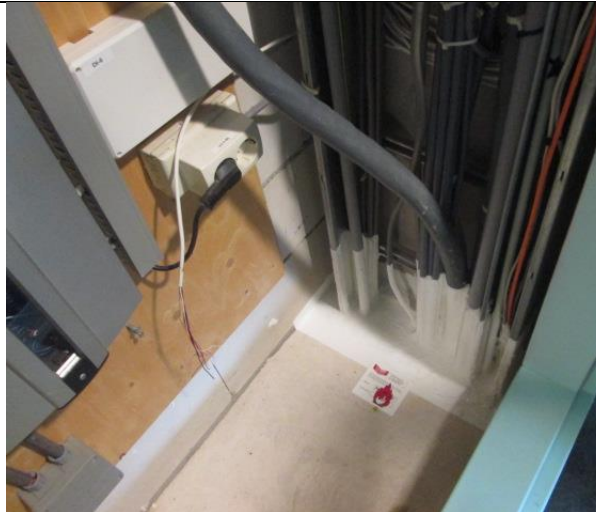
Fire hazards: The fire hazards are limited to the electrical installation and the research in laboratories. In general the test in the laboratories are small scale and there are some endurance testing. The laboratories are equipped in the Alexander Numan building with fire detection and in the LSI building with automatic sprinklers. The supervision of housekeeping and safe working is done by the university and regarding the overall housekeeping and procedures during the survey this is adequately controlled. The electrical installation is checked in accordance with the local standards NEN 3140 including infrared scanning. The cable penetrations are properly sealed off by a specialized contractor.

Adequately sealed off cable penetrations.

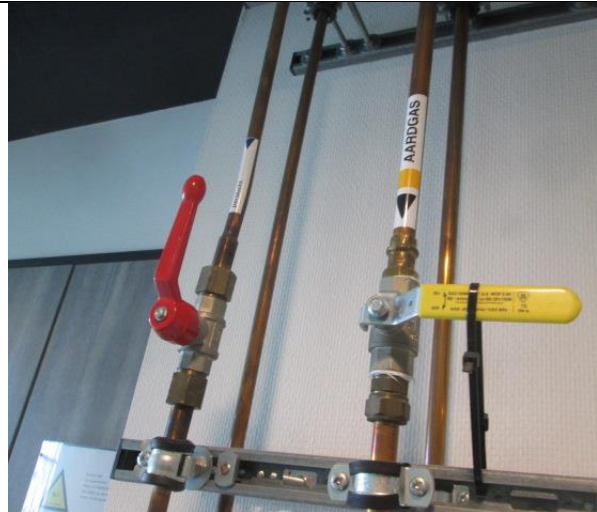
Gases: Some ignitable gases are being distributed via copper pipes to the various laboratories. The gas systems are properly maintained and gas bottles are stored outside the building in well-ventilated rooms. The gas distribution is fully maintained and arranged by the university. The risk is adequate controlled.

Gas distribution pipes with valves in the corridors.

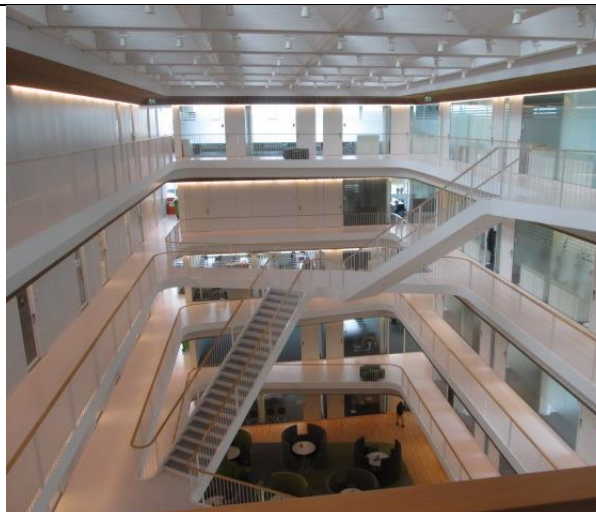
**Overall an average to good risk with normal to good controls. (Average). However LSI is sprinkler protected but has an open structure that can cause a serious smoke and soot damage. Alexander Numan has no sprinklers but compartmentation in combination with fire detection.**

The atrium of LSI (photo taken from the top floor)

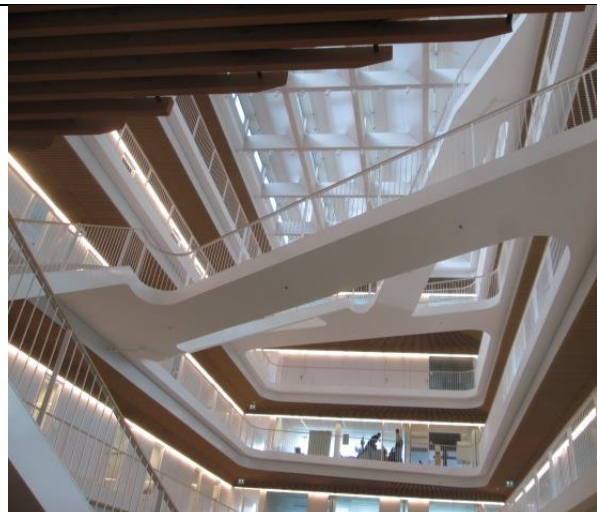
Atrium of LSI (photo taken from grade level)

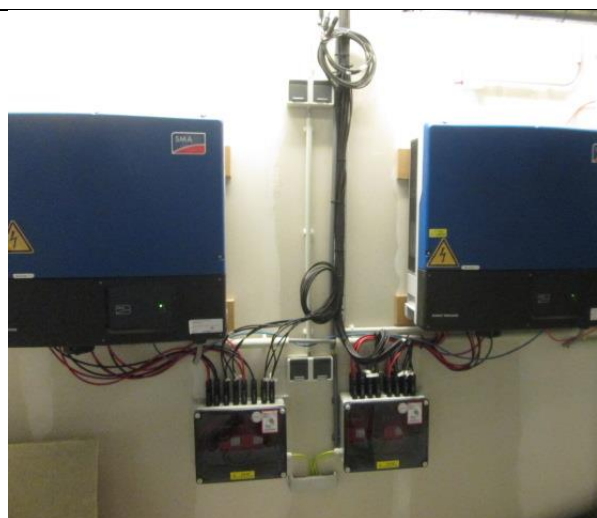
Inverters of LSI
